**SUMMARY REPORT  
146 BIRCH DRIVE (FORMERLY 110 BIRCH DRIVE)  
LAUREL BAY MILITARY HOUSING AREA  
MARINE CORPS AIR STATION BEAUFORT  
BEAUFORT, SC**

**Contract Number: N62470-14-D-9016  
CTO WE52  
JUNE 2021**

**FINAL**  
**ASSESSMENT REPORT**

LAUREL BAY HOUSING AREA, 110 BIRCH STREET  
MARINE CORPS AIR STATION, BEAUFORT, SOUTH CAROLINA

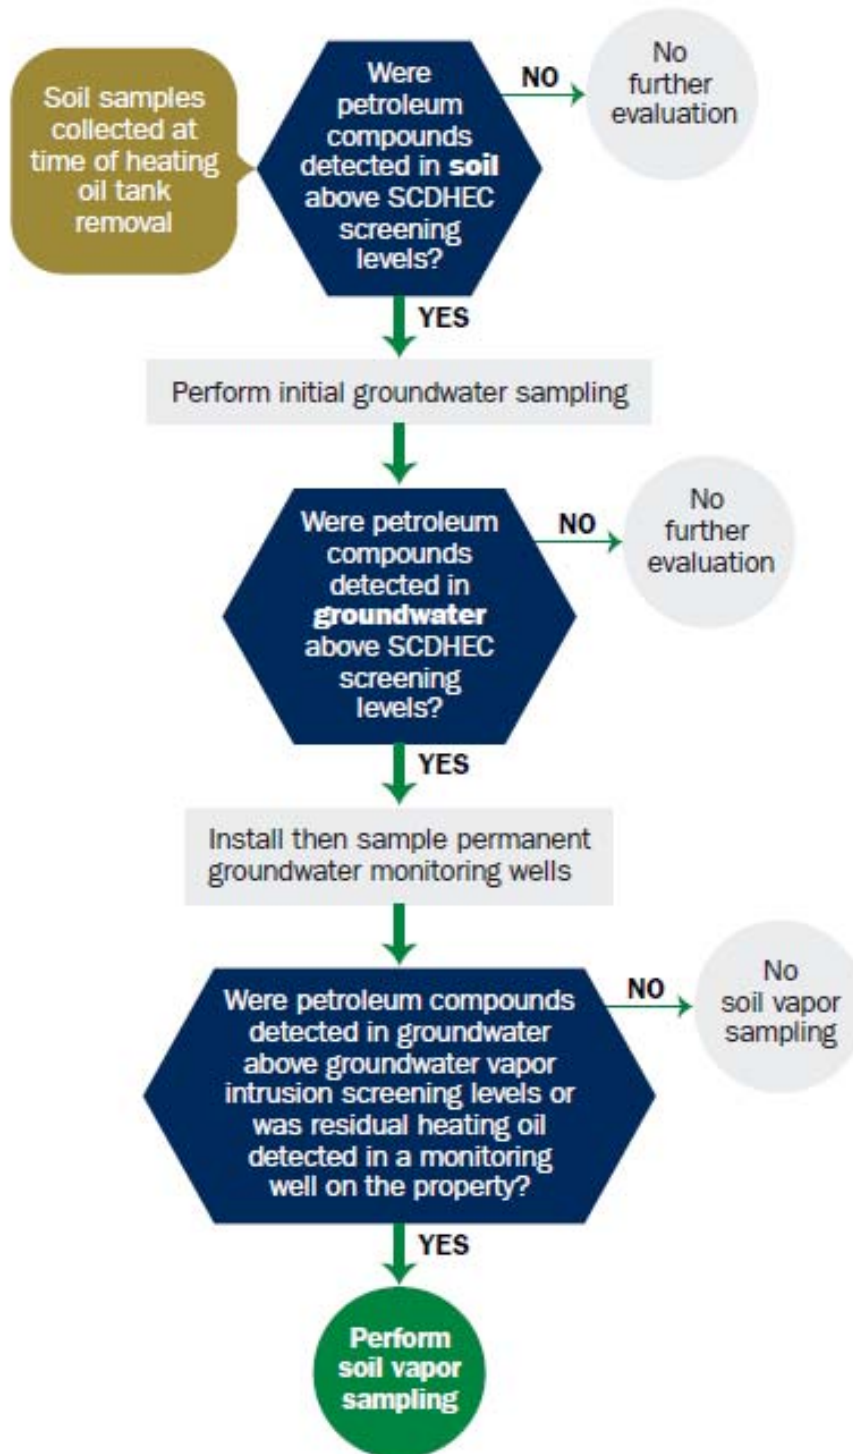
Appendix A - Multi-Media Selection Process for LBMH

The LBMH UST removal and assessment process is described below in Section 1.2. The LBMH multi-media investigation selection process tree, used to evaluate the environmental impact of USTs for most sites at LBMH, is presented in Appendix A. It should be noted that because the USTs were removed prior to 2007, the subject property of this report did not follow the typical multi-media investigation selection process presented in Appendix A.
