**SUMMARY REPORT
39 BIRCH DRIVE (FORMERLY 113 BIRCH DRIVE)
LAUREL BAY MILITARY HOUSING AREA
MARINE CORPS AIR STATION BEAUFORT
BEAUFORT, SC**

**Contract Number: N62470-14-D-9016
CTO WE52
JUNE 2021**

South Carolina Department of Health and Environmental Control (SCDHEC)
Underground Storage Tank (UST) Assessment Report

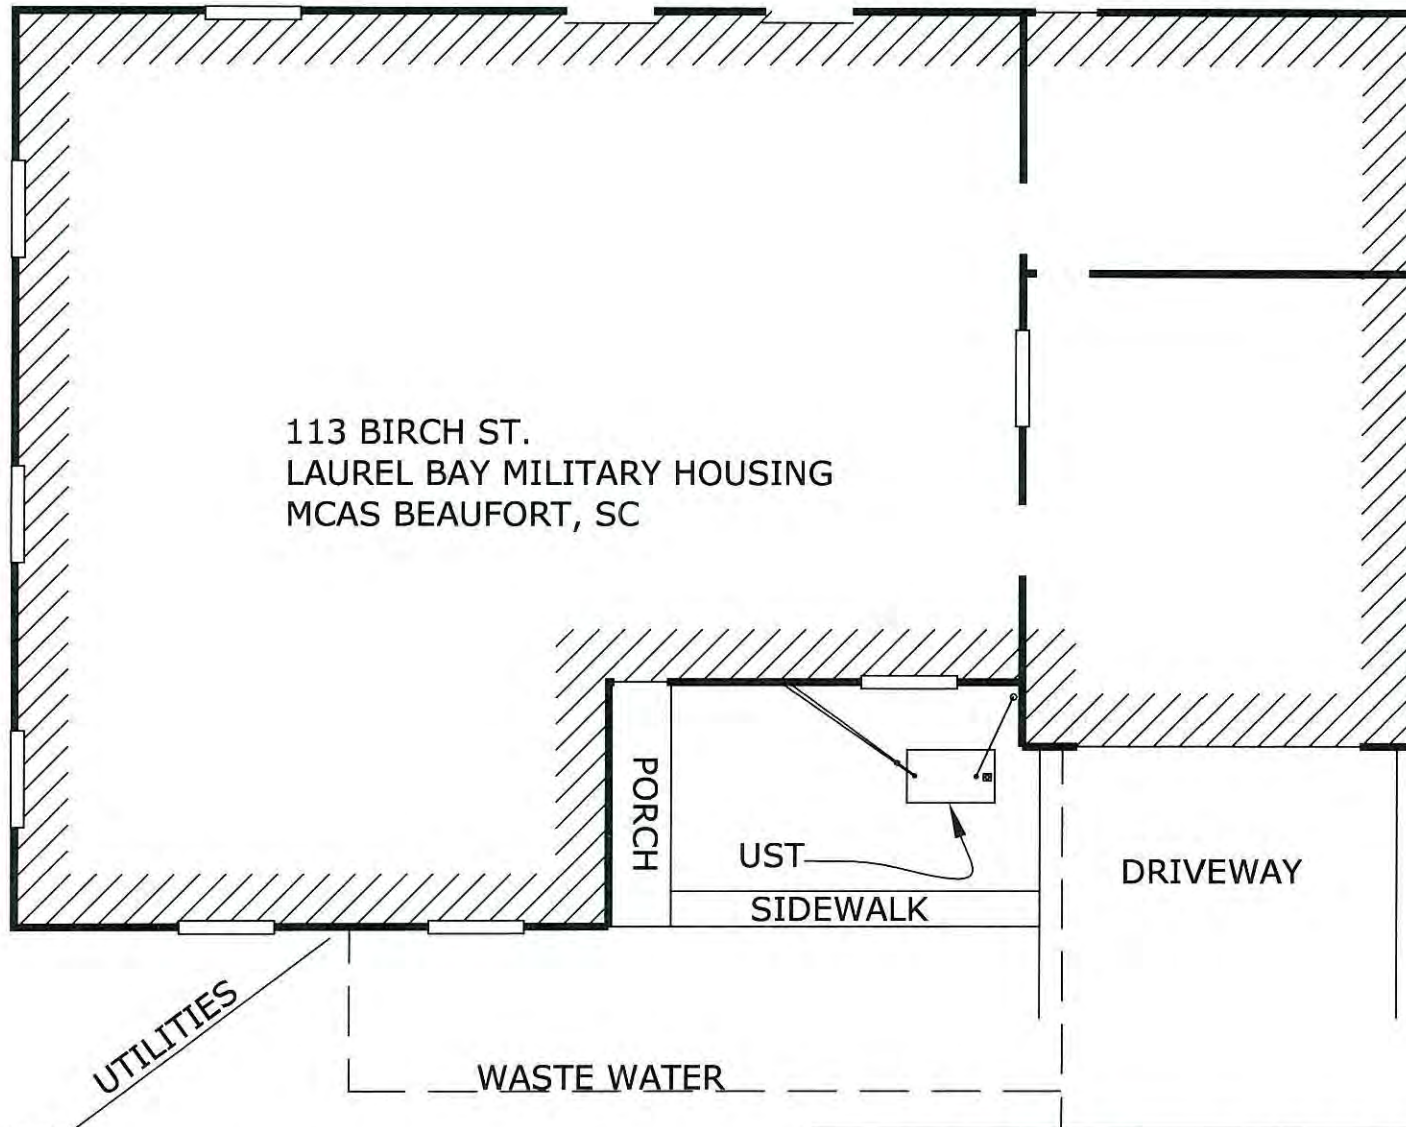
FIGURE 1 UST LOCATION
113 BIRCH ST., LAUREL BAY
MCAS BEAUFORT SC

UST

DRIVEWAY

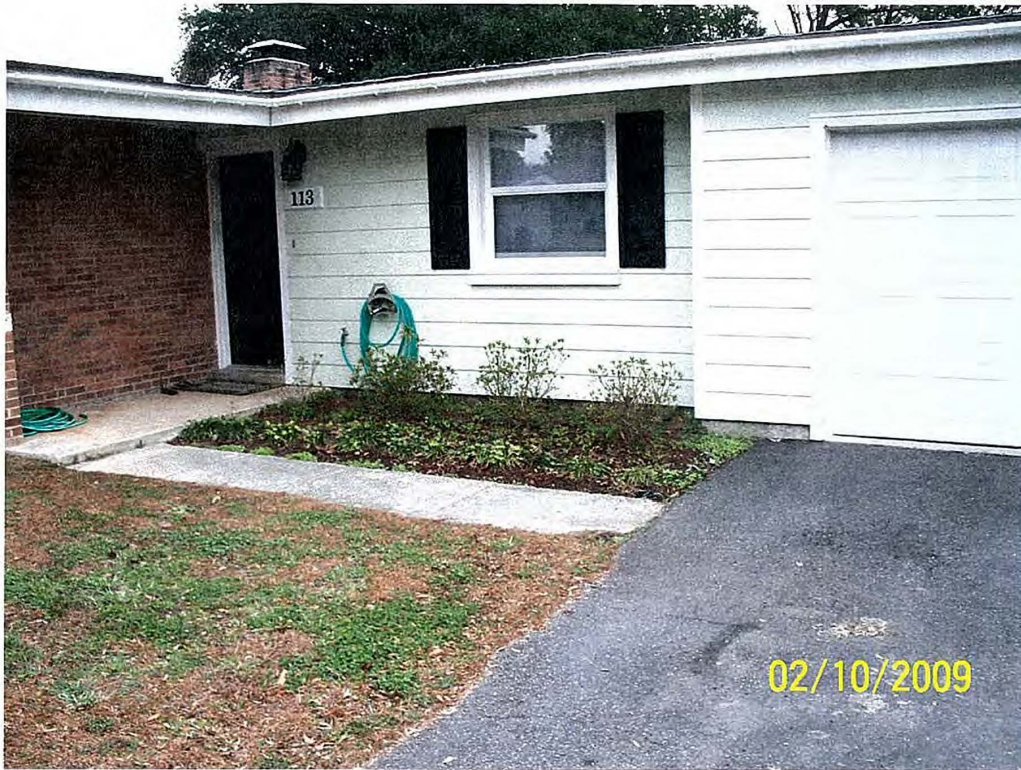
Picture 1: 113 Birch St. site prior to tank removal.

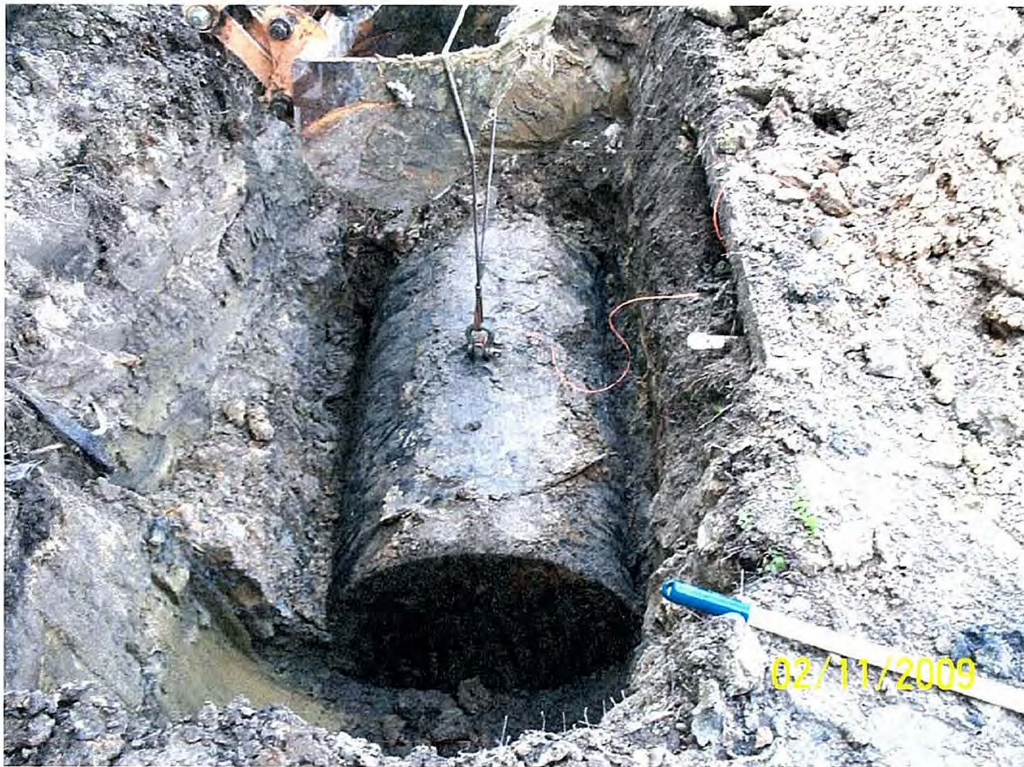
O. If any corrosion, pitting, or holes were observed, describe the location and extent for each UST
 Pitting and corrosion were found over the entire surface of the tank.
 Cleaning revealed seven 1/4 inch holes on the fill end, four near top, three on the bottom seam.

Picture 2: 113 Birch St. UST during excavation.

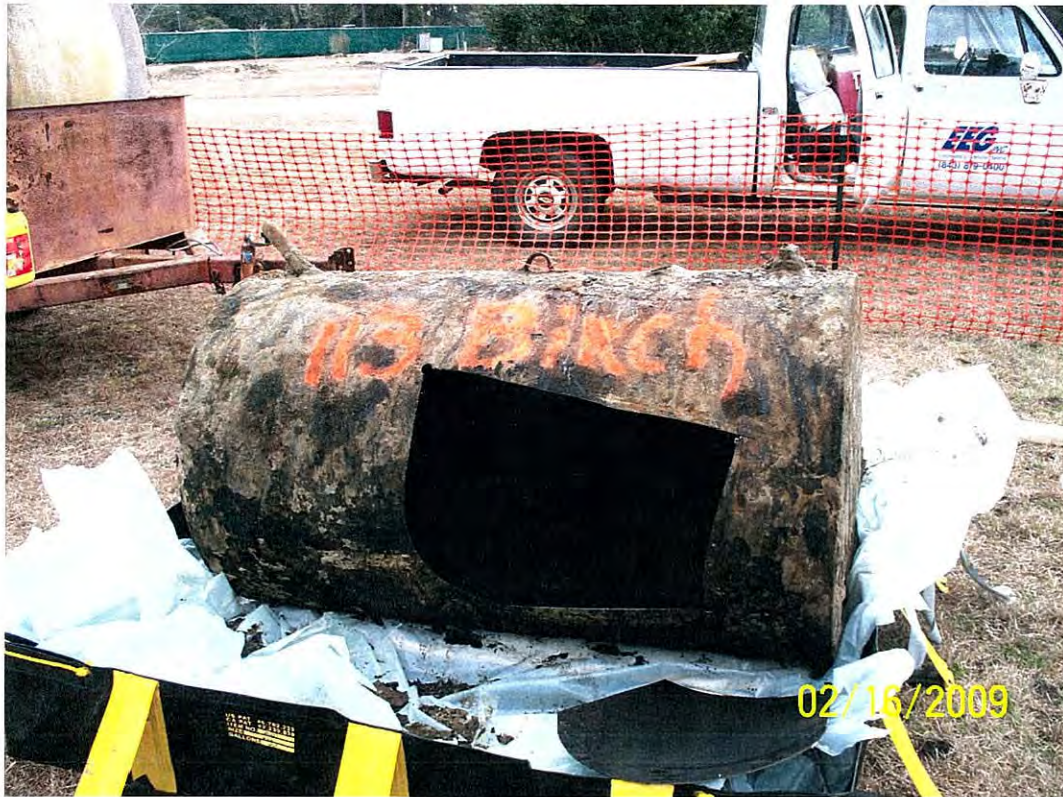
Picture 3: Demolition of tank in process.

M. Method of disposal for any USTs removed from the ground (attach disposal manifests)
 Tank was removed from the ground, cleaned, cut up
 and the steel re-cycled.
