**SUMMARY REPORT
102 BANYAN DRIVE (FORMERLY 122 BANYAN DRIVE)
LAUREL BAY MILITARY HOUSING AREA
MARINE CORPS AIR STATION BEAUFORT
BEAUFORT, SC**

JUNE 2021

**Contract Number: N62470-14-D-9016
CTO WE52
JUNE 2021**

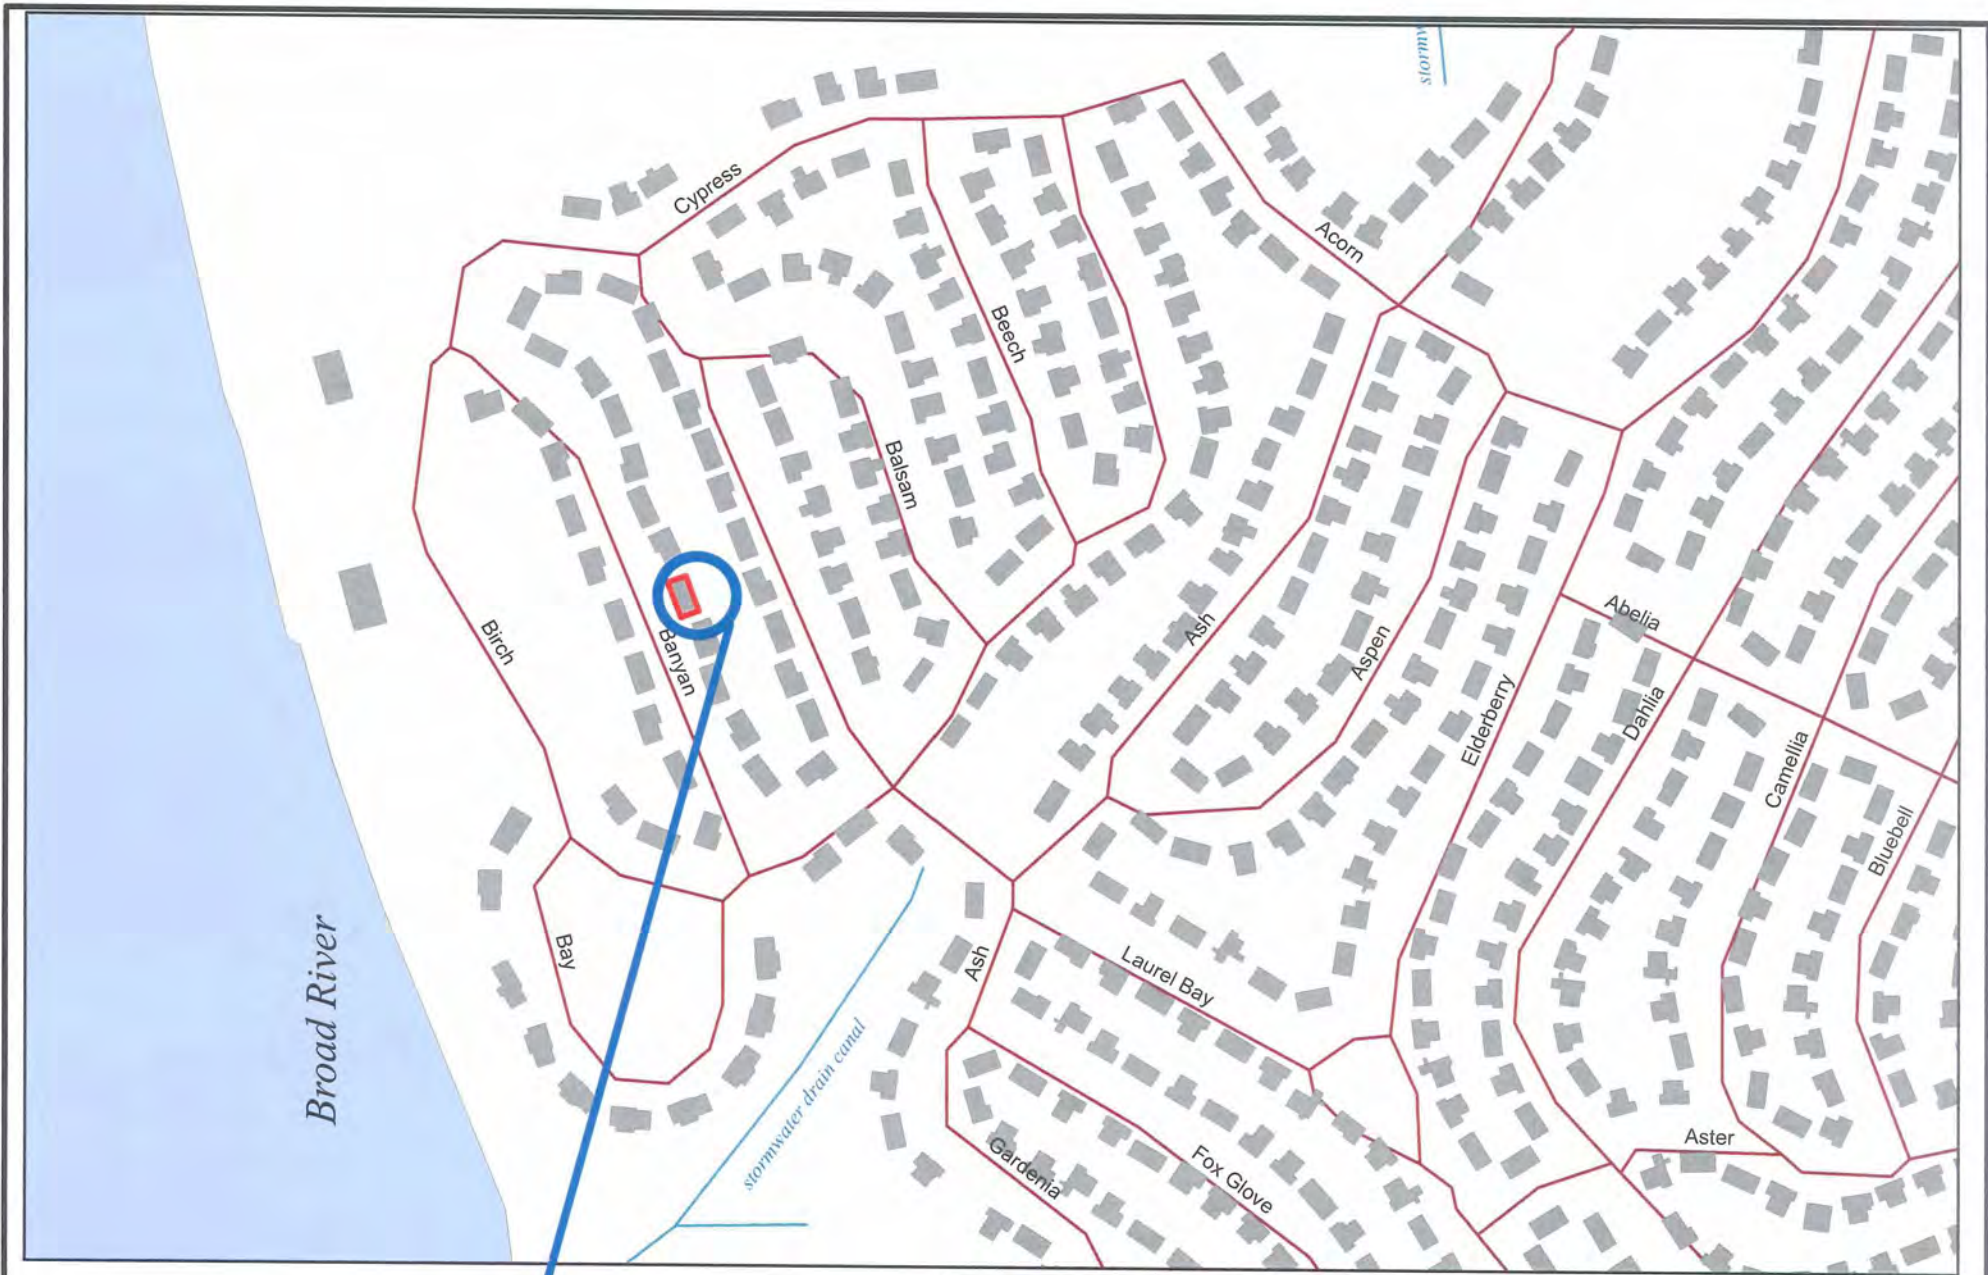
**FIGURE 1: LOCATION MAP
122 BANYAN DRIVE
LAUREL BAY, BEAUFORT SC**

BROAD RIVER \approx 740'

122 BANYAN DRIVE
LAUREL BAY MILITARY HOUSING
MCAS BEAUFORT, SC

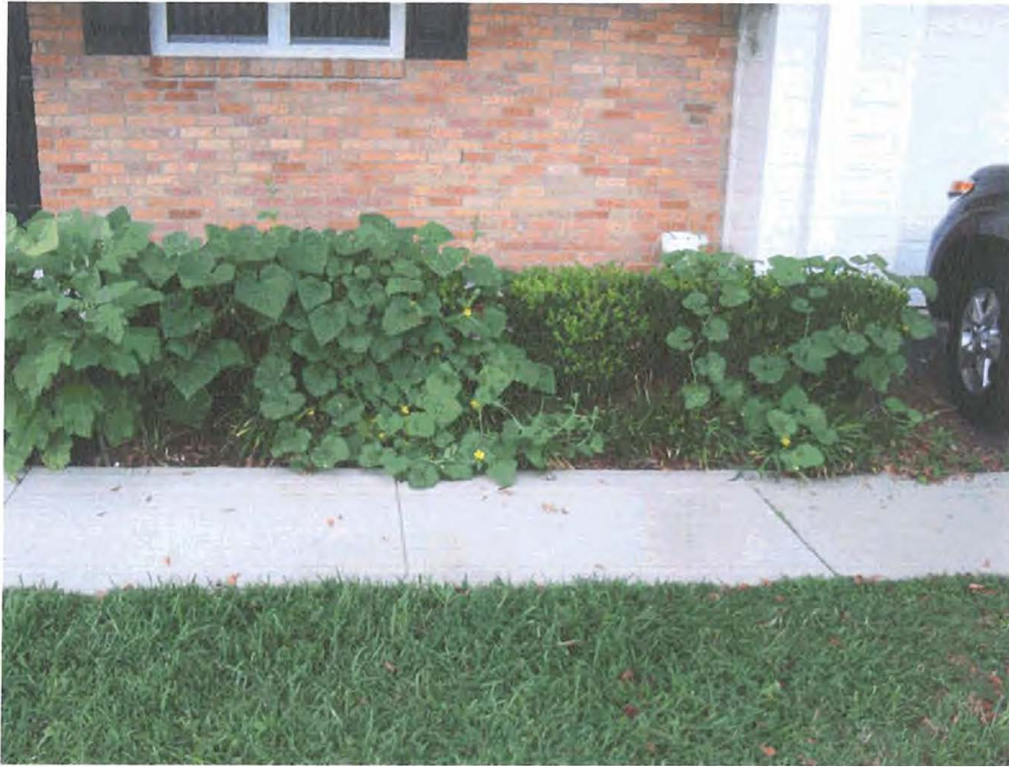
Picture 1: UST 122Banyan location.

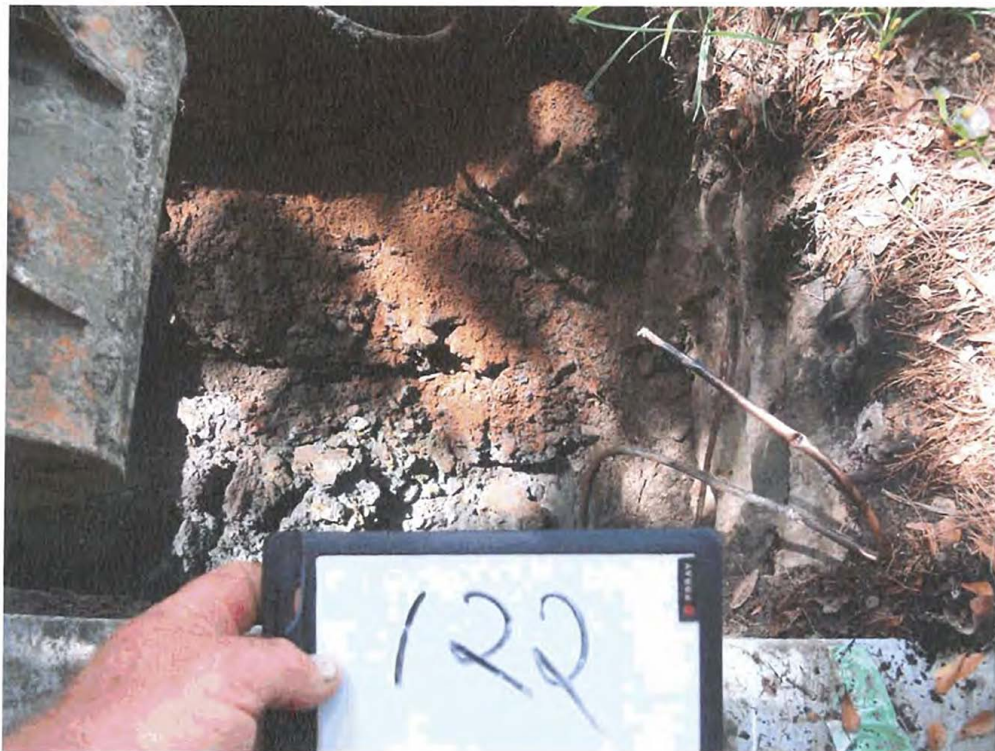
O. If any corrosion, pitting, or holes were observed, describe the location and extent for each UST
Corrosion, pitting and holes were present throughout the tank.

Picture 2: UST 122Banyan tank pit after removal of tank.
