**SUMMARY REPORT
378 BIRCH DRIVE (FORMERLY 135 BIRCH DRIVE)
LAUREL BAY MILITARY HOUSING AREA
MARINE CORPS AIR STATION BEAUFORT
BEAUFORT, SC**

JUNE 2021

CDM - AECOM
Multimedia Joint Venture

**Contract Number: N62470-14-D-9016
CTO WE52
JUNE 2021**

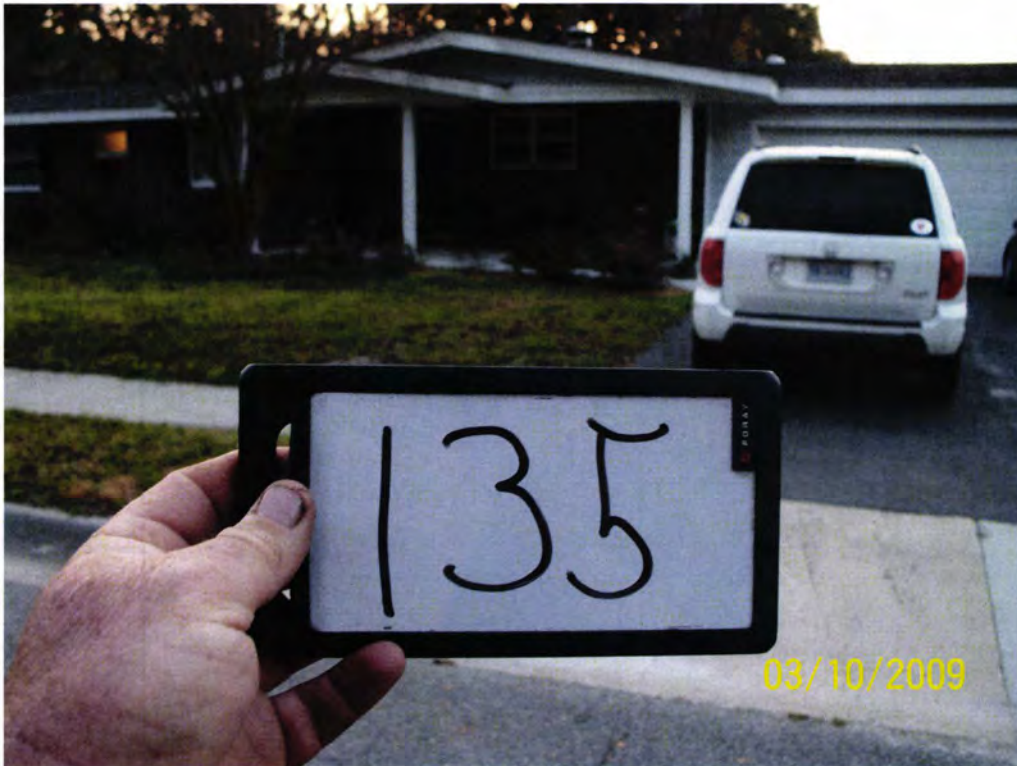
Picture 1: 135 Birch St. site.

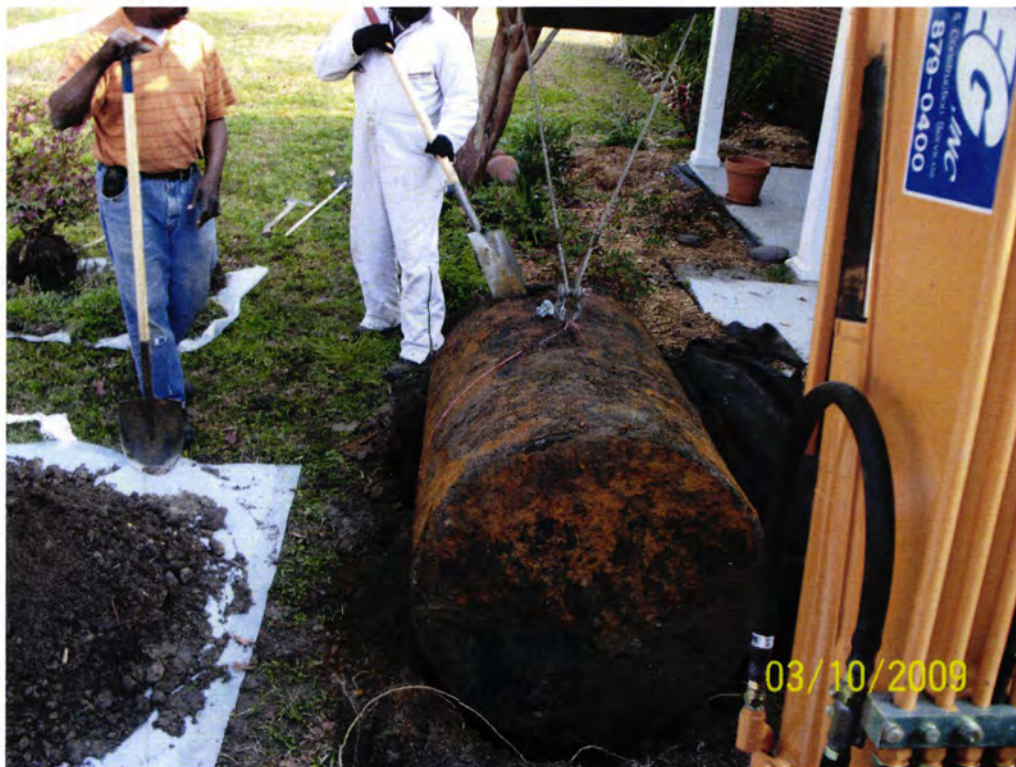
O. If any corrosion, pitting, or holes were observed, describe the location and extent for each UST
 Corrosion, pitting and holes were found on the entire surface.

Picture 2: UST 135Birch being removed from the excavation.
