SUMMARY REPORT
27 BEECH STREET (FORMERLY 252 BEECH STREET)
LAUREL BAY MILITARY HOUSING AREA
MARINE CORPS AIR STATION BEAUFORT
BEAUFORT, SC

Contract Number: N62470-14-D-9016
CTO WE52
JUNE 2021

South Carolina Department of Health and Environmental Control (SCDHEC)
Underground Storage Tank (UST) Assessment Report

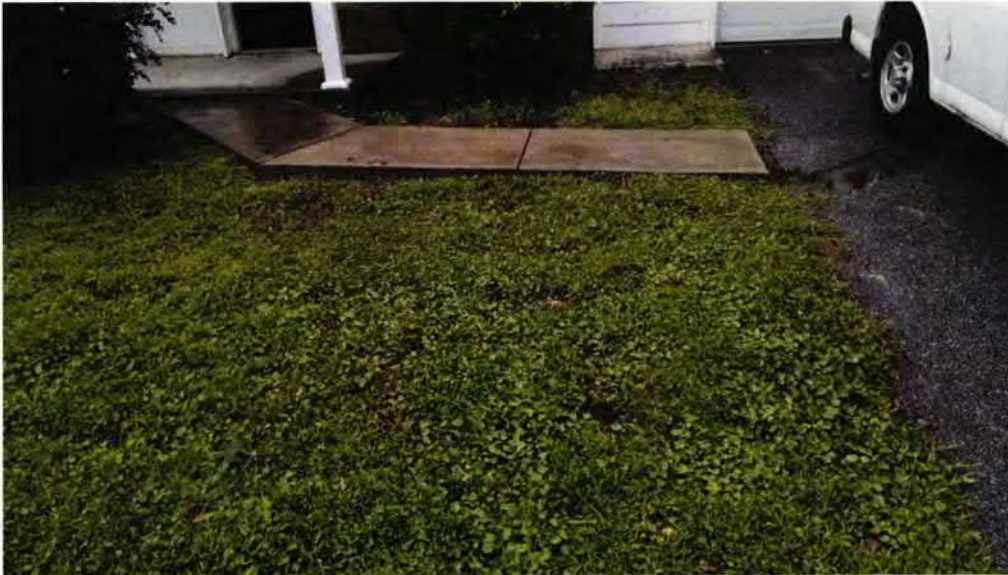
Picture 1: Location of UST 252Beech.

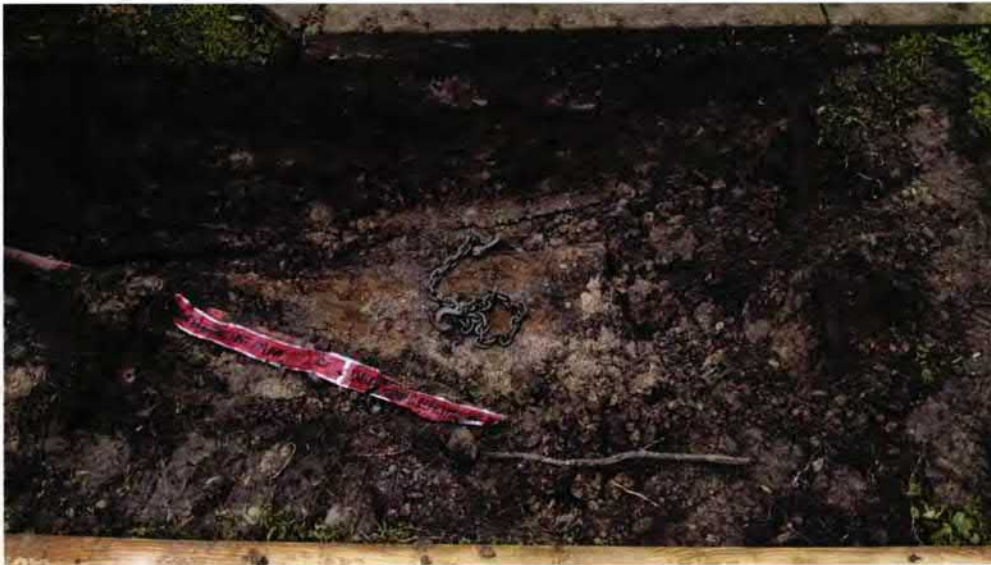
O. If any corrosion, pitting, or holes were observed, describe the location and extent for each UST
Corrosion, pitting and holes were found throughout the tank.

Steel vent pitting was corroded and pitted.

Picture 2: UST 252Beech excavation.

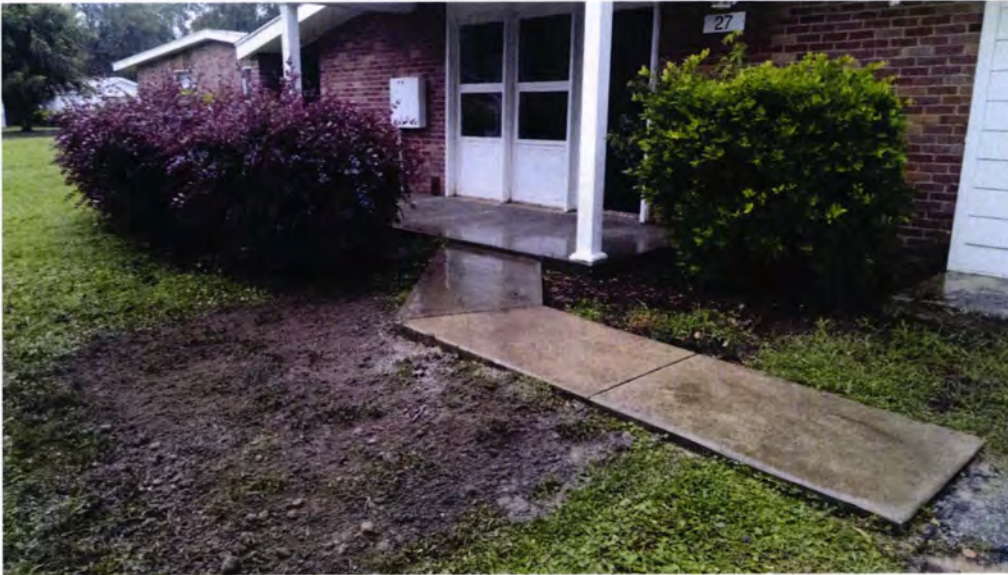
Picture 3: Site after completion of work.
