**SUMMARY REPORT
68 BANYAN DRIVE (FORMERLY 118 BANYAN DRIVE)
LAUREL BAY MILITARY HOUSING AREA
MARINE CORPS AIR STATION BEAUFORT
BEAUFORT, SC**

**Contract Number: N62470-14-D-9016
CTO WE52
JUNE 2021**

The following section presents the sampling activities and associated results for 68 Banyan Drive (Formerly 118 Banyan Drive). Details regarding the soil investigation at this site are provided in the *SCDHEC UST Assessment Report – 118 Banyan Drive* (MCAS Beaufort, 2011). The UST Assessment Report is provided in Appendix B. Details regarding the IGWA sampling activities at this site are provided in the *Initial Groundwater Investigation Report – November and December 2015* (Resolution Consultants, 2016). The laboratory report that includes the pertinent IGWA analytical results for this site is presented in Appendix C.

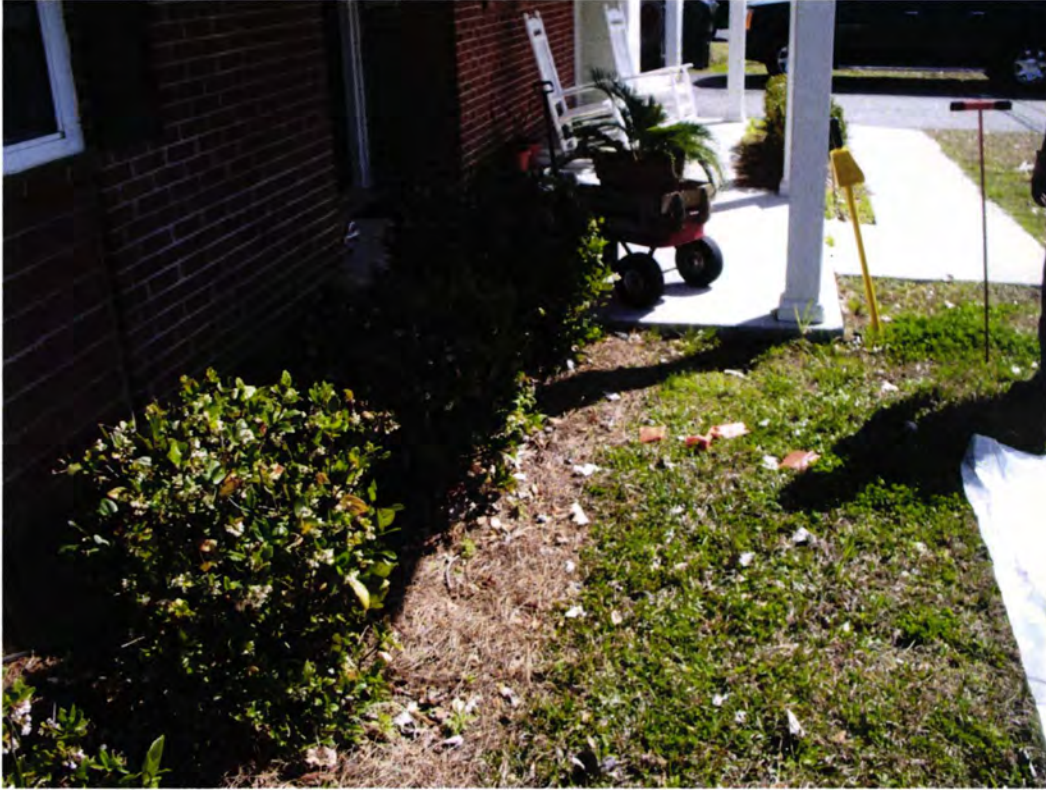
Picture 1: Location of UST 118Banyan.

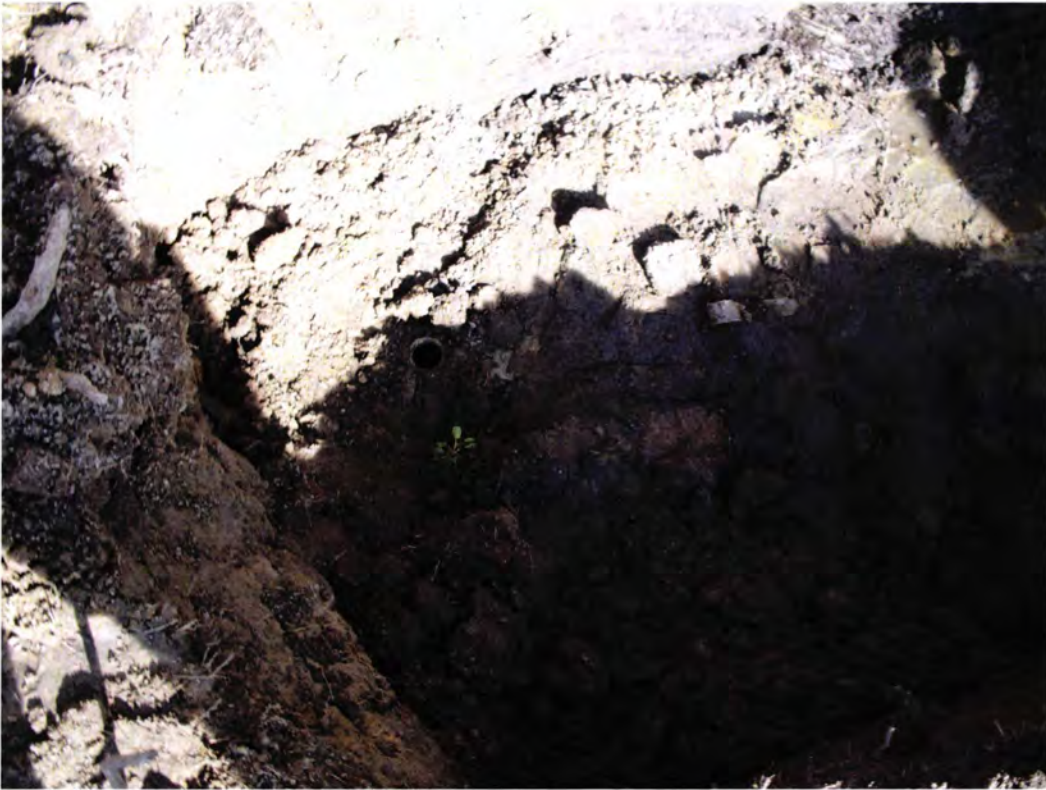
- M. Method of disposal for any USTs removed from the ground (attach disposal manifests)
UST 118Banyan was removed from the ground, cleaned and recycled.
See Attachment "A".
- N. Method of disposal for any liquid petroleum, sludges, or wastewaters removed from the USTs (attach disposal manifests)
Contaminated water was pumped from the tank and disposed by MCAS.
- O. If any corrosion, pitting, or holes were observed, describe the location and extent for each UST
Corrosion, pitting and holes were found throughout the tank.

Picture 2: UST 118Banyan in tank excavation.
