**SUMMARY REPORT
20 BIRCH DRIVE (FORMERLY 136 BIRCH DRIVE)
LAUREL BAY MILITARY HOUSING AREA
MARINE CORPS AIR STATION BEAUFORT
BEAUFORT, SC**

**Contract Number: N62470-14-D-9016
CTO WE52
JUNE 2021**

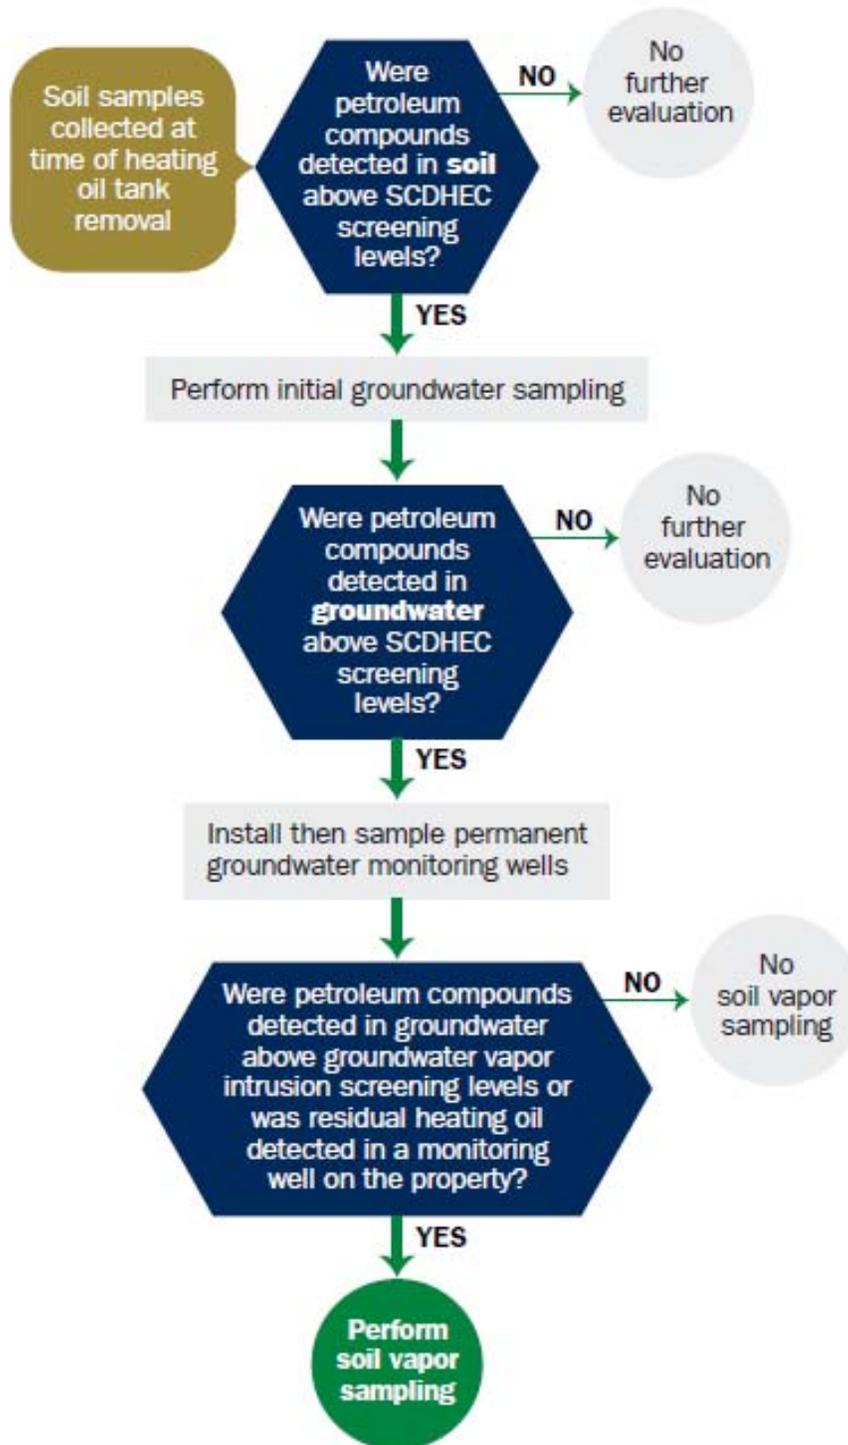
Appendix A - Multi-Media Selection Process for LBMH

The results of the soil sampling at each former UST location were used to determine if a potential for groundwater contamination exists (i.e., soil results greater than RBSLs) and subsequently to select properties for follow-up initial groundwater assessment (IGWA) sampling. The results of the IGWA sampling (if necessary) are used to determine the presence or absence of the aforementioned COPCs in groundwater and identify whether former UST locations will require additional delineation of COPCs in groundwater. In order to delineate the extent of impact to groundwater, permanent wells are installed and a sampling program is established for those former UST locations where IGWA sampling has indicated the presence of COPCs in excess of the SCDHEC RBSLs for groundwater. Groundwater analytical results are also compared to the site specific groundwater vapor intrusion screening levels (VISLs) to evaluate the potential for vapor intrusion and the necessity for an investigation associated with this media. A multi-media investigation selection process tree, applicable to the LBMH UST investigations, is presented as Appendix A.

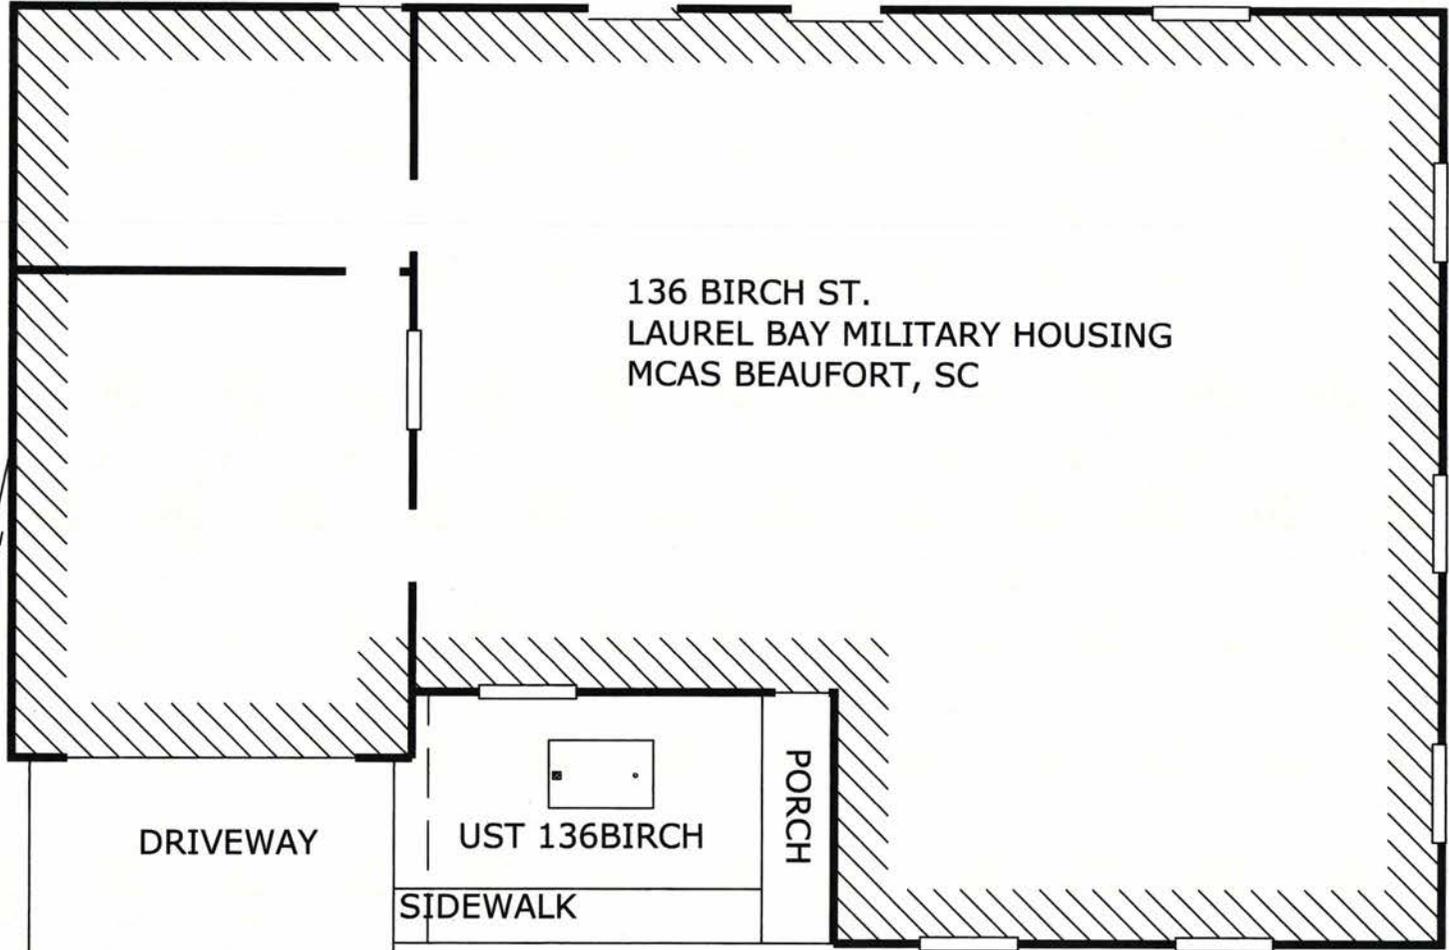
FIGURE 2 SITE MAP
136 BIRCH ST., LAUREL BAY
MCAS BEAUFORT SC

DRIVEWAY

UST 136BIRCH

PORCH

SIDEWALK

WASTE WATER

POWER
POLE

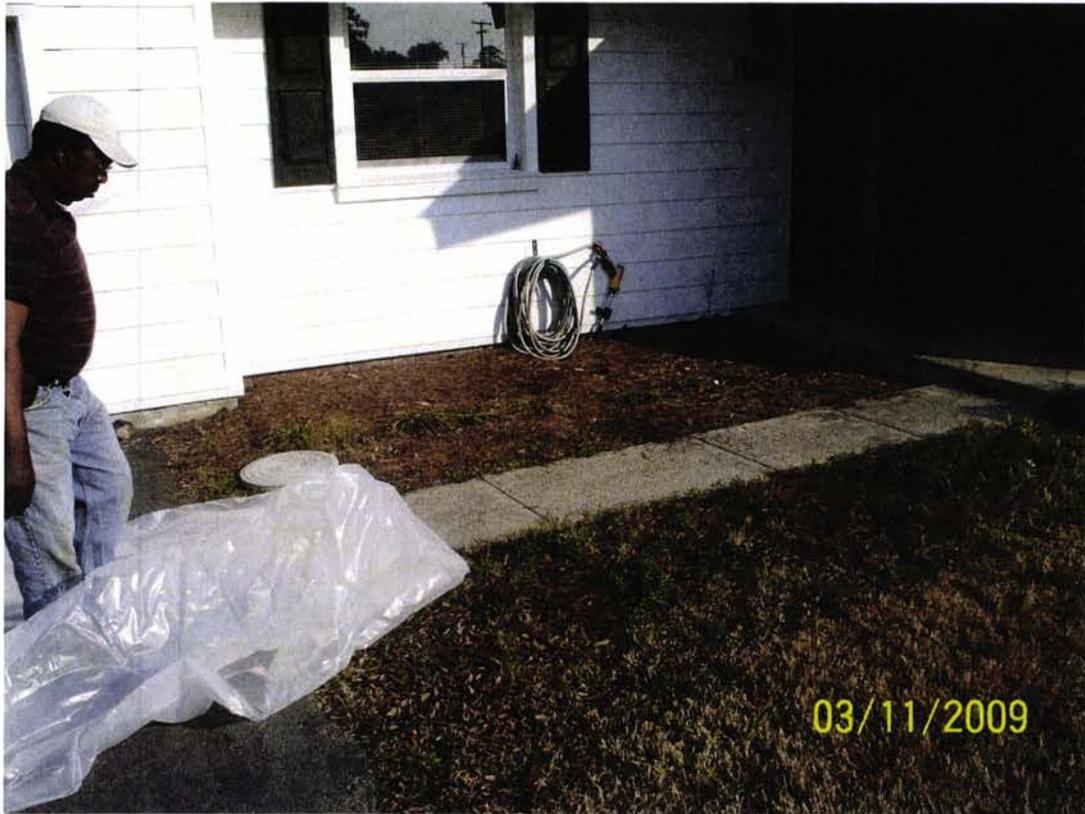
Picture 1: 136 Birch St. site prior to excavation.

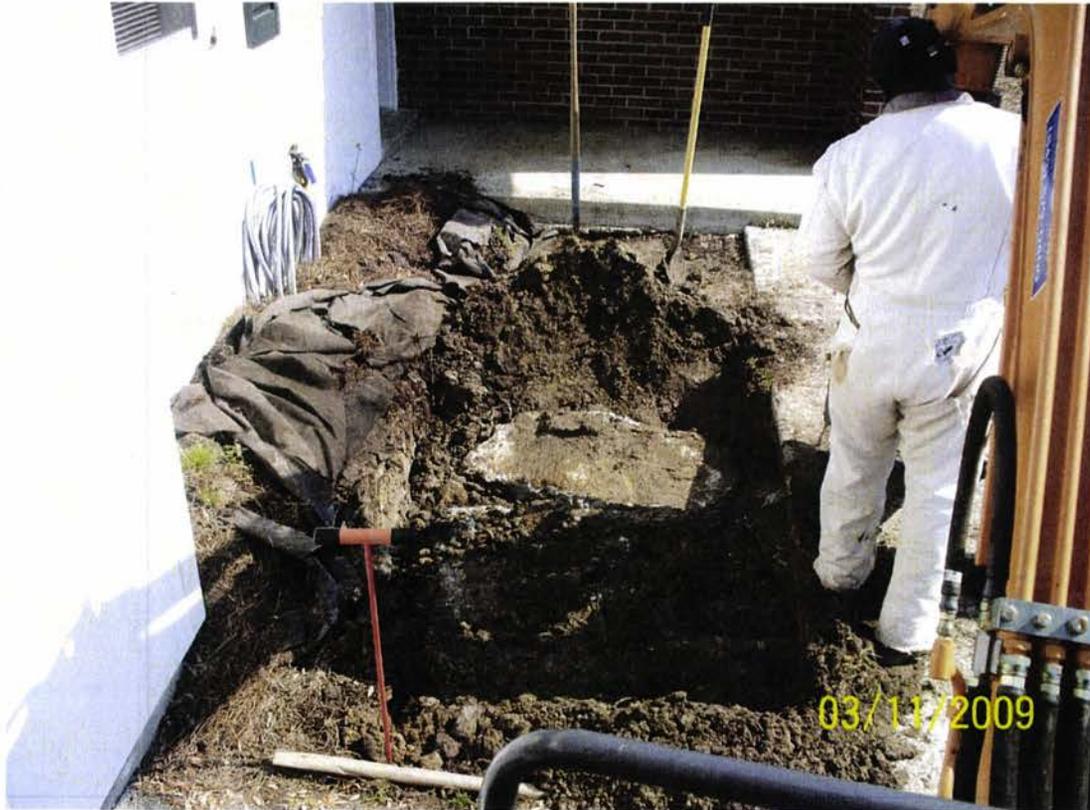
O. If any corrosion, pitting, or holes were observed, describe the location and extent for each UST
 Corrosion, pitting and holes were found on the entire surface of the tank.

Picture 2: 136 Birch St. UST with concrete pad on top.

M. Method of disposal for any USTs removed from the ground (attach disposal manifests)
 Tank was removed from the ground, cleaned and recycled. See Attachment "A".
