SUMMARY REPORT
827 WEST LAUREL BAY BOULEVARD
(FORMERLY 138 WEST LAUREL BAY BOULEVARD)
LAUREL BAY MILITARY HOUSING AREA
MARINE CORPS AIR STATION BEAUFORT
BEAUFORT, SC

JUNE 2021

Contract Number: N62470-14-D-9016
CTO WE52
JUNE 2021

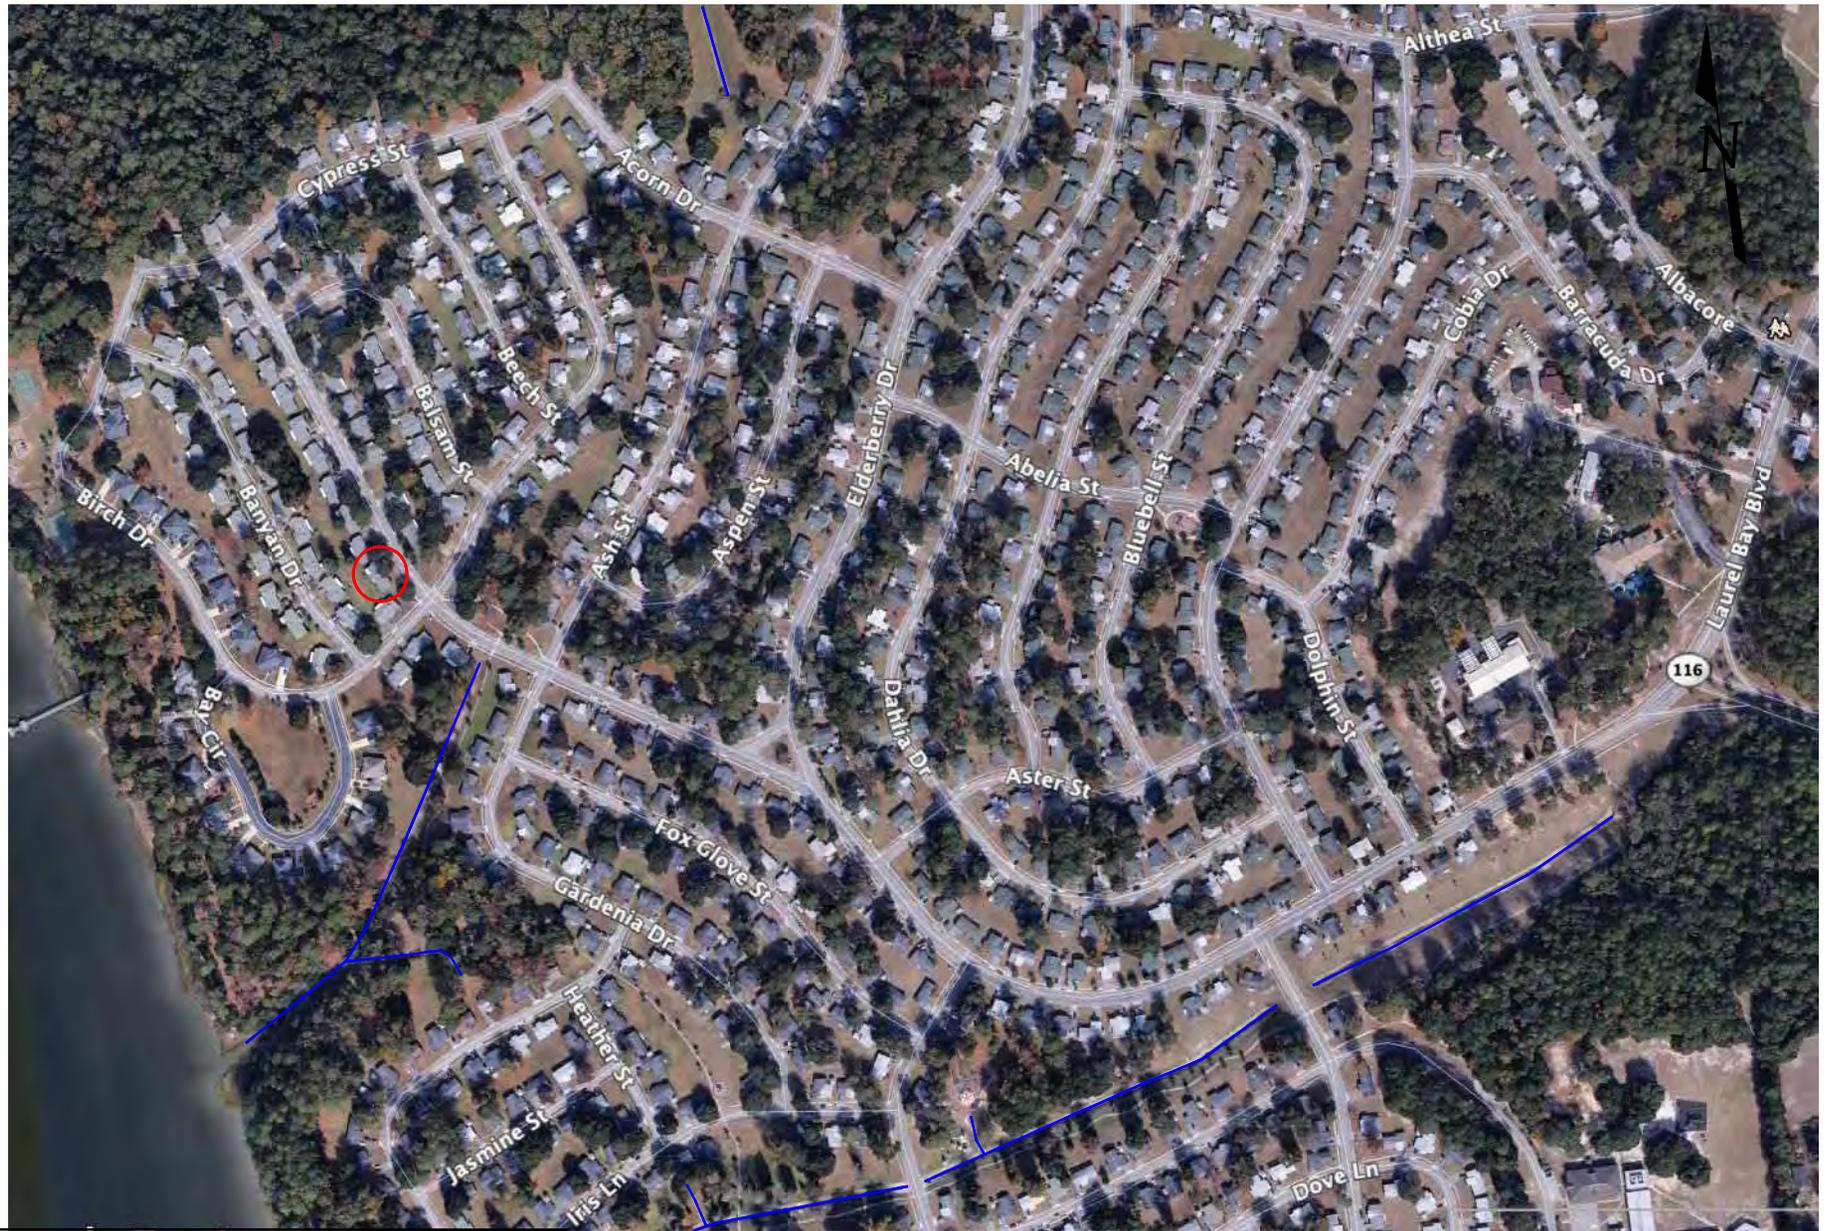
FIGURE 1: UST REMOVAL SITE MAP
 827 W LAUREL BAY BLVD (FORMERLY 138 W
 LAUREL BAY BLVD)
 LAUREL BAY HOUSING AREA
 MCAS BEAUFORT, SC

On December 16, 2019, a single 280 gallon heating oil UST was removed from the front landscaped area, adjacent to the concrete porch at 827 West Laurel Bay Boulevard (Formerly 138 West Laurel Bay Boulevard). The former UST location is indicated on Figures 2 and 3 of the UST Assessment Report (Appendix E). The UST was removed and properly disposed of (i.e., shipped offsite for recycling or transported to a landfill). There was no visual evidence (i.e., staining or sheen) of petroleum impact at the time of the UST removal. According to the UST Assessment Report (Appendix E), the depth to the base of the UST was 4'3" bgs. A single soil sample was collected from a depth of 2'1" bgs. The sample was collected from the fill port side of the former UST to represent a worst case scenario and shipped to an offsite laboratory for analysis of the petroleum COPCs. Sampling was performed in accordance with applicable South Carolina regulation R.61-92, Part 280 (SCDHEC, 2017) and assessment guidelines.

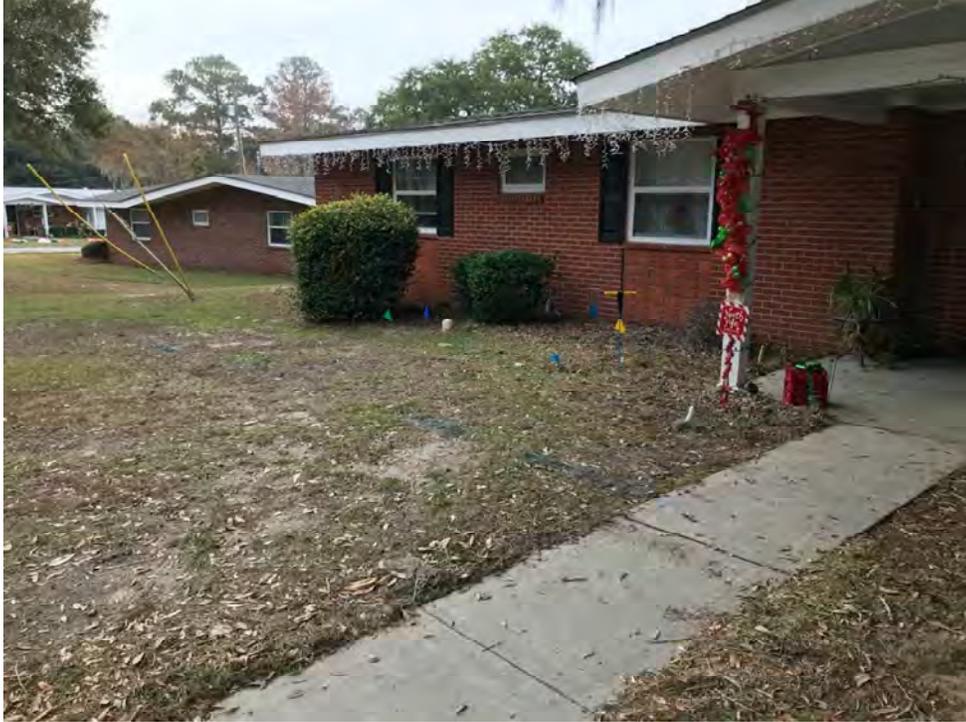
Photo 1: Tank Site Location

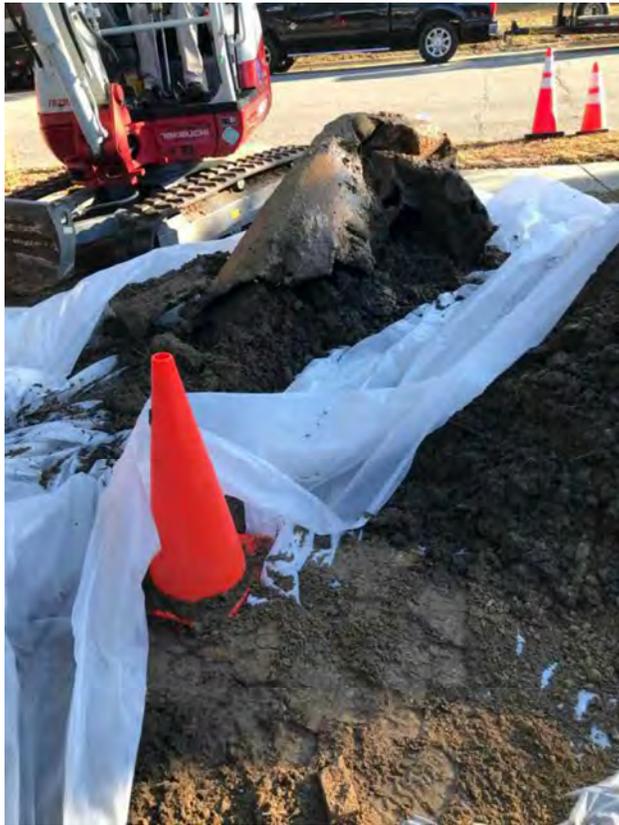
3. If any corrosion, pitting, or holes were observed, describe the location and extent for each UST:
Tank shell showed signs of corrosion. One large hole was found in the area of the fill port which appeared to have been created and utilized to fill the tank in place previously. Tank shell fell apart while being removed from the ground due to being highly corroded.

Photo 2: Tank Removed
