**SUMMARY REPORT**  
**840 WEST LAUREL BAY BOULEVARD (FORMERLY 139 WEST LAUREL BAY**  
**BOULEVARD)**  
**LAUREL BAY MILITARY HOUSING AREA**  
**MARINE CORPS AIR STATION BEAUFORT**  
**BEAUFORT, SC**

**JUNE 2021**

**Contract Number: N62470-14-D-9016**  
**CTO WE52**  
**JUNE 2021**

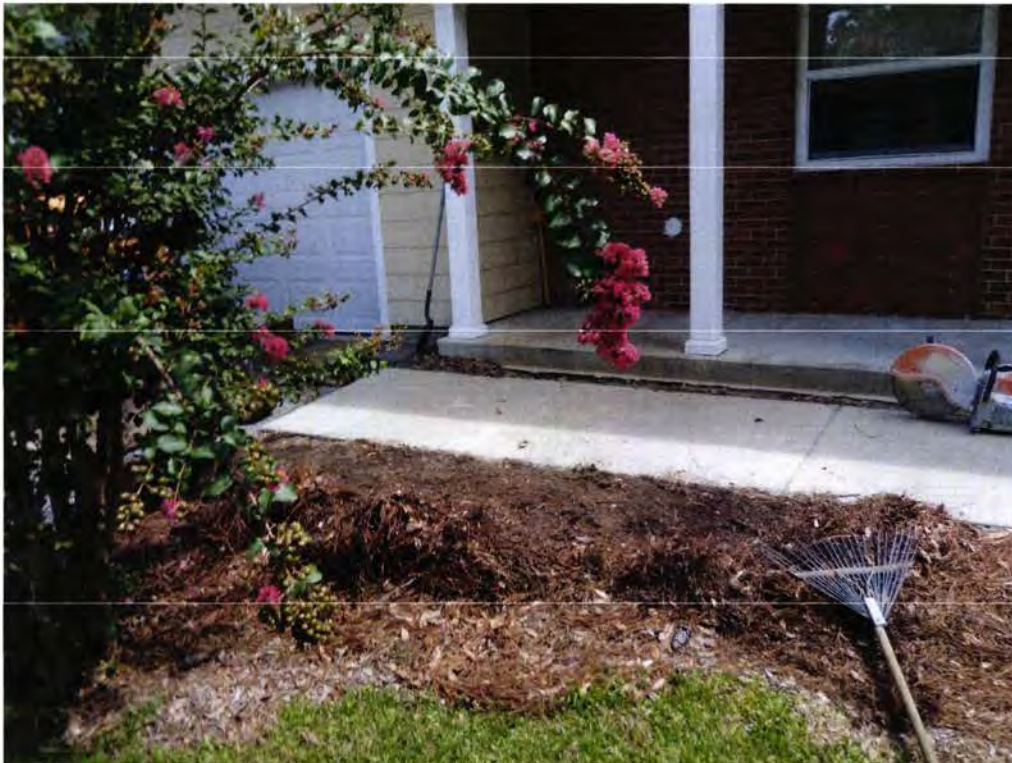
Picture 1: Location of UST 139LaurelBB.

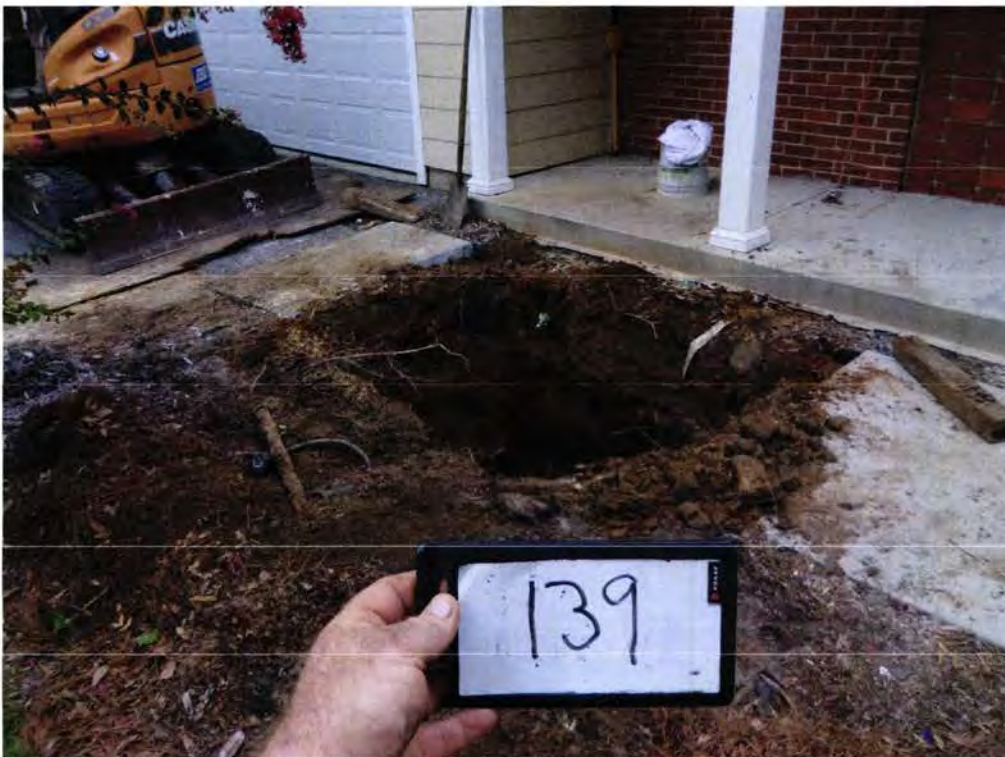
O. If any corrosion, pitting, or holes were observed, describe the location and extent for each UST  
Corrosion, pitting and holes were found throughout the tank.

Picture 2: Excavation of UST 139LaurelBB.
