SUMMARY REPORT
188 BIRCH ROAD (FORMERLY 287 BIRCH ROAD)
LAUREL BAY MILITARY HOUSING AREA
MARINE CORPS AIR STATION BEAUFORT
BEAUFORT, SC

Contract Number: N62470-14-D-9016
CTO WE52
JUNE 2021

South Carolina Department of Health and Environmental Control (SCDHEC)
Underground Storage Tank (UST) Assessment Report

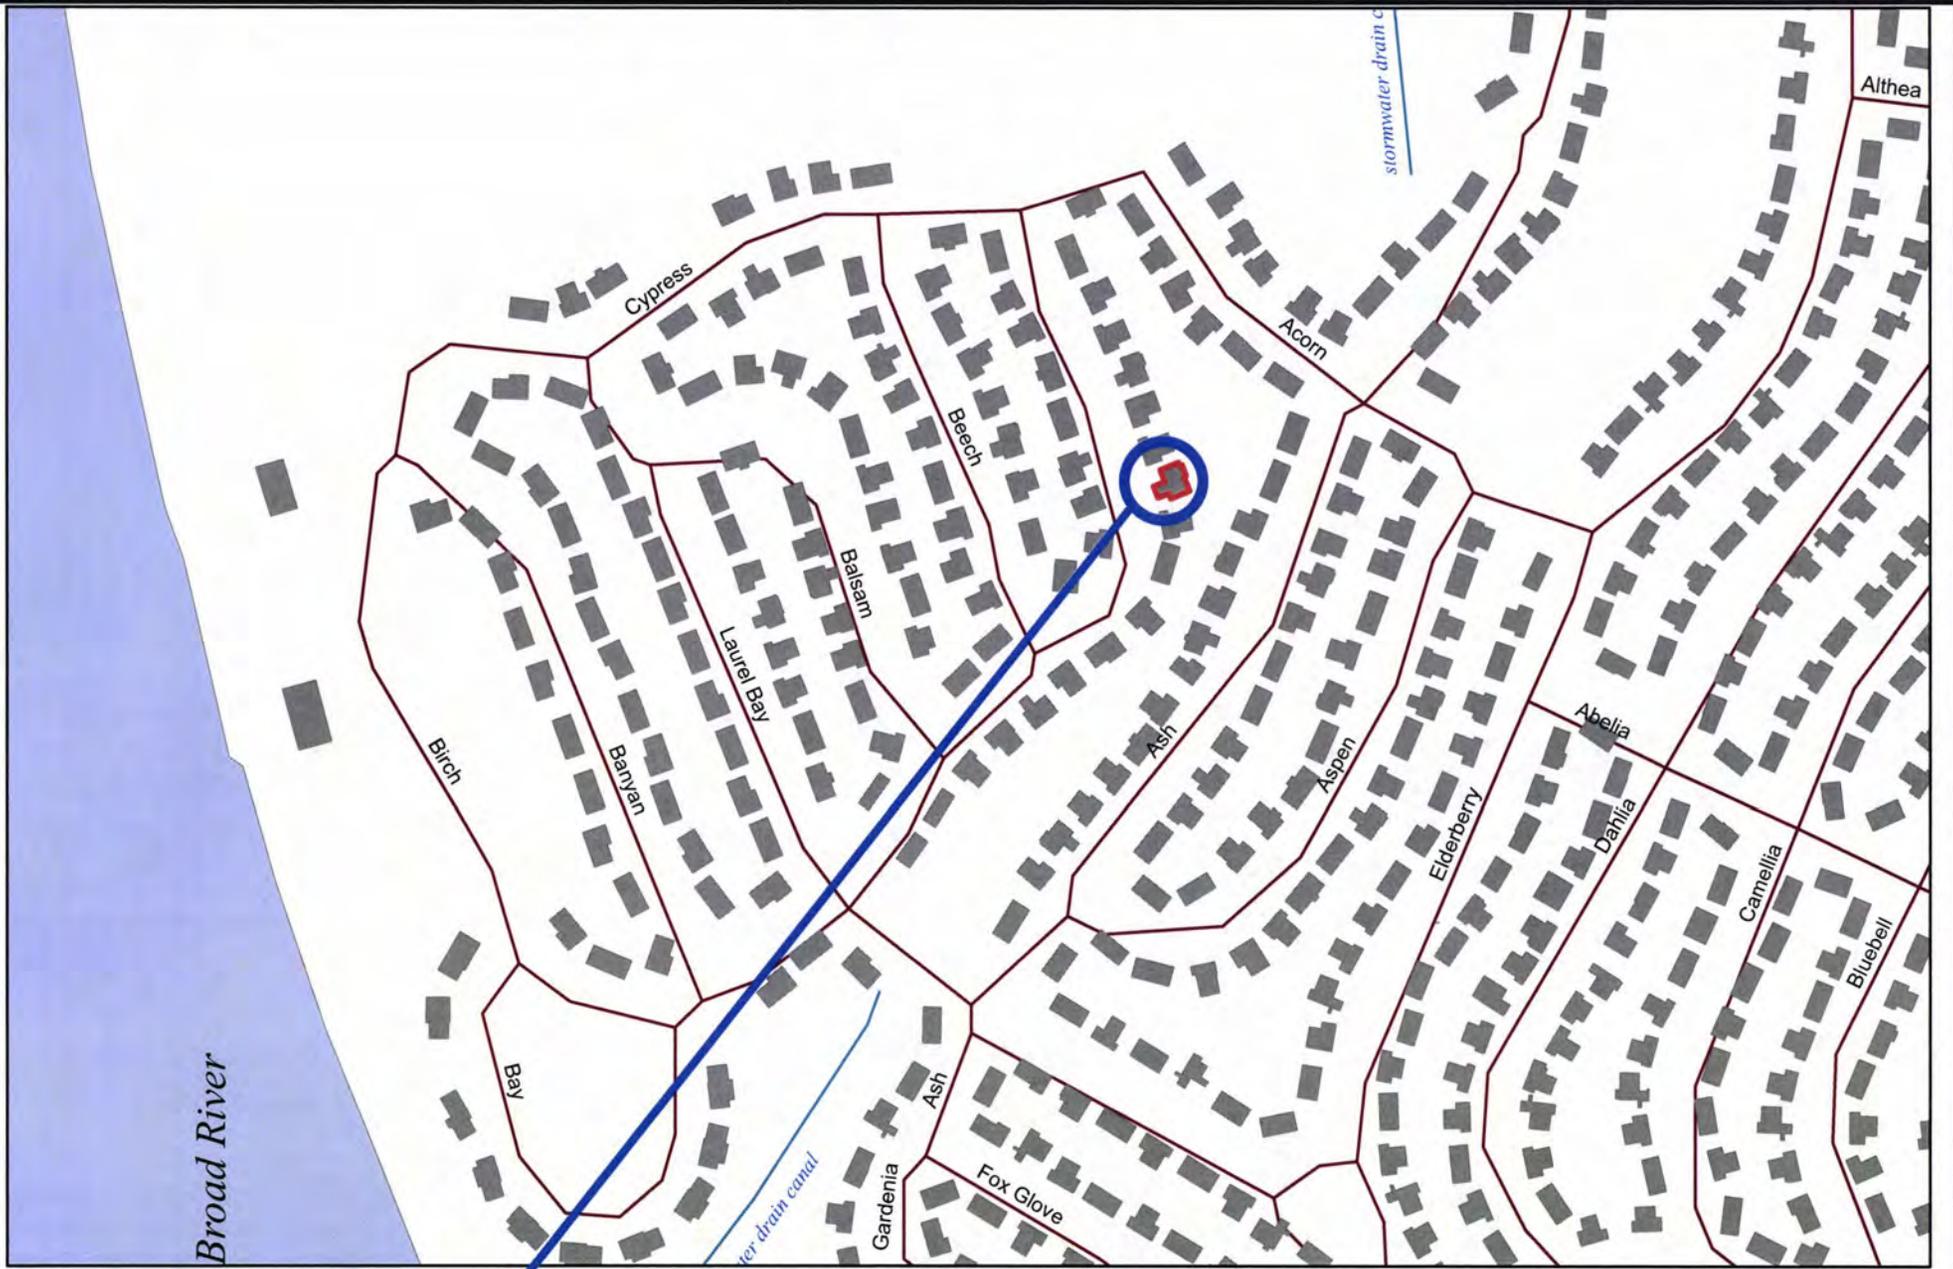
287 BIRCH DR.

You must supply a scaled site map. It should include all buildings, road names, utilities, tank and dispenser island locations, labeled sample locations, extent of excavation, and any other pertinent information.

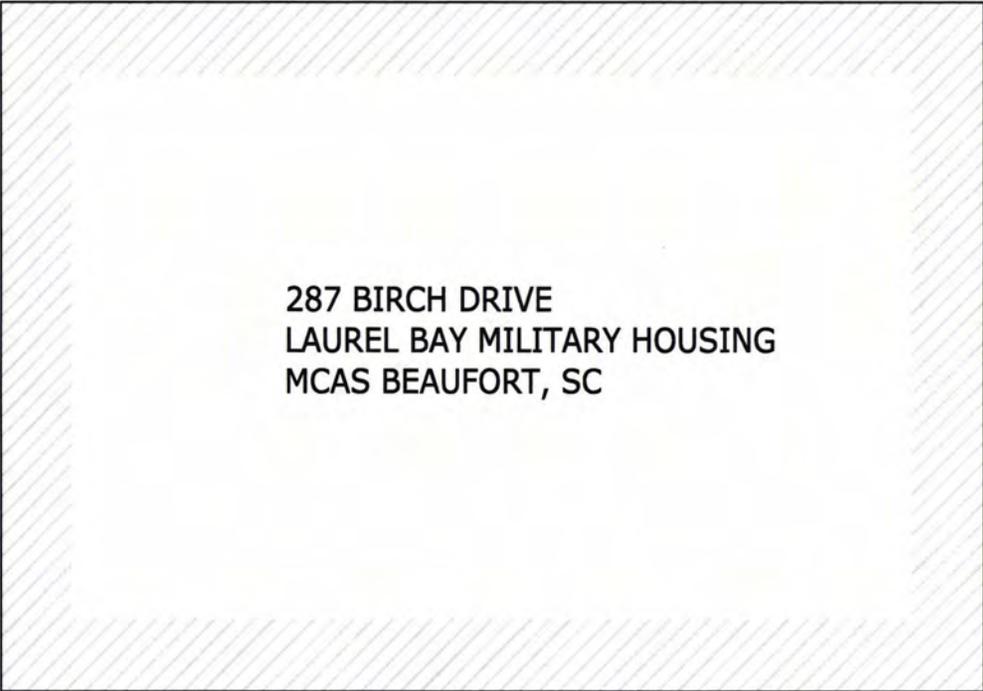
FIGURE 2 SITE MAP
287 BIRCH DR., LAUREL BAY
MCAS BEAUFORT SC

STORMWATER DRAINAGE
CANAL \approx 660'

UST 287BIRCH
280 GAL.

CONCRETE
PORCH & WALK

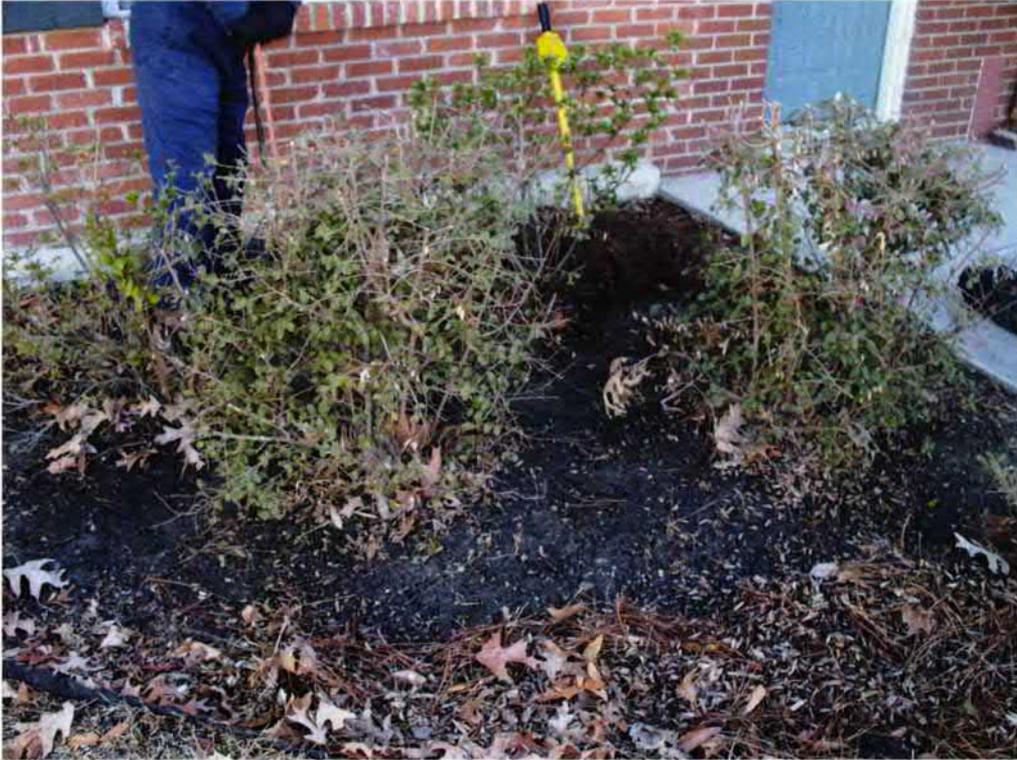
Picture 1: Location of UST 287Birch.

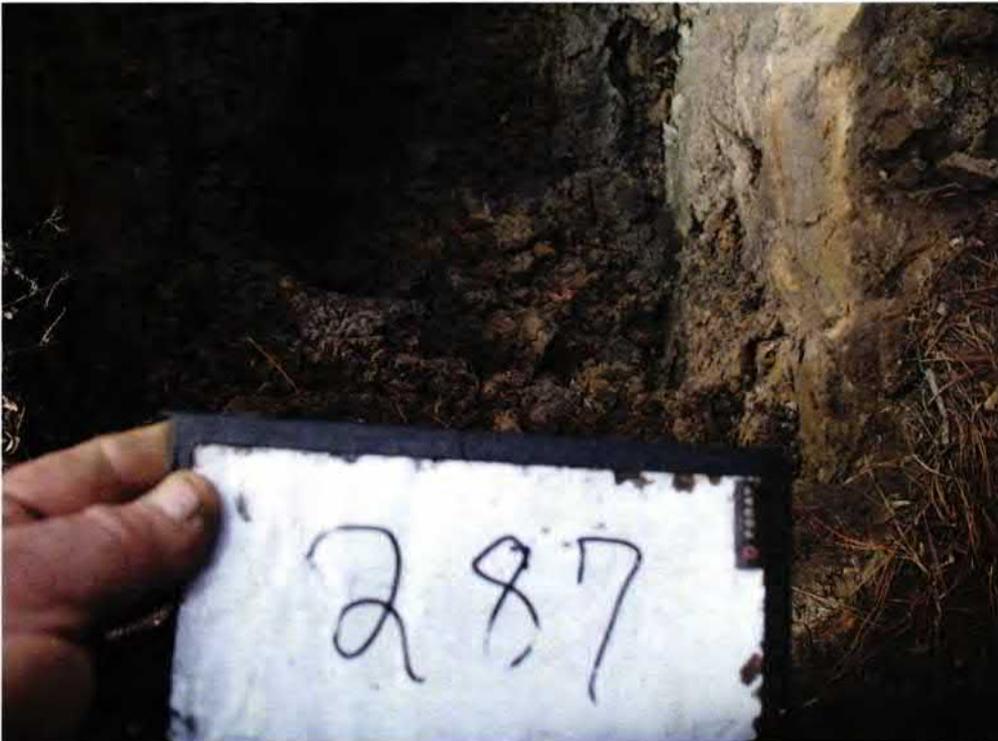
- O. If any corrosion, pitting, or holes were observed, describe the location and extent for each UST
Corrosion, pitting and holes were found throughout the tank.

Steel vent piping was corroded and pitted. Copper supply and return piping were sound.

Picture 2: UST 287Birch excavation.
