**SUMMARY REPORT  
63 ASH STREET (FORMERLY 304 ASH STREET)  
LAUREL BAY MILITARY HOUSING AREA  
MARINE CORPS AIR STATION BEAUFORT  
BEAUFORT, SC**

**Contract Number: N62470-14-D-9016  
CTO WE52  
JUNE 2021**

South Carolina Department of Health and Environmental Control (SCDHEC)  
**Underground Storage Tank (UST) Assessment Report**

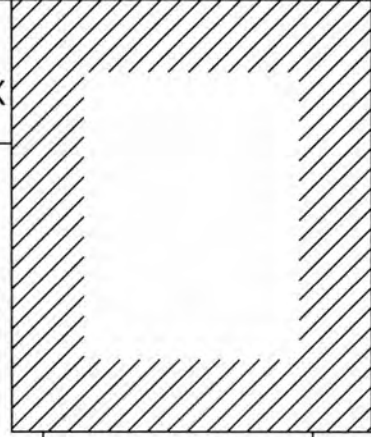
304 ASH STREET  
LAUREL BAY MILITARY HOUSING  
MCAS BEAUFORT, SC

UST 304ASH,  
280 GAL.

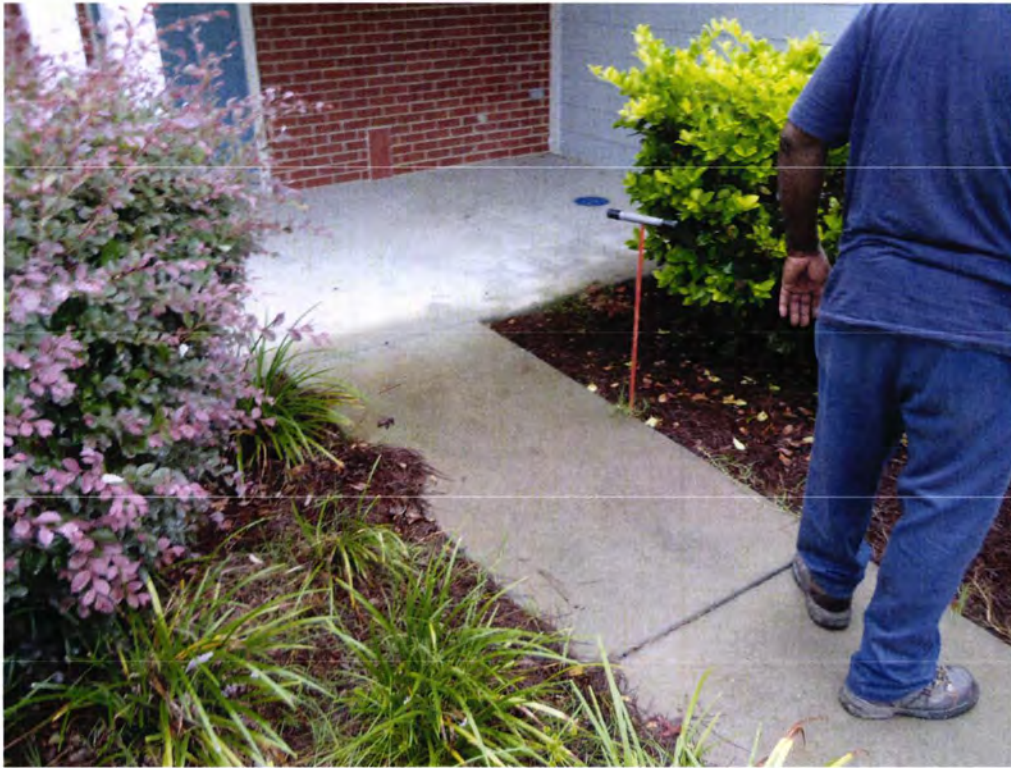
O. If any corrosion, pitting, or holes were observed, describe the location and extent for each UST  
Corrosion, pitting and holes were found throughout the tank.

Picture 1: Location of UST 304Ash.

M. Method of disposal for any USTs removed from the ground (attach disposal manifests)  
UST 304Ash was removed from the ground, cleaned and recycled. See Attachment "A."

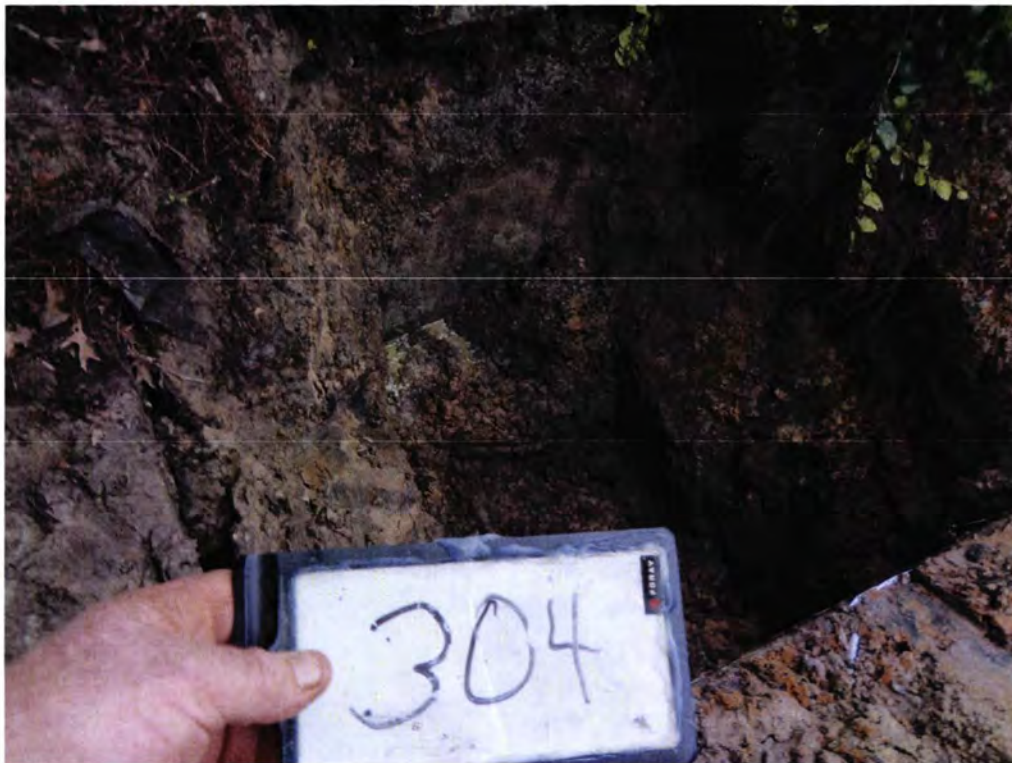
evidence (i.e., staining or sheen) of petroleum impact at the time of the UST removal. According to the UST Assessment Report (Appendix B), the depth to the base of the UST was 5'7" bgs and a single soil sample was collected from that depth. The sample was collected from the fill port side of the former UST to represent a worst case scenario.

Picture 2: UST 304Ash excavation.
