SUMMARY REPORT
114 ASH STREET (FORMERLY 309 ASH STREET)
LAUREL BAY MILITARY HOUSING AREA
MARINE CORPS AIR STATION BEAUFORT
BEAUFORT, SC

Contract Number: N62470-14-D-9016
CTO WE52
JUNE 2021

FIGURE 1 SITE MAP
309 ASH ST., LAUREL BAY
MCAS BEAUFORT SC

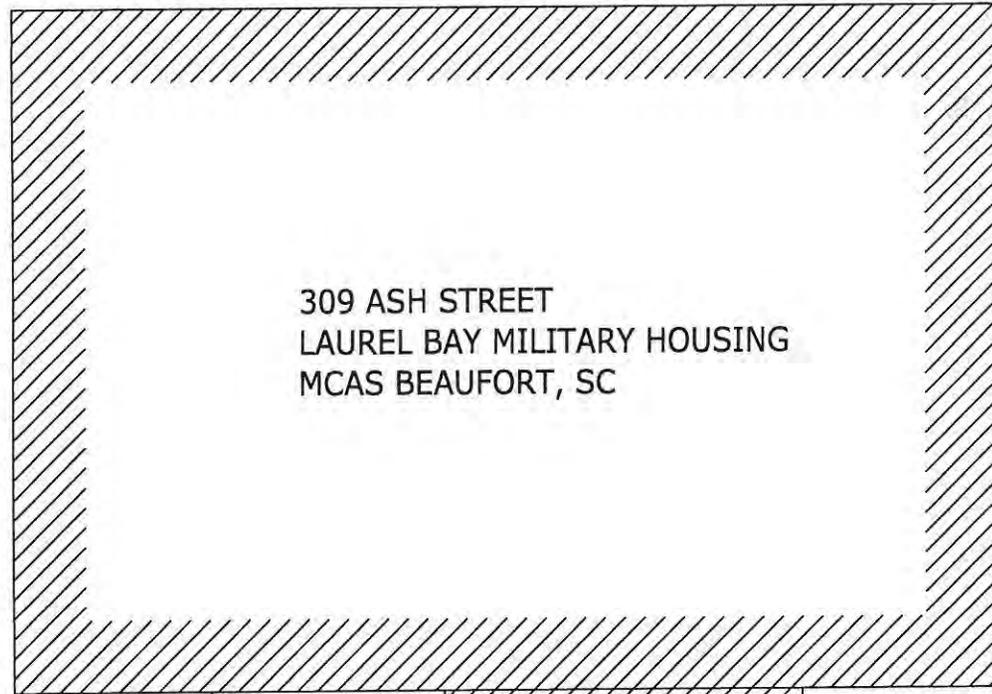
309 ASH STREET
LAUREL BAY MILITARY HOUSING
MCAS BEAUFORT, SC

UST 309ASH,
280 GAL.

STORMWATER DRAINAGE
CANAL \approx 650'

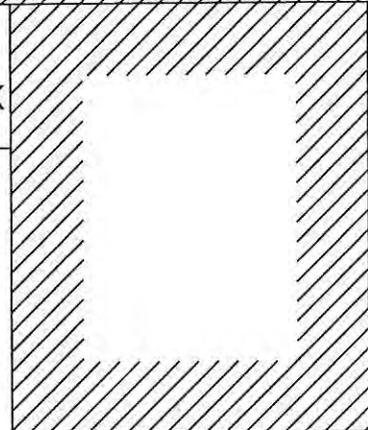
FIGURE 2 UST SAMPLE LOCATION
309 ASH ST., LAUREL BAY
MCAS BEAUFORT SC
SCALE: GRAPHIC | DWG DATE MAR 2015

FILL END

*EXCAVATION

SOIL SAMPLE
309 ASH

*A PORTION OF THE CONCRETE
SIDEWALK WAS REMOVED TO
FACILITATE TANK EXTRACTION.

TANK DEPTH BELOW GRADE
309ASH = 33"

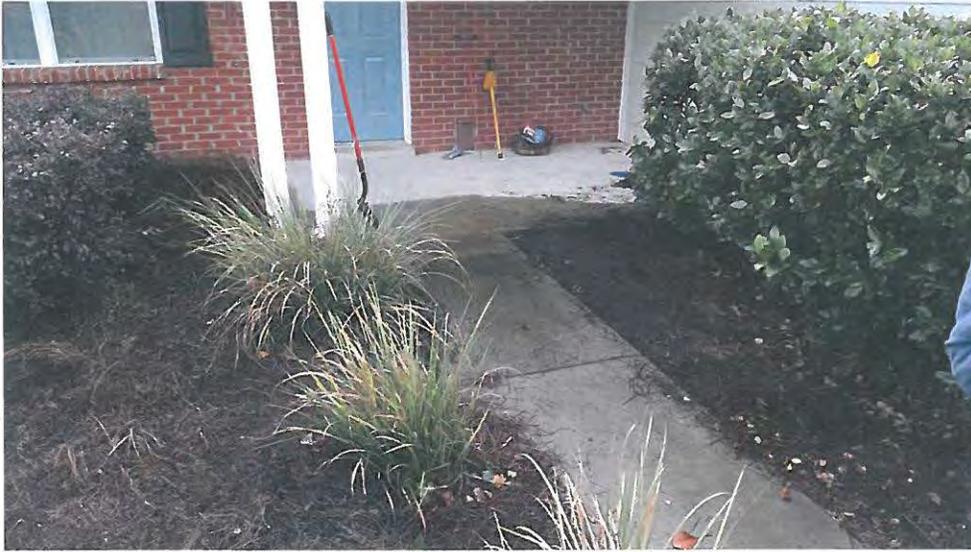
Picture 1: Location of UST 309Ash.

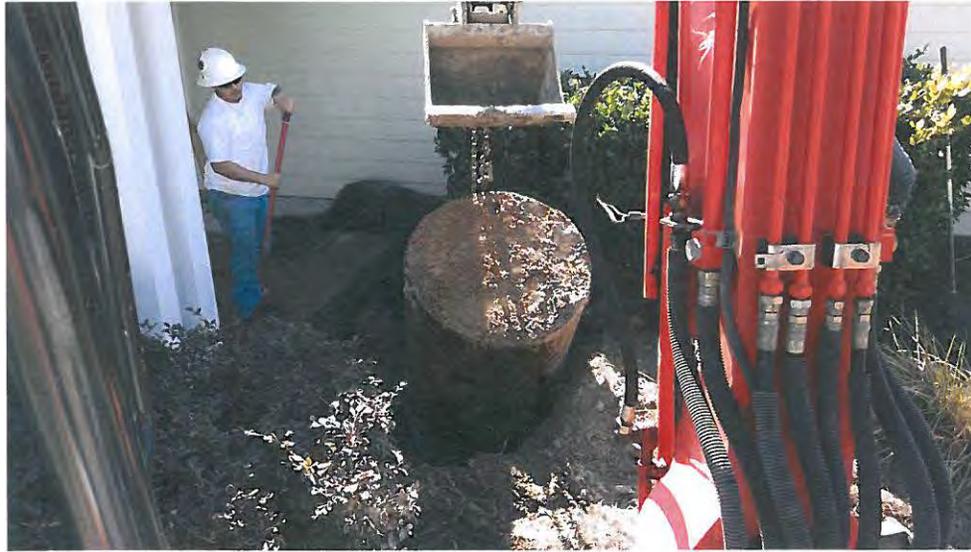
O. If any corrosion, pitting, or holes were observed, describe the location and extent for each UST
Corrosion, pitting and holes were found throughout the tank.

Picture 2: The tank being lifted from the excavation.

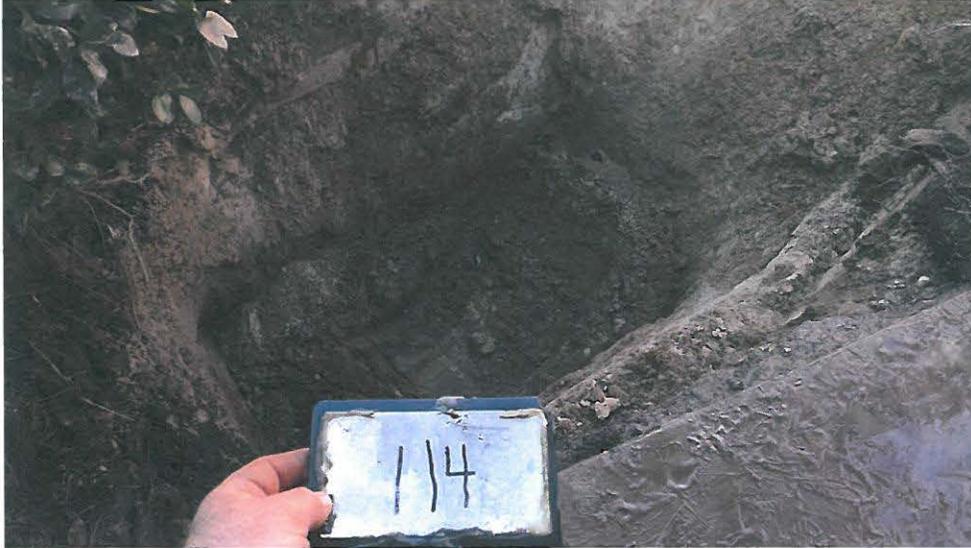
Picture 3: Tank excavation. 114 Ash St. was formerly known as 309 Ash Street.

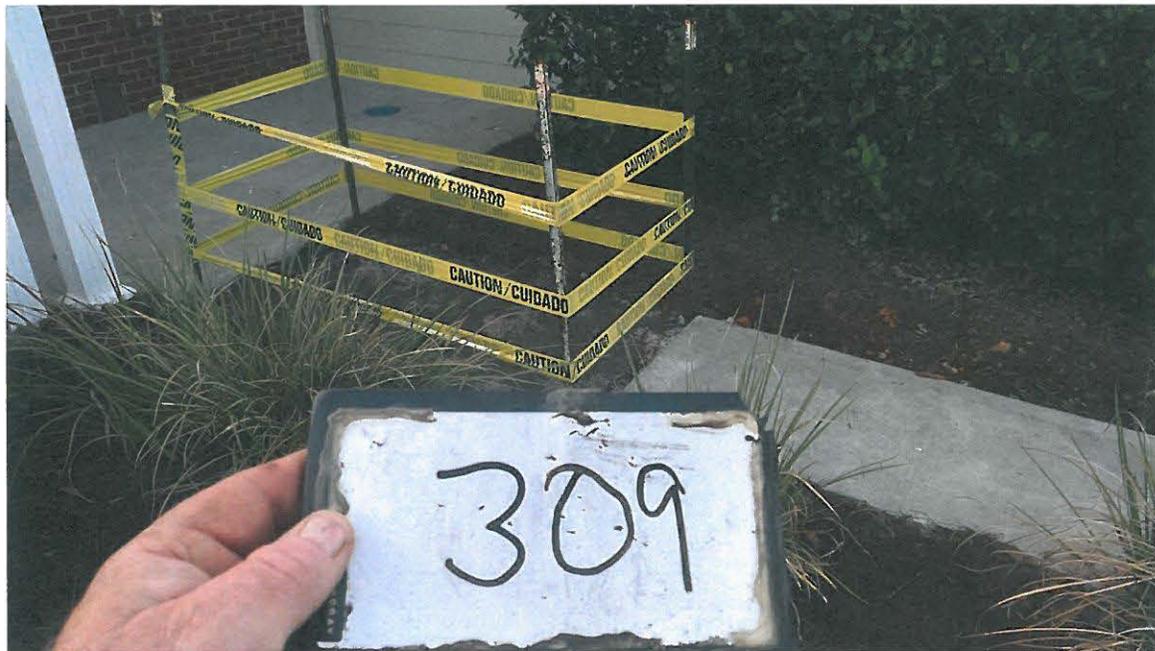
Picture 4: Site after completion of tank removal.
