**SUMMARY REPORT
155 FOXGLOVE STREET (FORMERLY 1022 FOXGLOVE STREET)
LAUREL BAY MILITARY HOUSING AREA
MARINE CORPS AIR STATION BEAUFORT
BEAUFORT, SC**

Contract Number: N62470-14-D-9016
CTO WE52
JUNE 2021

South Carolina Department of Health and Environmental Control (SCDHEC)
Underground Storage Tank (UST) Assessment Report

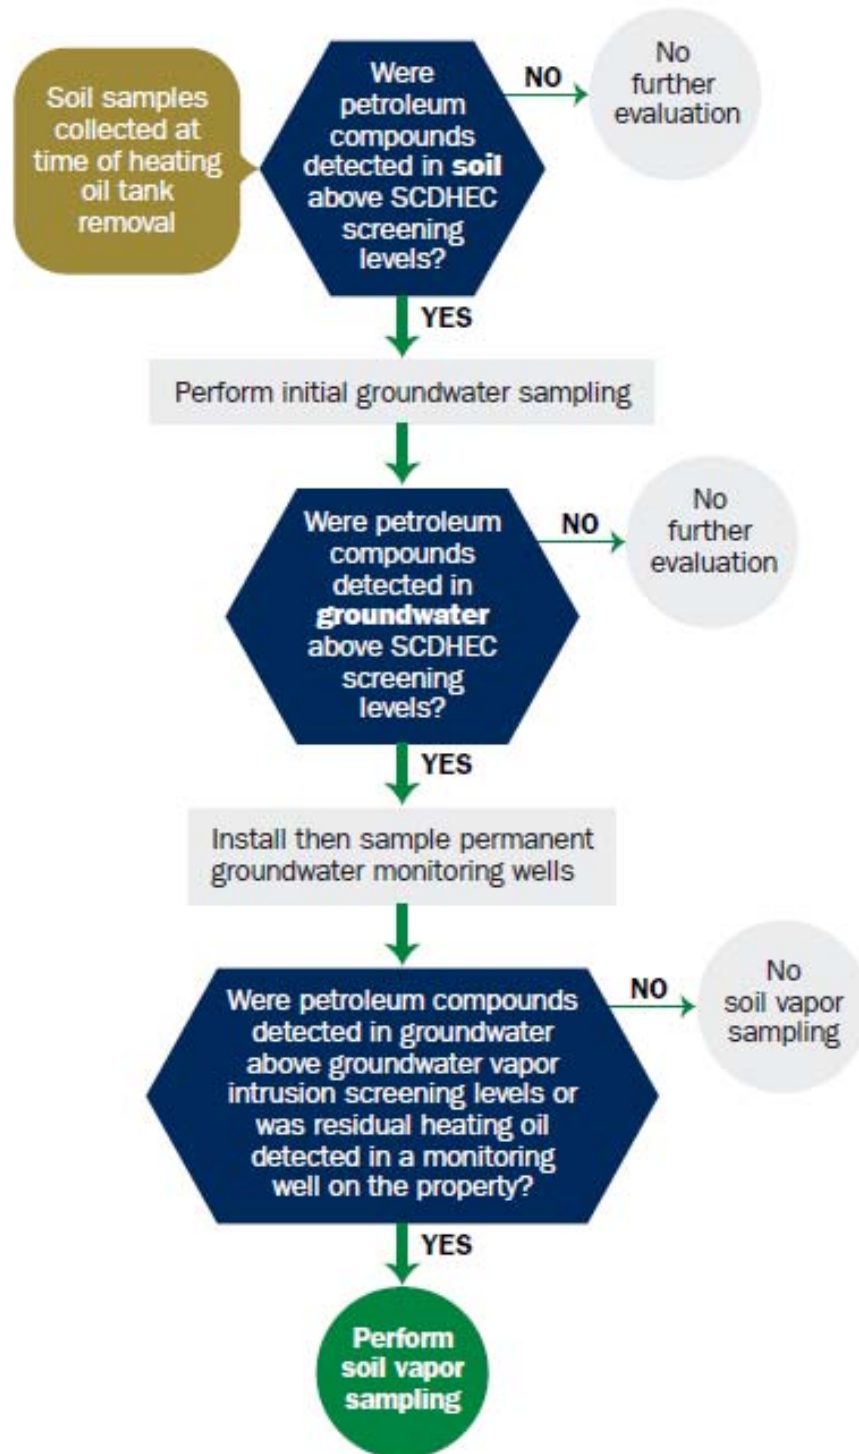
Appendix A - Multi-Media Selection Process for LBMH

The results of the soil sampling at each former UST location were used to determine if a potential for groundwater contamination exists (i.e., soil results greater than RBSLs) and subsequently to select properties for follow-up initial groundwater assessment (IGWA) sampling. The results of the IGWA sampling (if necessary) are used to determine the presence or absence of the aforementioned COPCs in groundwater and identify whether former UST locations will require additional delineation of COPCs in groundwater. In order to delineate the extent of impact to groundwater, permanent wells are installed and a sampling program is established for those former UST locations where IGWA sampling has indicated the presence of COPCs in excess of the SCDHEC RBSLs for groundwater. Groundwater analytical results are also compared to the site specific groundwater vapor intrusion screening levels (VISLs) to evaluate the potential for vapor intrusion and the necessity for an investigation associated with this media. A multi-media investigation selection process tree, applicable to the LBMH UST investigations, is presented as Appendix A.

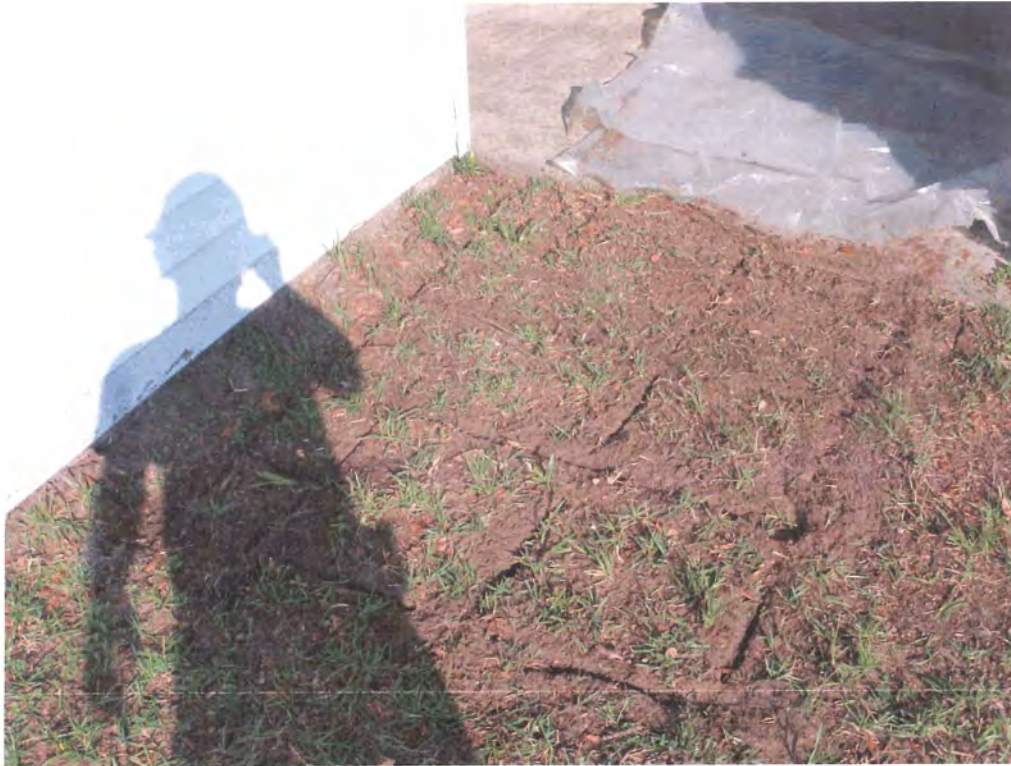
Picture 1: Location of UST 1022Foxglove.

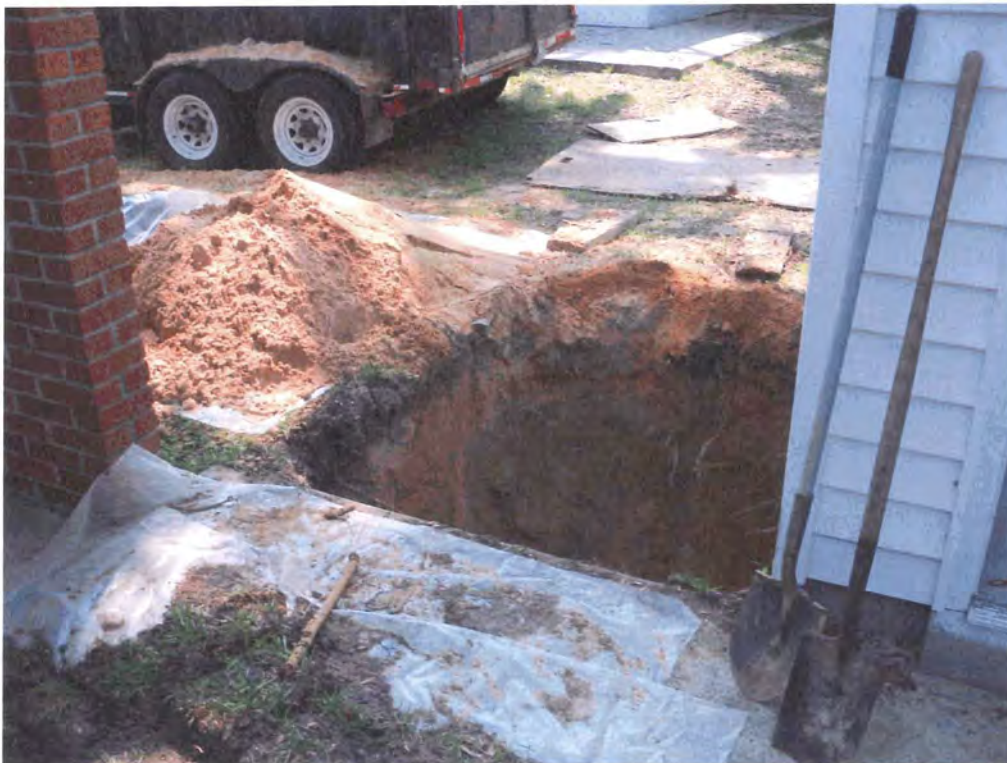
O. If any corrosion, pitting, or holes were observed, describe the location and extent for each UST
Corrosion, pitting and holes were found throughout the tank.

Picture 2: UST 1022Foxglove tank pit.
