SUMMARY REPORT
367 IRIS LANE (FORMERLY 1136 IRIS LANE)
LAUREL BAY MILITARY HOUSING AREA
MARINE CORPS AIR STATION BEAUFORT
BEAUFORT, SC

South Carolina Department of Health and Environmental Control (SCDHEC)
Underground Storage Tank (UST) Assessment Report

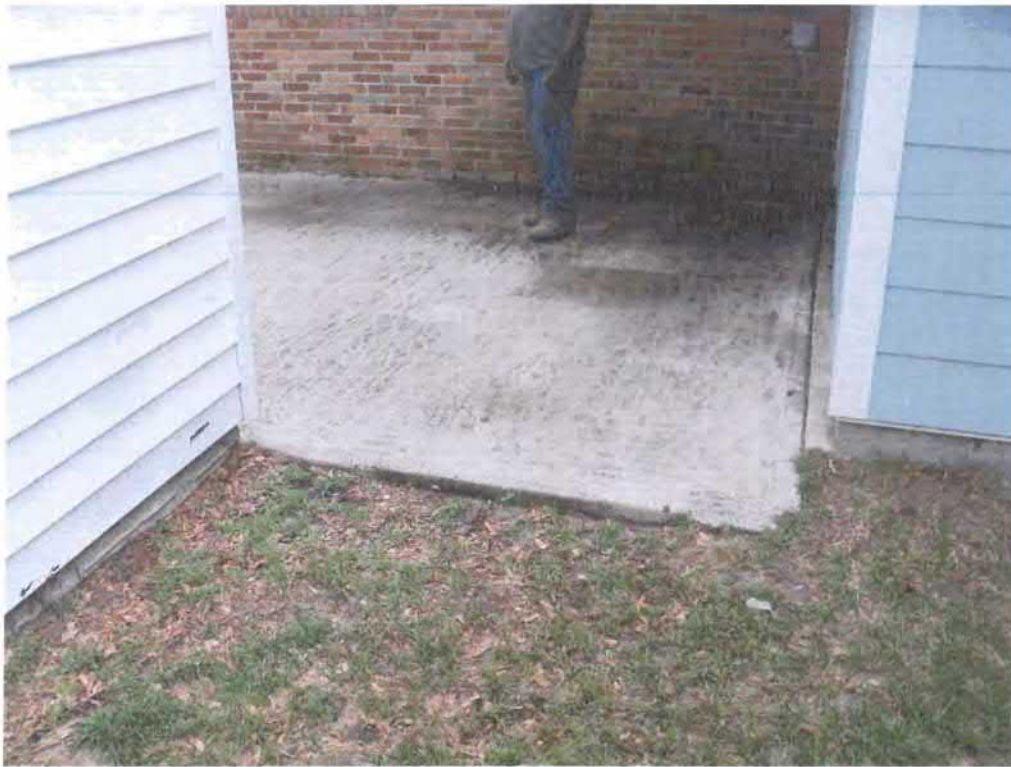
Picture 1: Location of UST 1136Iris.

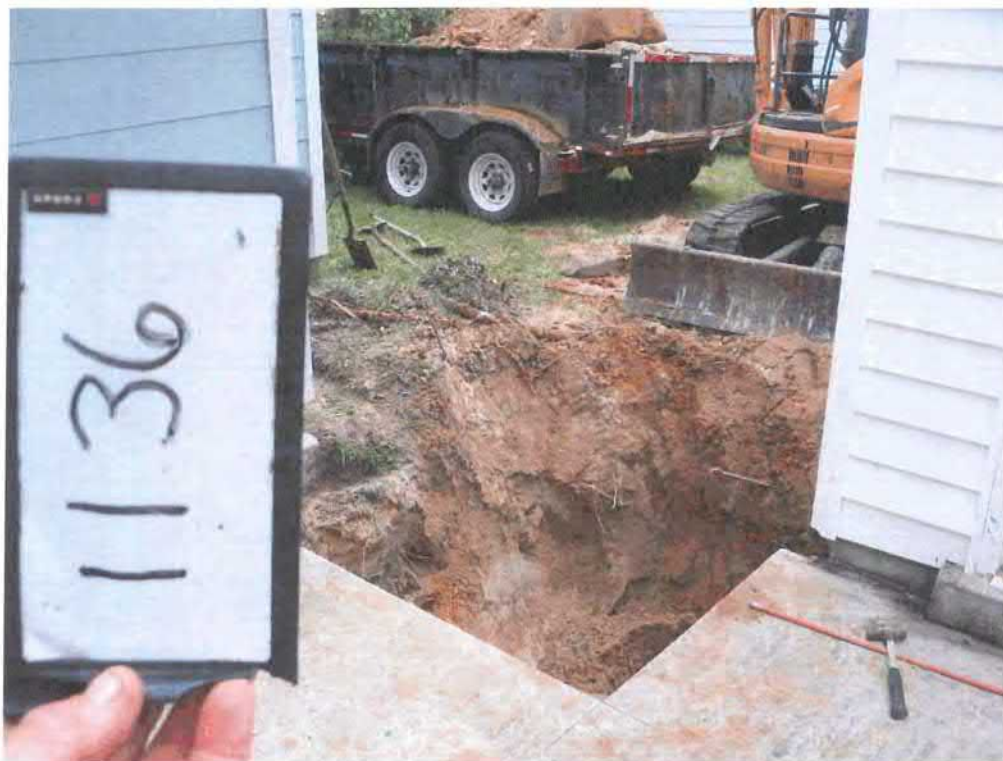
- M. Method of disposal for any USTs removed from the ground (attach disposal manifests)
UST 1136Iris was removed from the ground and disposed at a
Subtitle "D" landfill. See Attachment "A".
-
- N. Method of disposal for any liquid petroleum, sludges, or wastewaters removed from the USTs (attach disposal manifests)
UST 1136Iris had been previously filled with sand by others.
-
- O. If any corrosion, pitting, or holes were observed, describe the location and extent for each UST
Corrosion, pitting and holes were found throughout the tank.
-

Picture 2: Excavation of UST 1136Iris.
