**SUMMARY REPORT
58 JASMINE STREET (FORMERLY 1166 JASMINE STREET)
LAUREL BAY MILITARY HOUSING AREA
MARINE CORPS AIR STATION BEAUFORT
BEAUFORT, SC**

JUNE 2021

**CDM - AECOM Multimedia Joint Venture
10560 Arrowhead Drive, Suite 500
Fairfax, Virginia 22030**

**Contract Number: N62470-14-D-9016
CTO WE52
JUNE 2021**

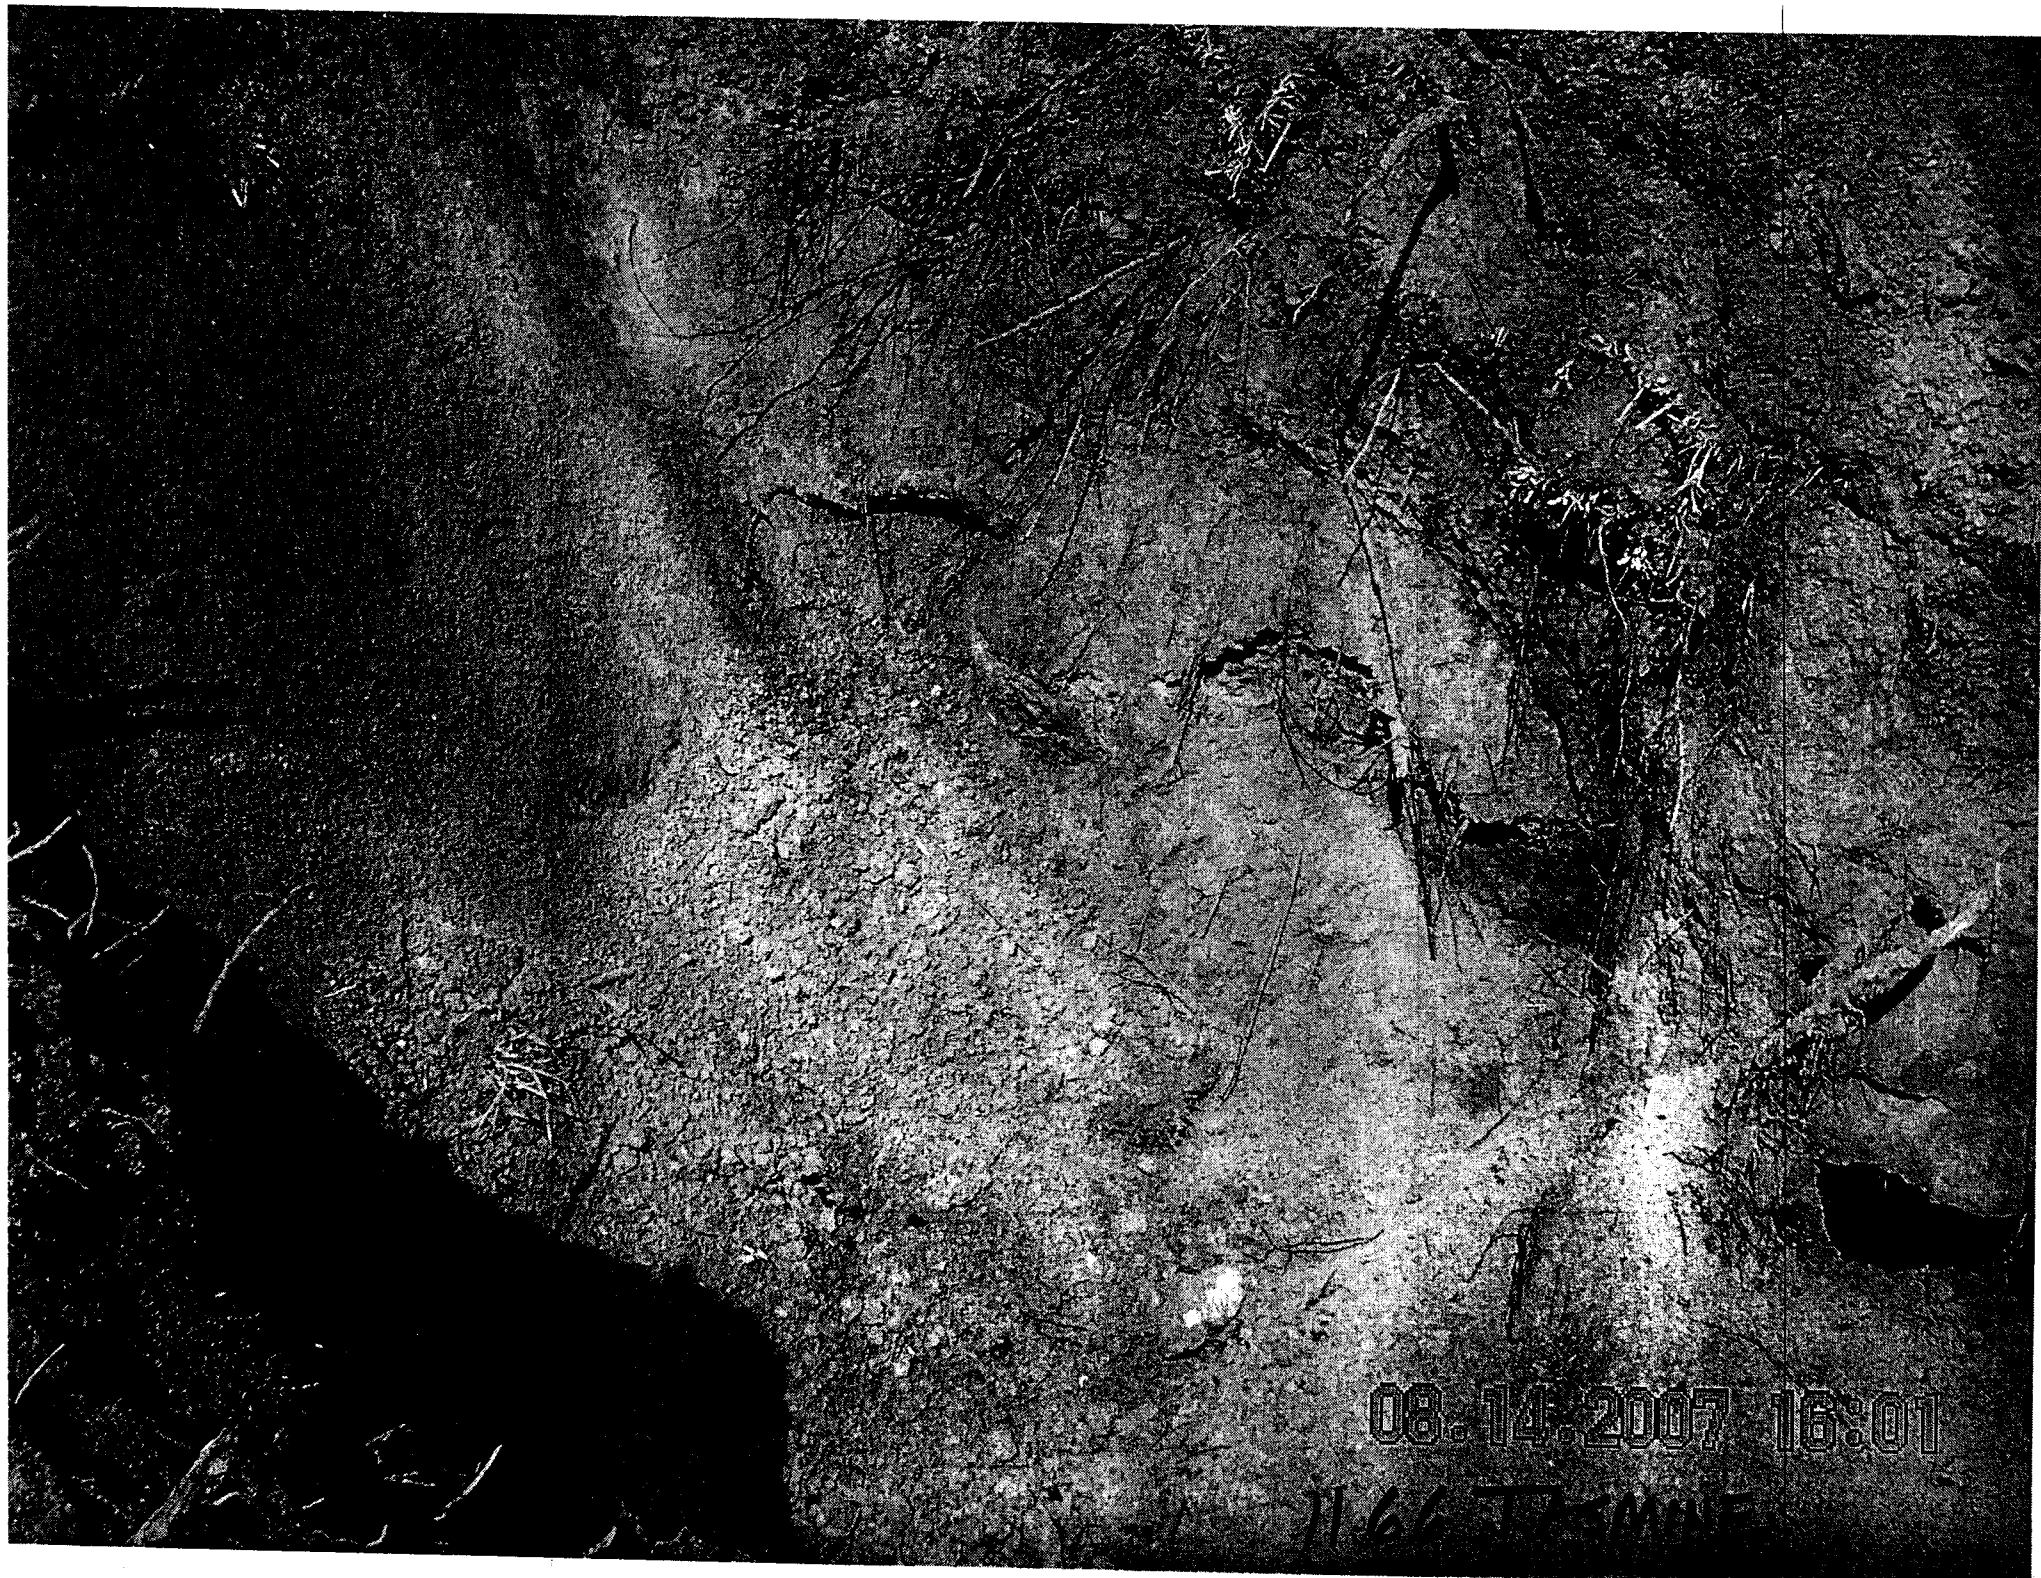
1166 Jasmine ST.

TANK #1 HAD PINHOLES ALL OVER BASE OF UST
TANK #2 HAD BEEN PREVIOUSLY EXCAVATED, CUT
AND FILLED WITH SAND.
