SUMMARY REPORT  
779 WEST CARDINAL LANE (FORMERLY 1476 WEST CARDINAL LANE)  
LAUREL BAY MILITARY HOUSING AREA  
MARINE CORPS AIR STATION BEAUFORT  
BEAUFORT, SC

South Carolina Department of Health and Environmental Control (SCDHEC)  
**Underground Storage Tank (UST) Assessment Report**

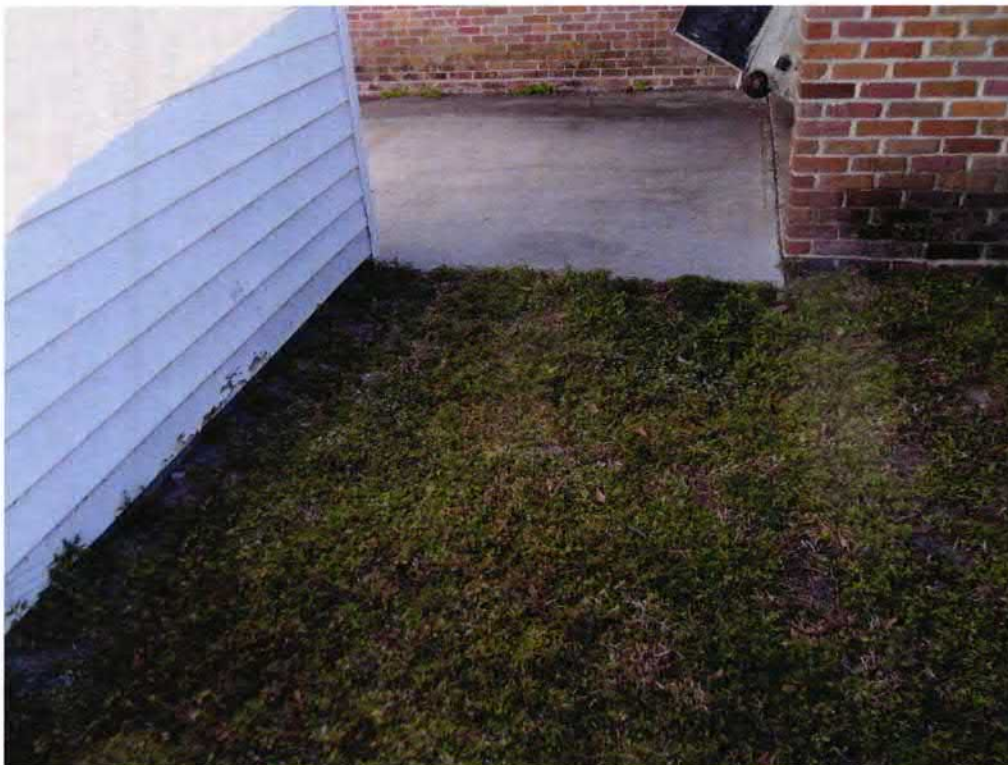
Picture 1: Location of UST 1476 Cardinal.

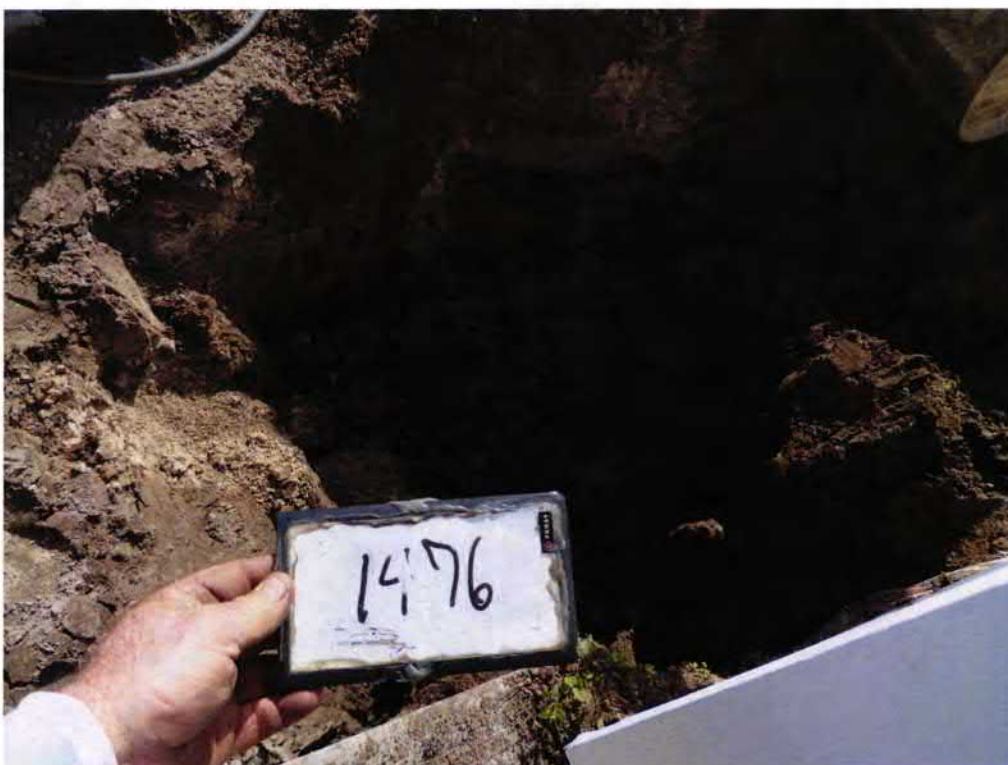
- M. Method of disposal for any USTs removed from the ground (attach disposal manifests)  
UST 1476Cardinal was removed from the ground and disposed  
at a Subtitle "D" landfill. See Attachment "A".
- N. Method of disposal for any liquid petroleum, sludges, or wastewaters removed from the USTs (attach disposal manifests)  
UST 1476Cardinal was previously filled with sand by others.
- O. If any corrosion, pitting, or holes were observed, describe the location and extent for each UST  
Corrosion, pitting and holes were found throughout the tank.

Picture 2: UST 1476 Cardinal excavation.
