SUMMARY REPORT  
347 WEST LAUREL BAY BOULEVARD (FORMERLY 526 WEST LAUREL BAY BOULEVARD)  
LAUREL BAY MILITARY HOUSING AREA  
MARINE CORPS AIR STATION BEAUFORT  
BEAUFORT, SC

JUNE 2021

Contract Number: N62470-14-D-9016  
CTO WE52  
JUNE 2021

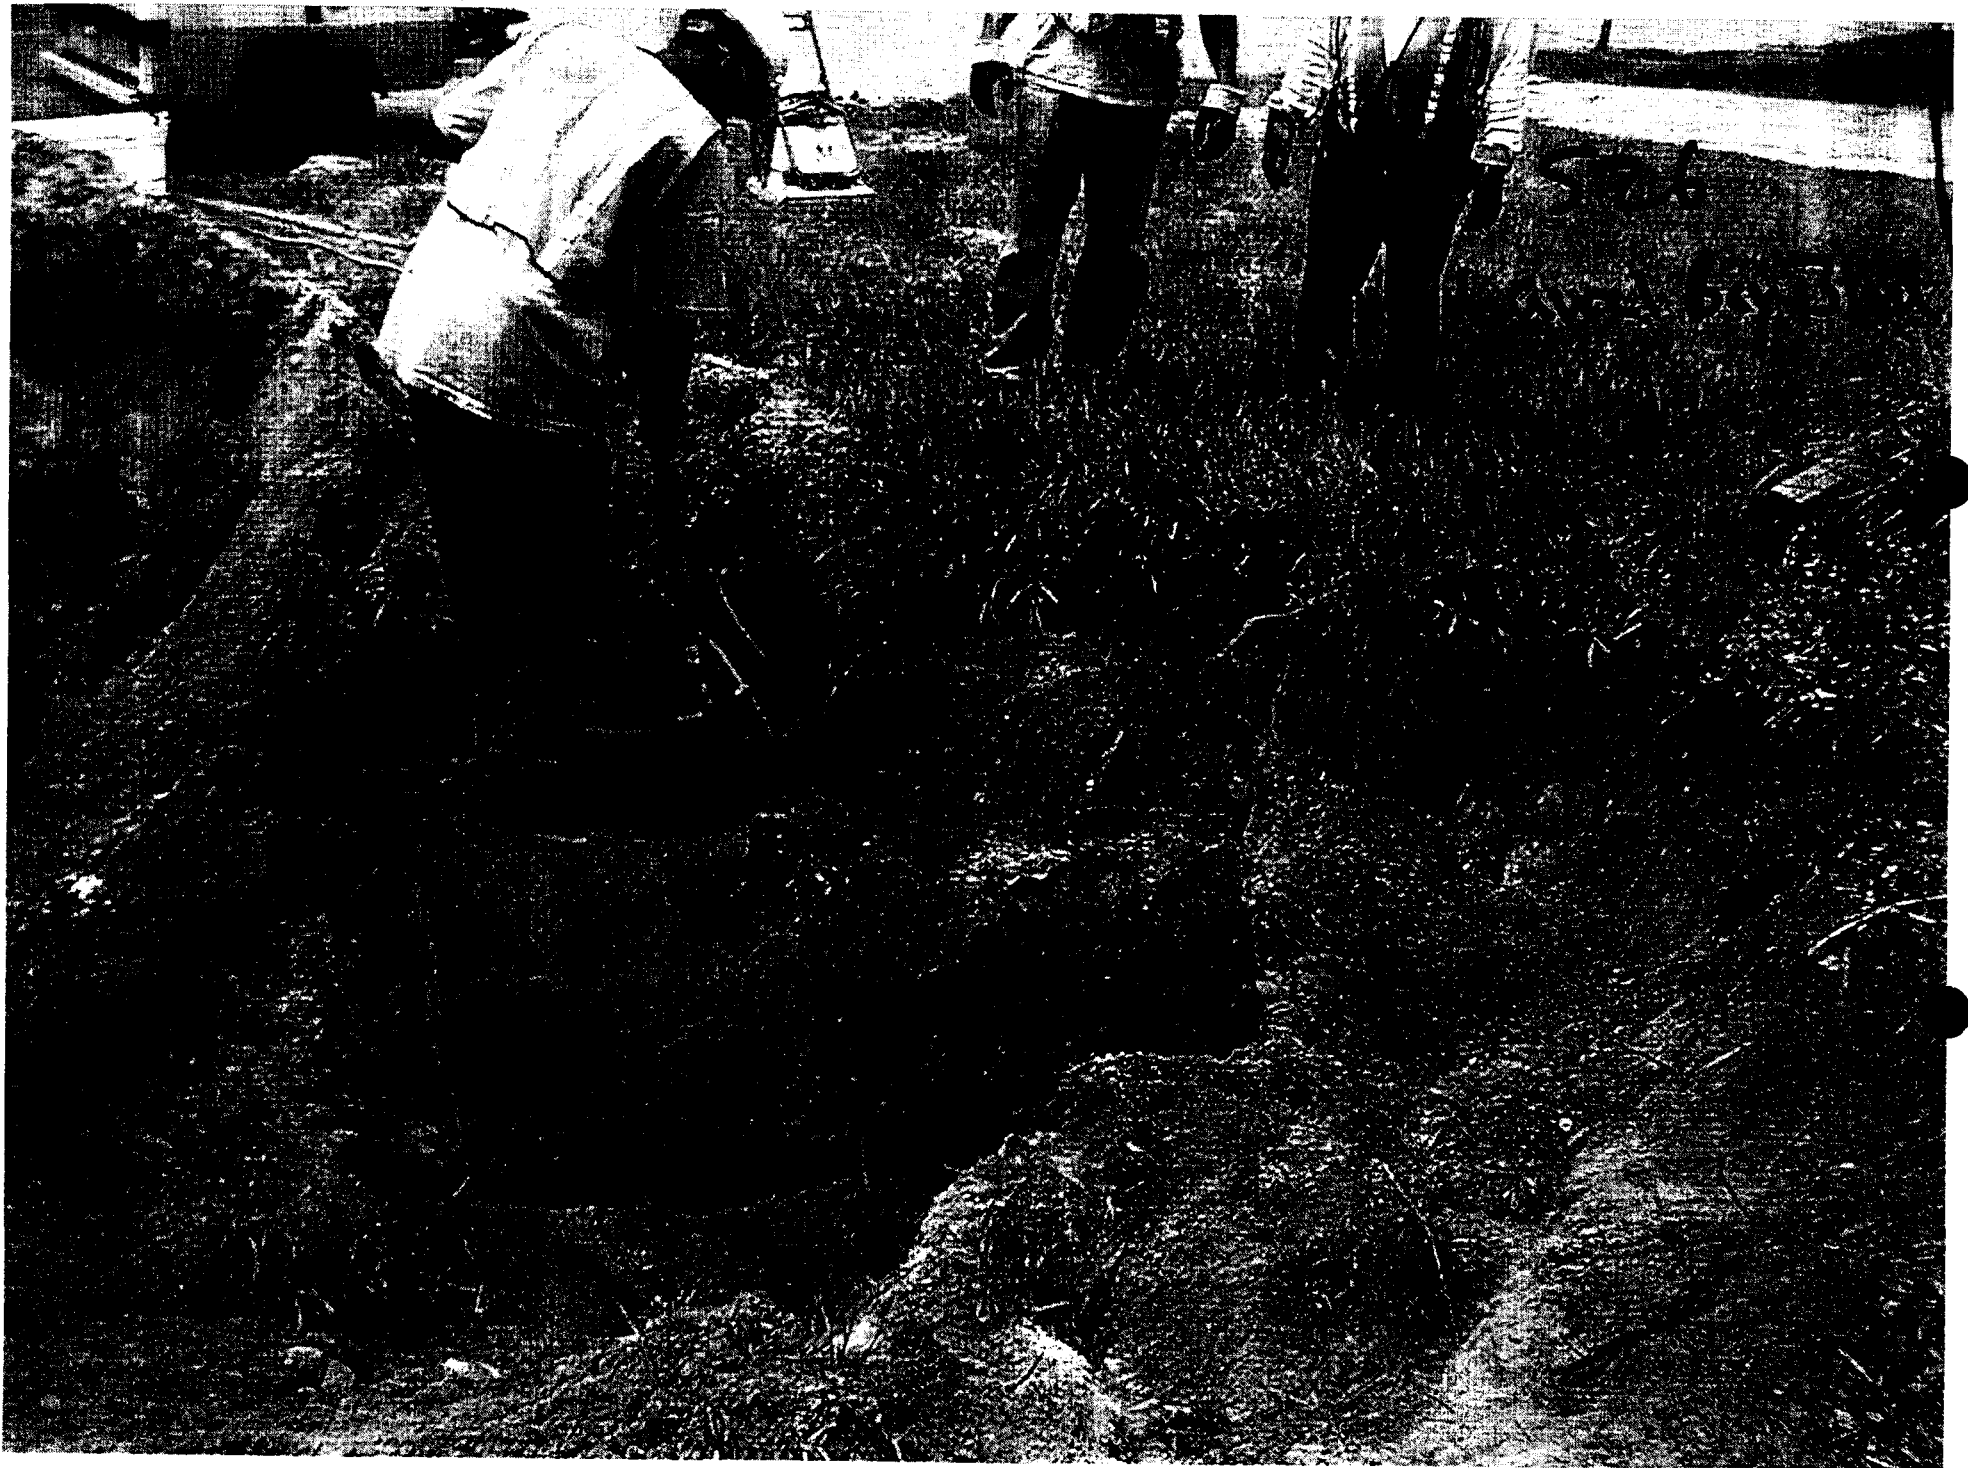
SW - street wall    HW - house wall    B - bottom  
Building 526 Laurel Bay

end wall to center of tank 16ft

house center of tank 5ft 2" in

depth of hole 7ft

size of hole dug 10ft 10in    " 6ft 7in
