SUMMARY REPORT
96 ELDERBERRY DRIVE (FORMERLY 409 ELDERBERRY DRIVE)
LAUREL BAY MILITARY HOUSING AREA
MARINE CORPS AIR STATION BEAUFORT
BEAUFORT, SC

Contract Number: N62470-14-D-9016
CTO WE52
JUNE 2021

South Carolina Department of Health and Environmental Control (SCDHEC)
Underground Storage Tank (UST) Assessment Report

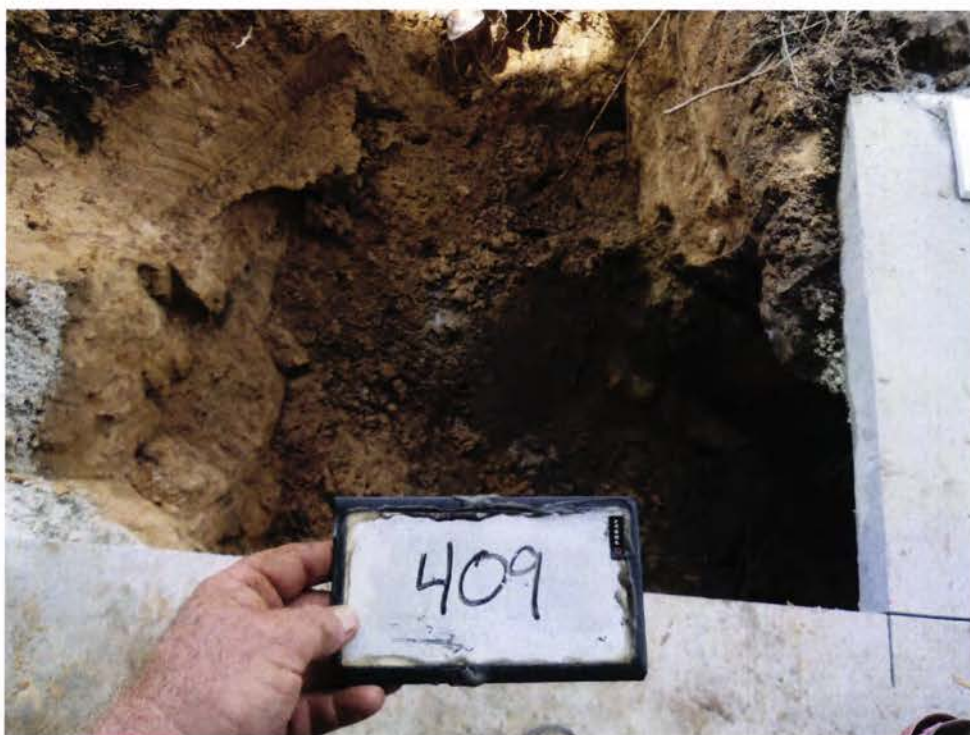
- M. Method of disposal for any USTs removed from the ground (attach disposal manifests)
UST 409Elderberry was removed from the ground and disposed at a
Subtitle "D" landfill. See Attachment "A".
- N. Method of disposal for any liquid petroleum, sludges, or wastewaters removed from the USTs (attach disposal manifests)
UST 409Elderberry had been previously filled with sand by others.
- O. If any corrosion, pitting, or holes were observed, describe the location and extent for each UST
Corrosion, pitting and holes were found throughout the tank.

Picture 2: UST 409Elderberry excavation.
