SUMMARY REPORT  
115 DAHLIA DRIVE (FORMERLY 562 DAHLIA DRIVE)  
LAUREL BAY MILITARY HOUSING AREA  
MARINE CORPS AIR STATION BEAUFORT  
BEAUFORT, SC

Contract Number: N62470-14-D-9016  
CTO WE52  
JUNE 2021

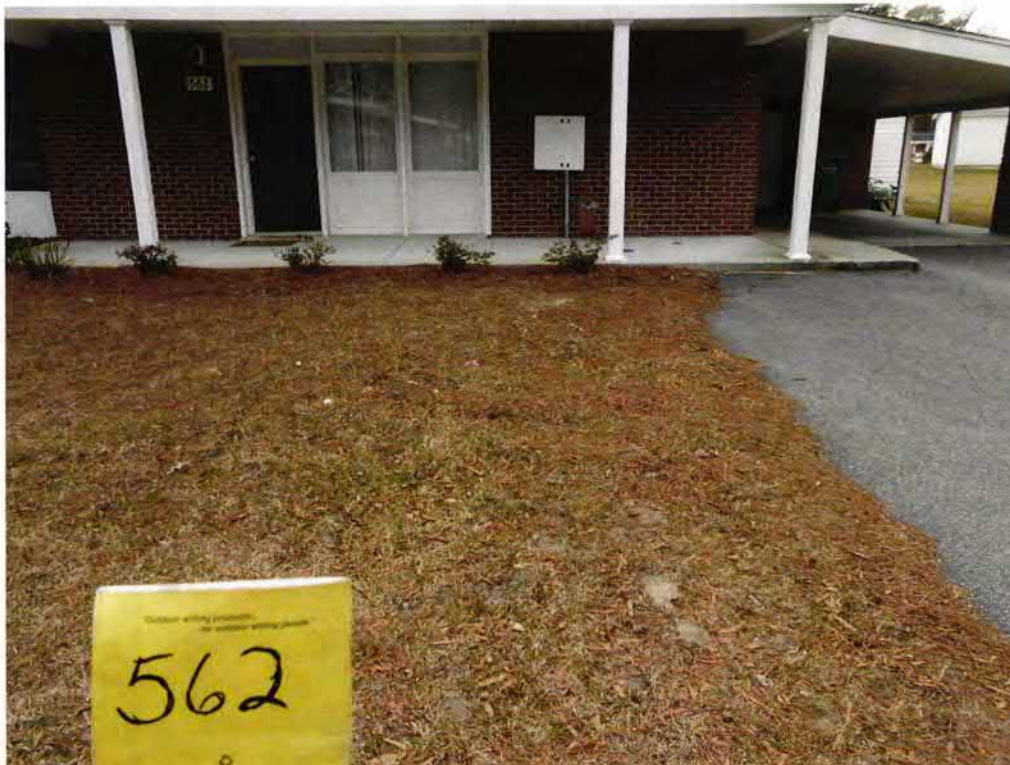
Picture 1: Location of UST 562Dahlia.

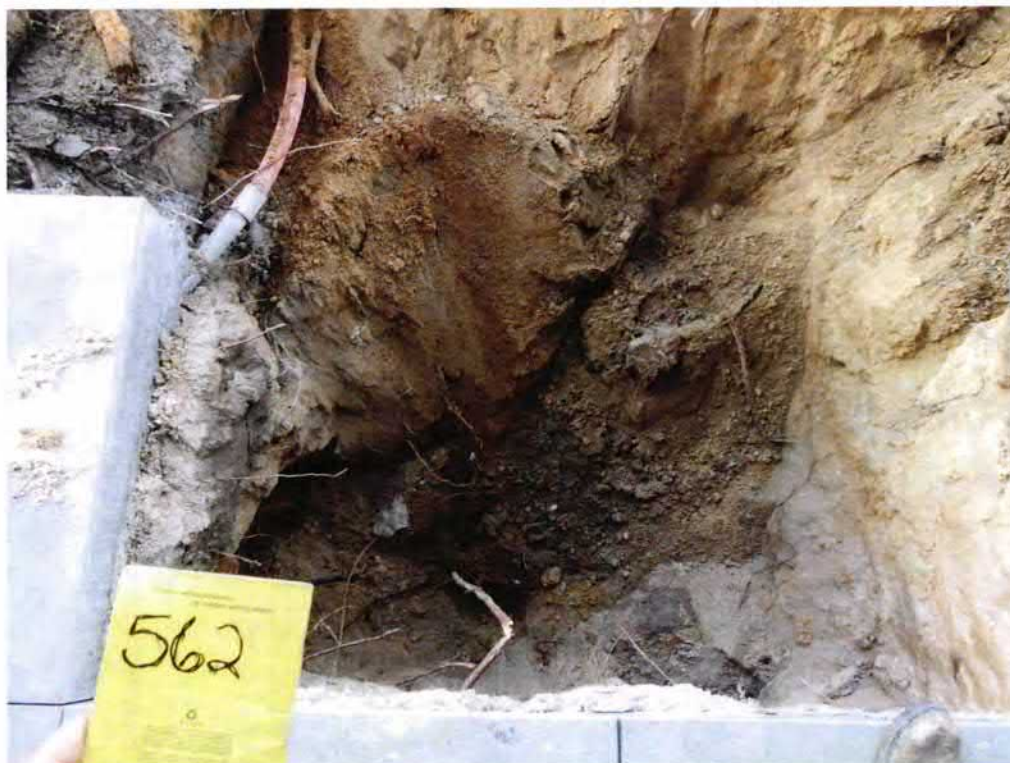
- M. Method of disposal for any USTs removed from the ground (attach disposal manifests)  
UST 562Dahlia was removed from the ground and disposed at a  
Subtitle "D" landfill. See Attachment "A".
- N. Method of disposal for any liquid petroleum, sludges, or wastewaters removed from the USTs (attach disposal manifests)  
UST 562Dahlia had been previously filled with sand by others.
- O. If any corrosion, pitting, or holes were observed, describe the location and extent for each UST  
Corrosion, pitting and holes were found throughout the tank.

Picture 2: UST 562Dahlia excavation.
