SUMMARY REPORT  
247 BLUEBELL LANE (FORMERLY 728 BLUEBELL LANE)  
LAUREL BAY MILITARY HOUSING AREA  
MARINE CORPS AIR STATION BEAUFORT  
BEAUFORT, SC

Contract Number: N62470-14-D-9016  
CTO WE52  
JUNE 2021

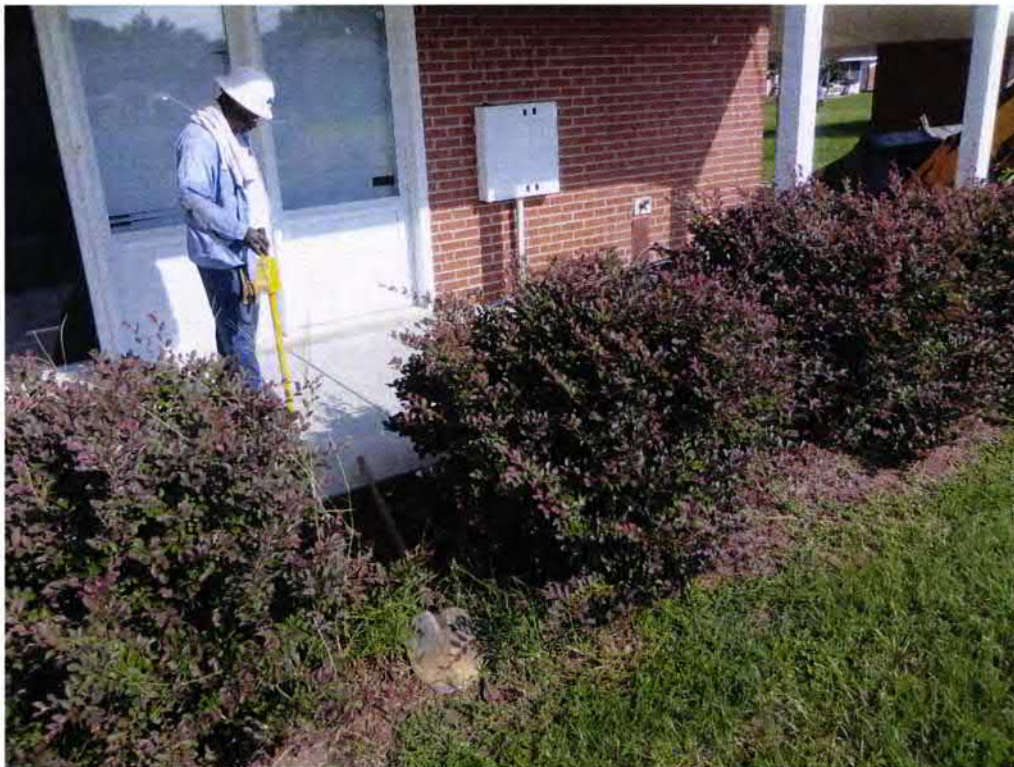
Picture 1: Location of UST 728Bluebell.

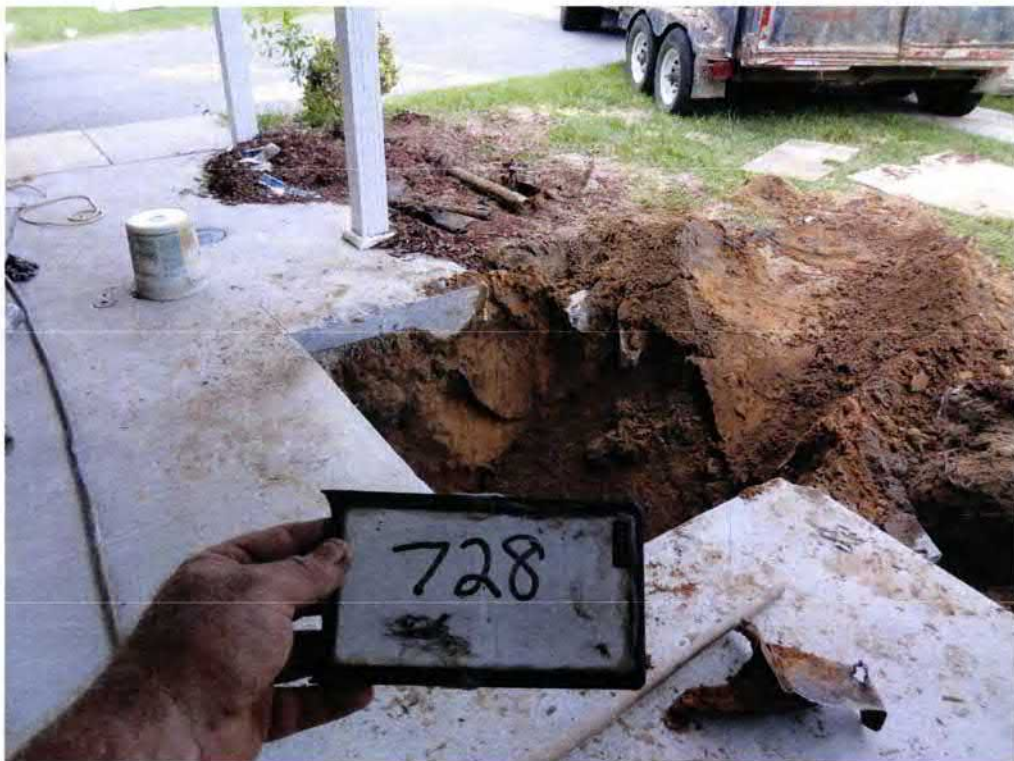
O. If any corrosion, pitting, or holes were observed, describe the location and extent for each UST  
Corrosion, pitting and holes were present throughout the tank.

Picture 2: UST 728Bluebell excavation.
