SUMMARY REPORT  
30 WEST ALTHEA STREET (FORMERLY 755 WEST ALTHEA STREET)  
LAUREL BAY MILITARY HOUSING AREA  
MARINE CORPS AIR STATION BEAUFORT  
BEAUFORT, SC

JUNE 2021

South Carolina Department of Health and Environmental Control (SCDHEC)  
**Underground Storage Tank (UST) Assessment Report**

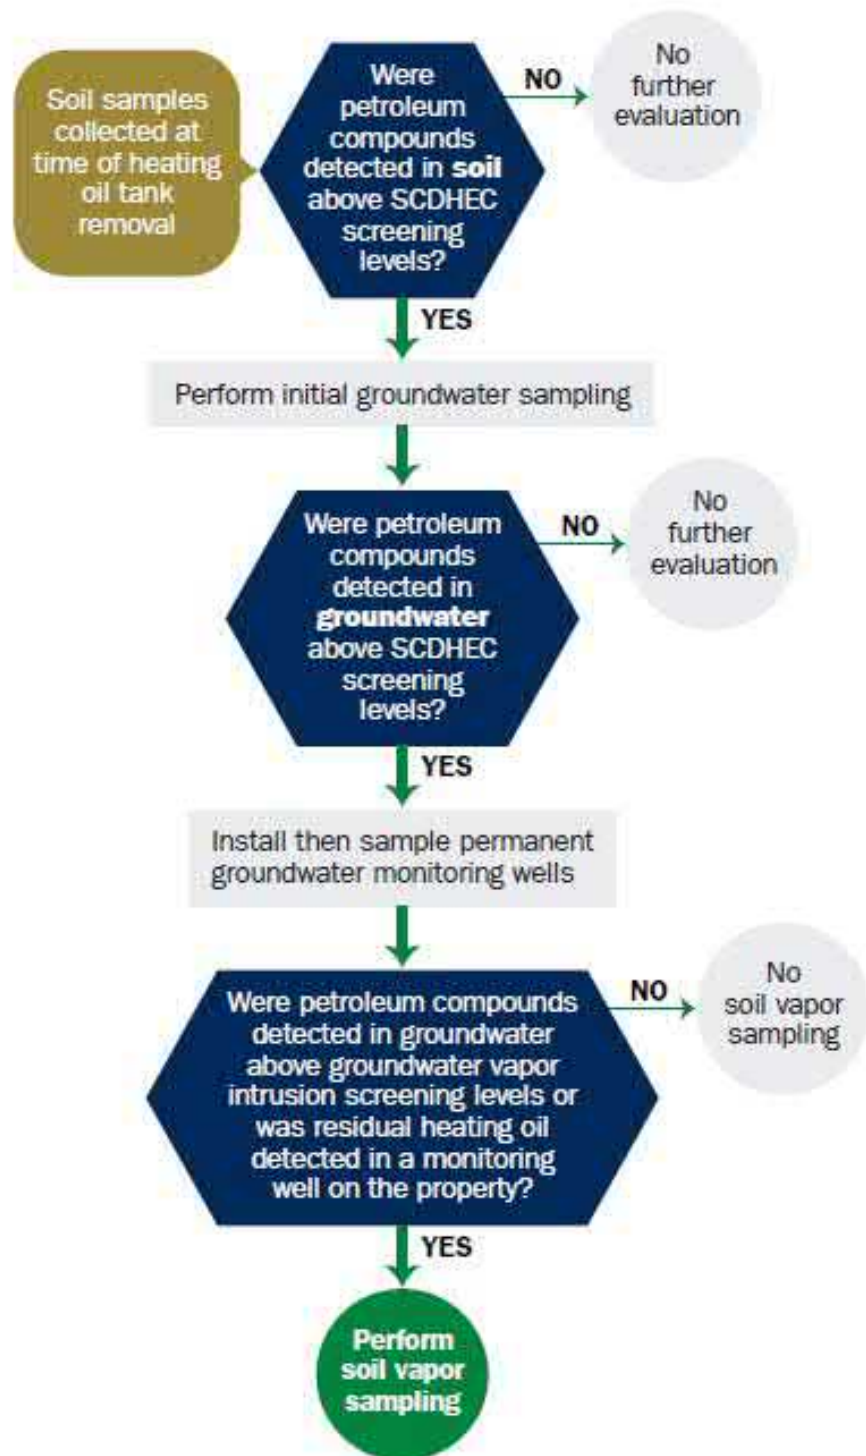
Appendix A - Multi-Media Selection Process for LBMH

The results of the soil sampling at each former UST location were used to determine if a potential for groundwater contamination exists (i.e., soil results greater than RBSLs) and subsequently to select properties for follow-up initial groundwater assessment (IGWA) sampling. The results of the IGWA sampling (if necessary) are used to determine the presence or absence of the aforementioned COPCs in groundwater and identify whether former UST locations will require additional delineation of COPCs in groundwater. In order to delineate the extent of impact to groundwater, permanent wells are installed and a sampling program is established for those former UST locations where IGWA sampling has indicated the presence of COPCs in excess of the SCDHEC RBSLs for groundwater. Groundwater analytical results are also used to evaluate the potential for vapor intrusion and the necessity for an investigation associated with this media. A multi-media investigation selection process tree, applicable to the LBMH UST investigations, is presented as Appendix A.

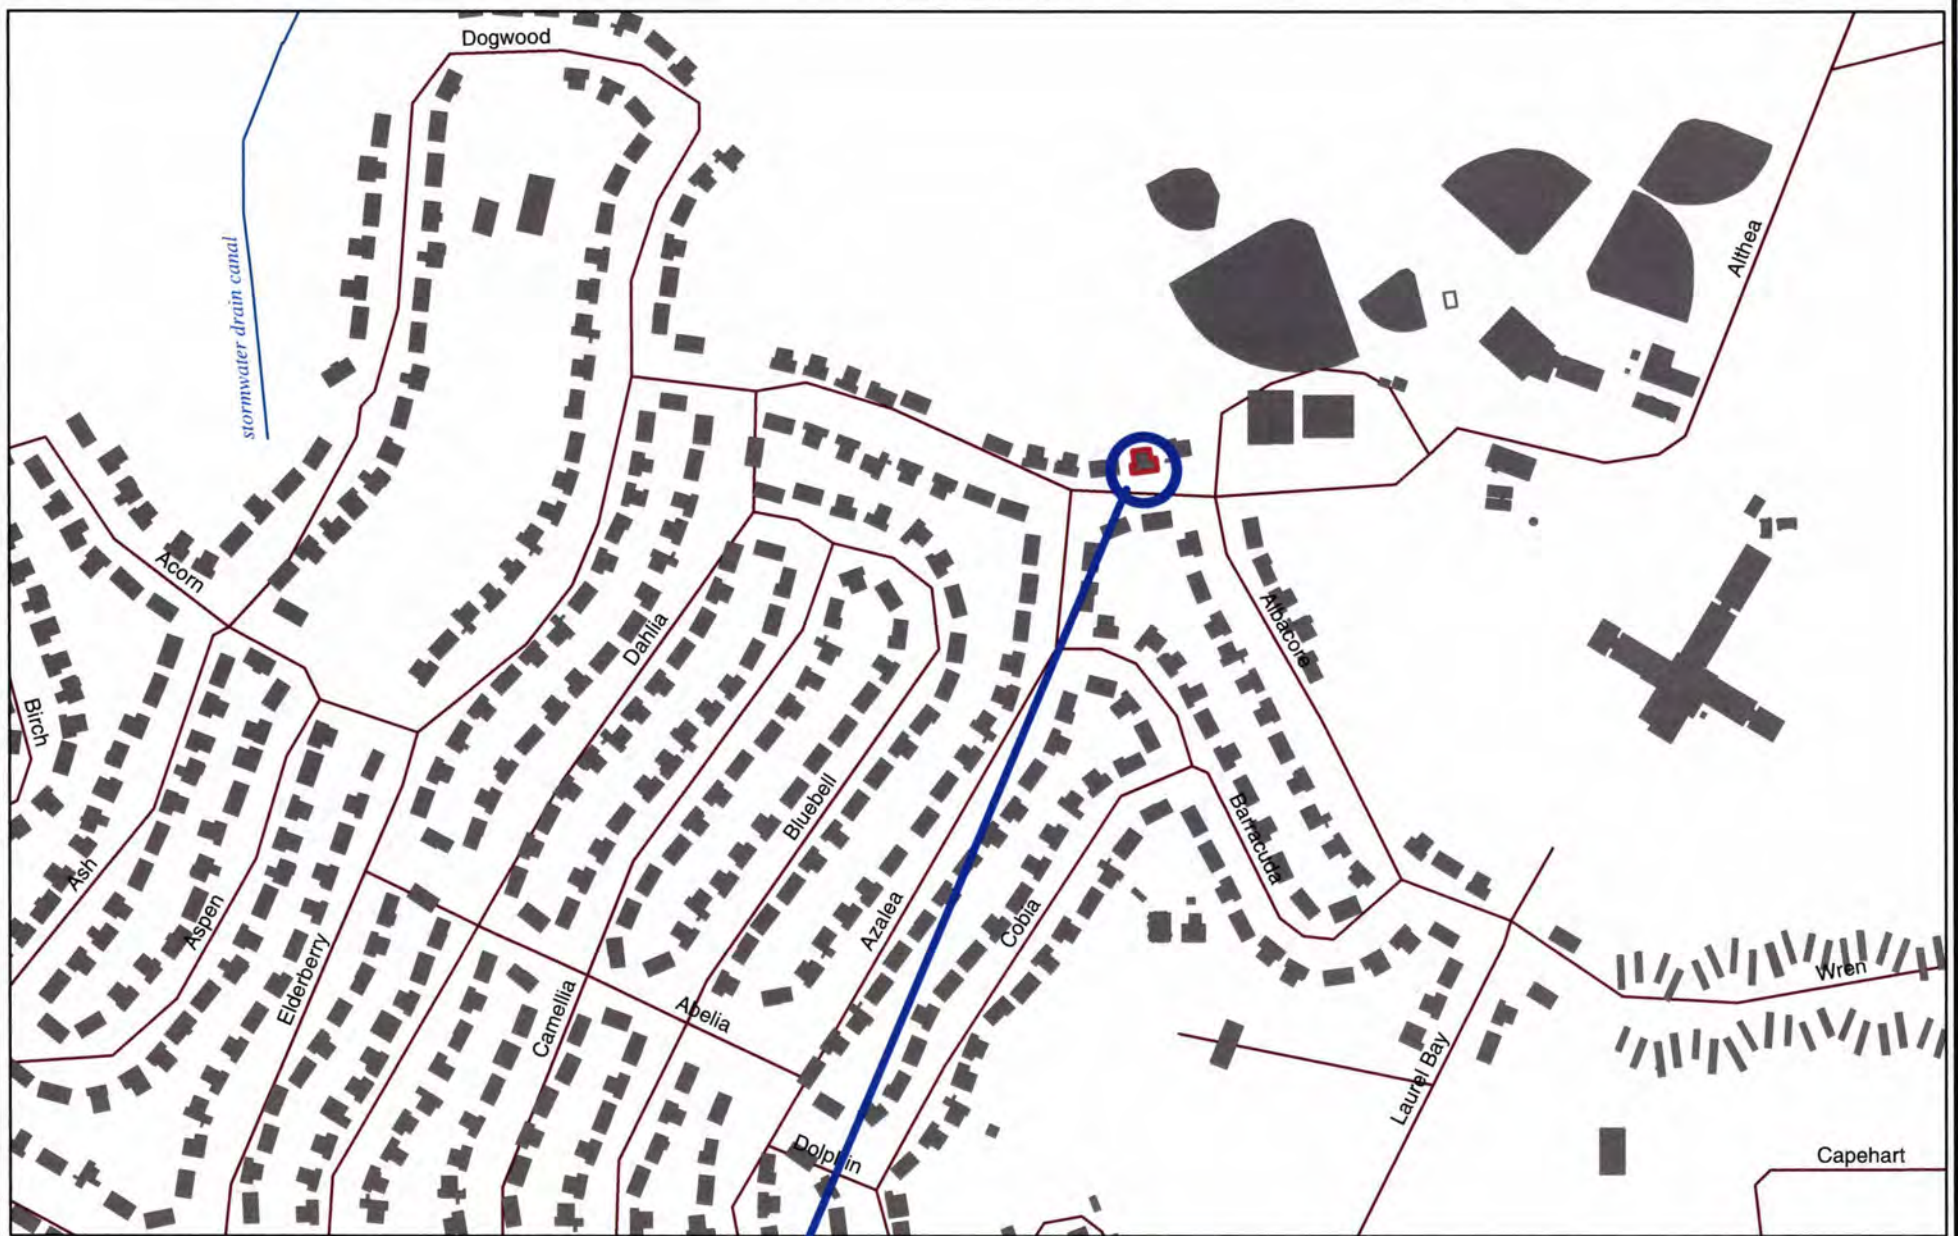
**755 ALTHEA**

**You must supply a scaled site map. It should include all buildings, road names, utilities, tank and dispenser island locations, labeled sample locations, extent of excavation, and any other pertinent information.**

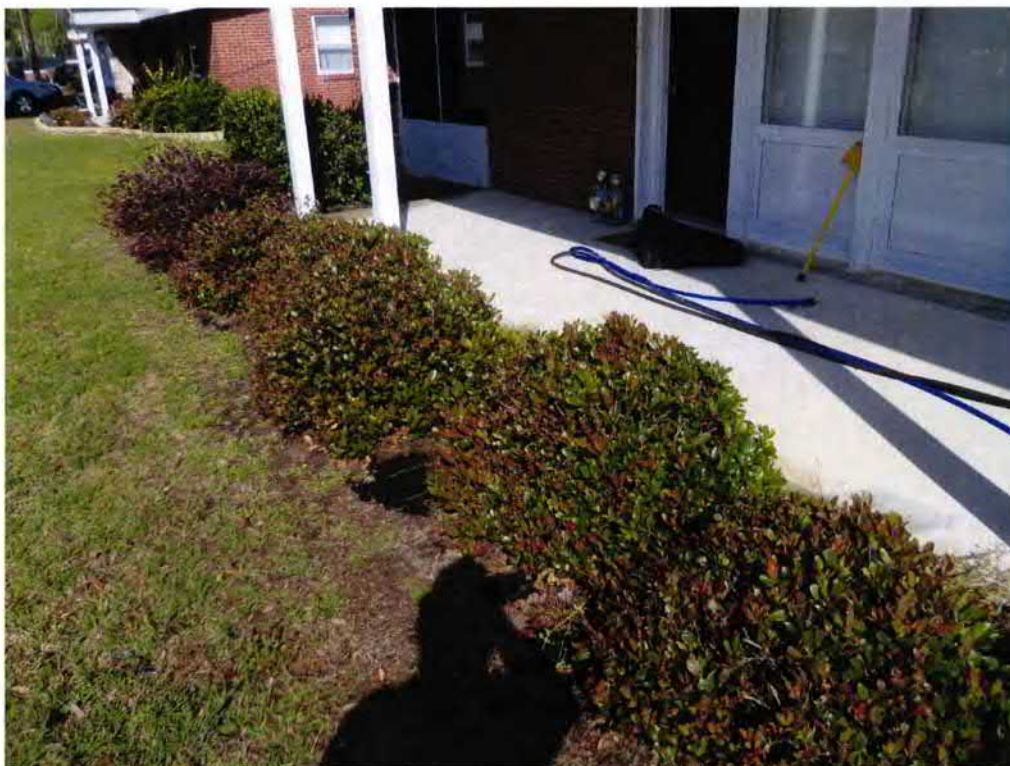
Picture 1: Location of UST 755Althea.

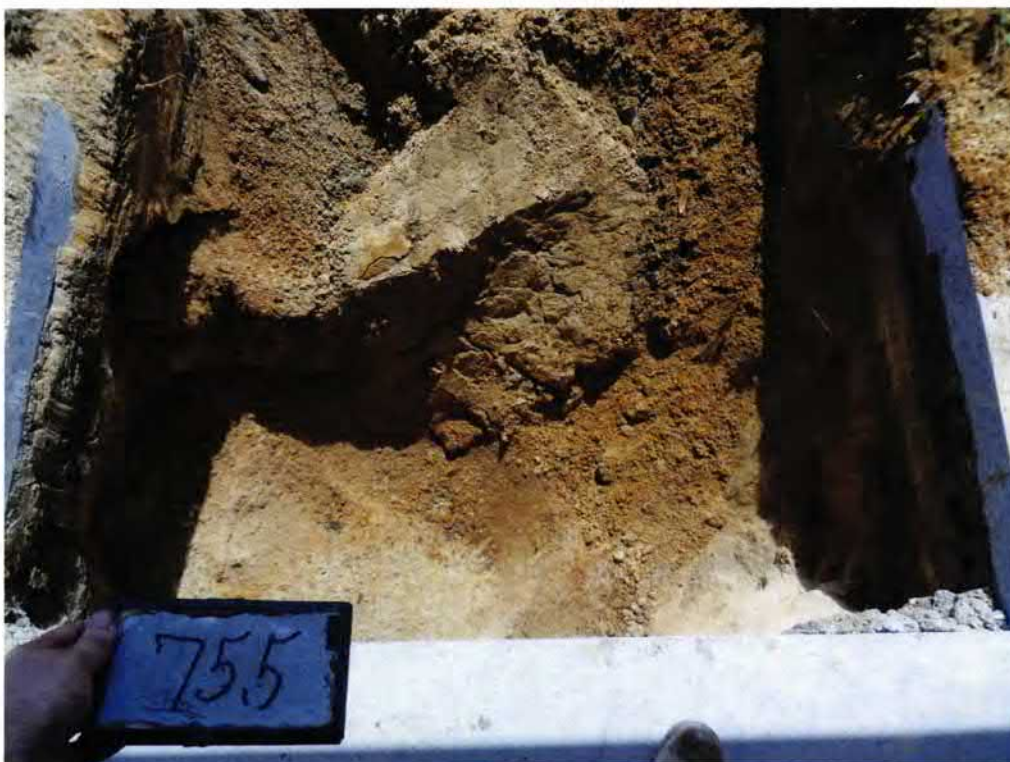
- O. If any corrosion, pitting, or holes were observed, describe the location and extent for each UST  
Corrosion, pitting and holes were scattered about the tank.

Picture 2: UST 755Althea excavation.
