SUMMARY REPORT
70 WEST ALTHEA STREET (FORMERLY 759 WEST ALTHEA STREET)
LAUREL BAY MILITARY HOUSING AREA
MARINE CORPS AIR STATION BEAUFORT
BEAUFORT, SC

JUNE 2021

South Carolina Department of Health and Environmental Control (SCDHEC)
Underground Storage Tank (UST) Assessment Report

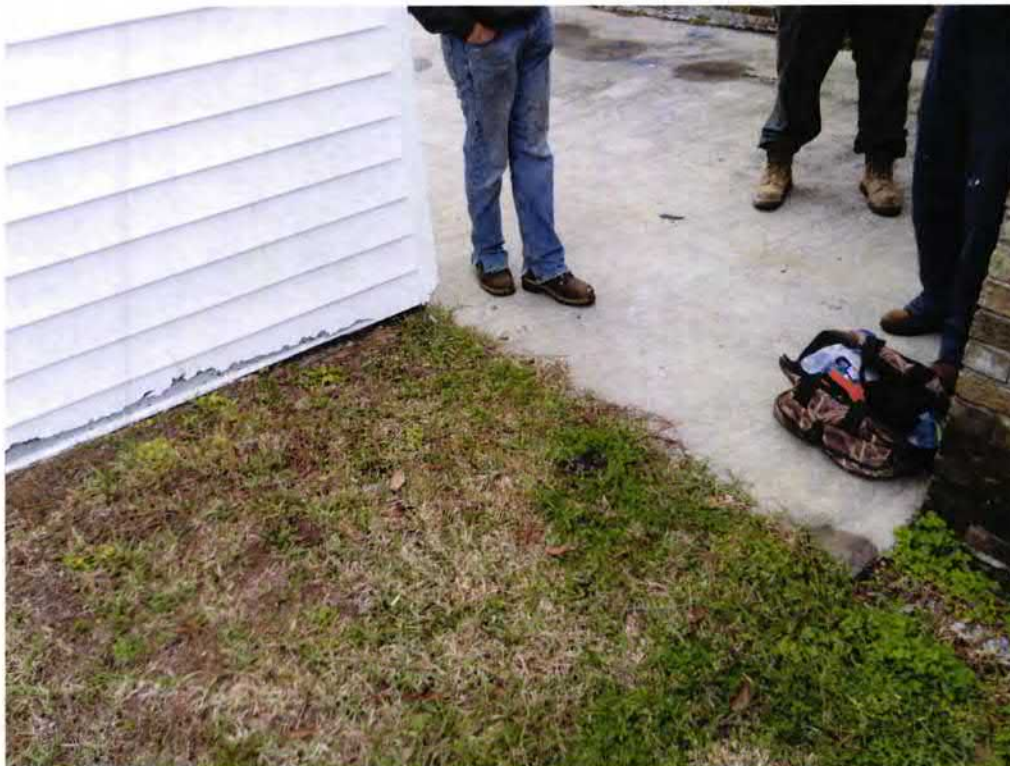
Picture 1: Location of UST 759Althea.

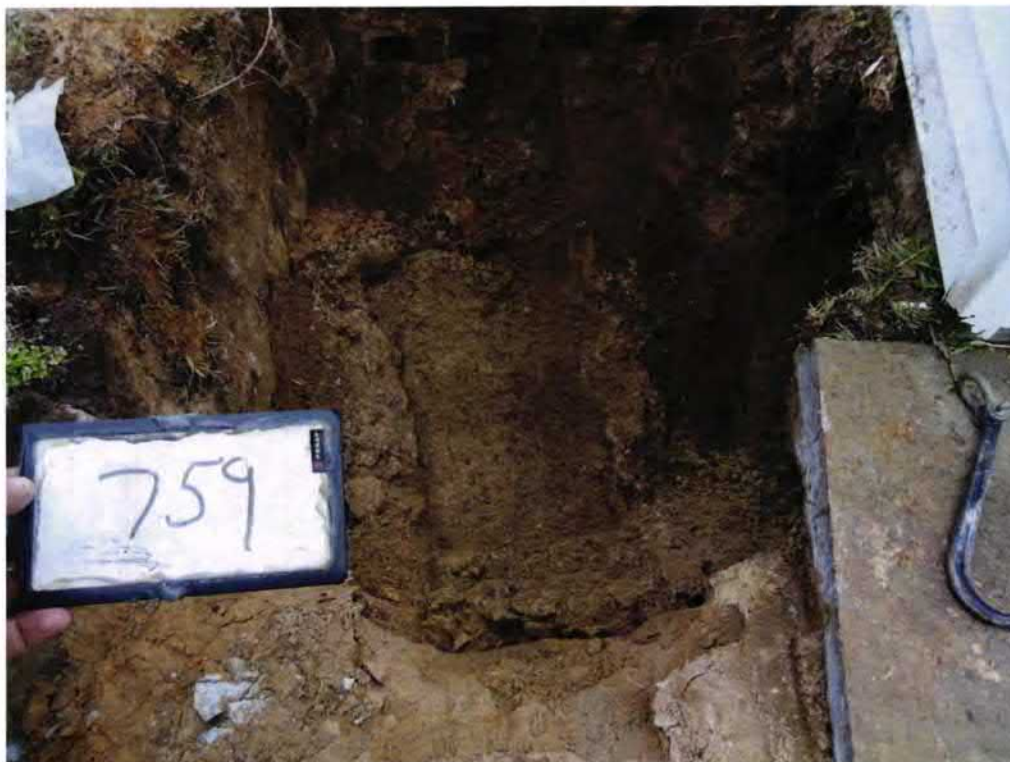
- O. If any corrosion, pitting, or holes were observed, describe the location and extent for each UST
Corrosion, pitting and holes were scattered about the tank.

Picture 2: UST 759Althea excavation.

- M. Method of disposal for any USTs removed from the ground (attach disposal manifests)
UST 759Althea was removed from the ground and disposed at a
"Subtitle D" landfill. See Attachment "A".
