SUMMARY REPORT
238 ASH STREET (FORMERLY 325 ASH STREET)
LAUREL BAY MILITARY HOUSING AREA
MARINE CORPS AIR STATION BEAUFORT
BEAUFORT, SC

JUNE 2021

CDM - AECOM
Multimedia Joint Venture

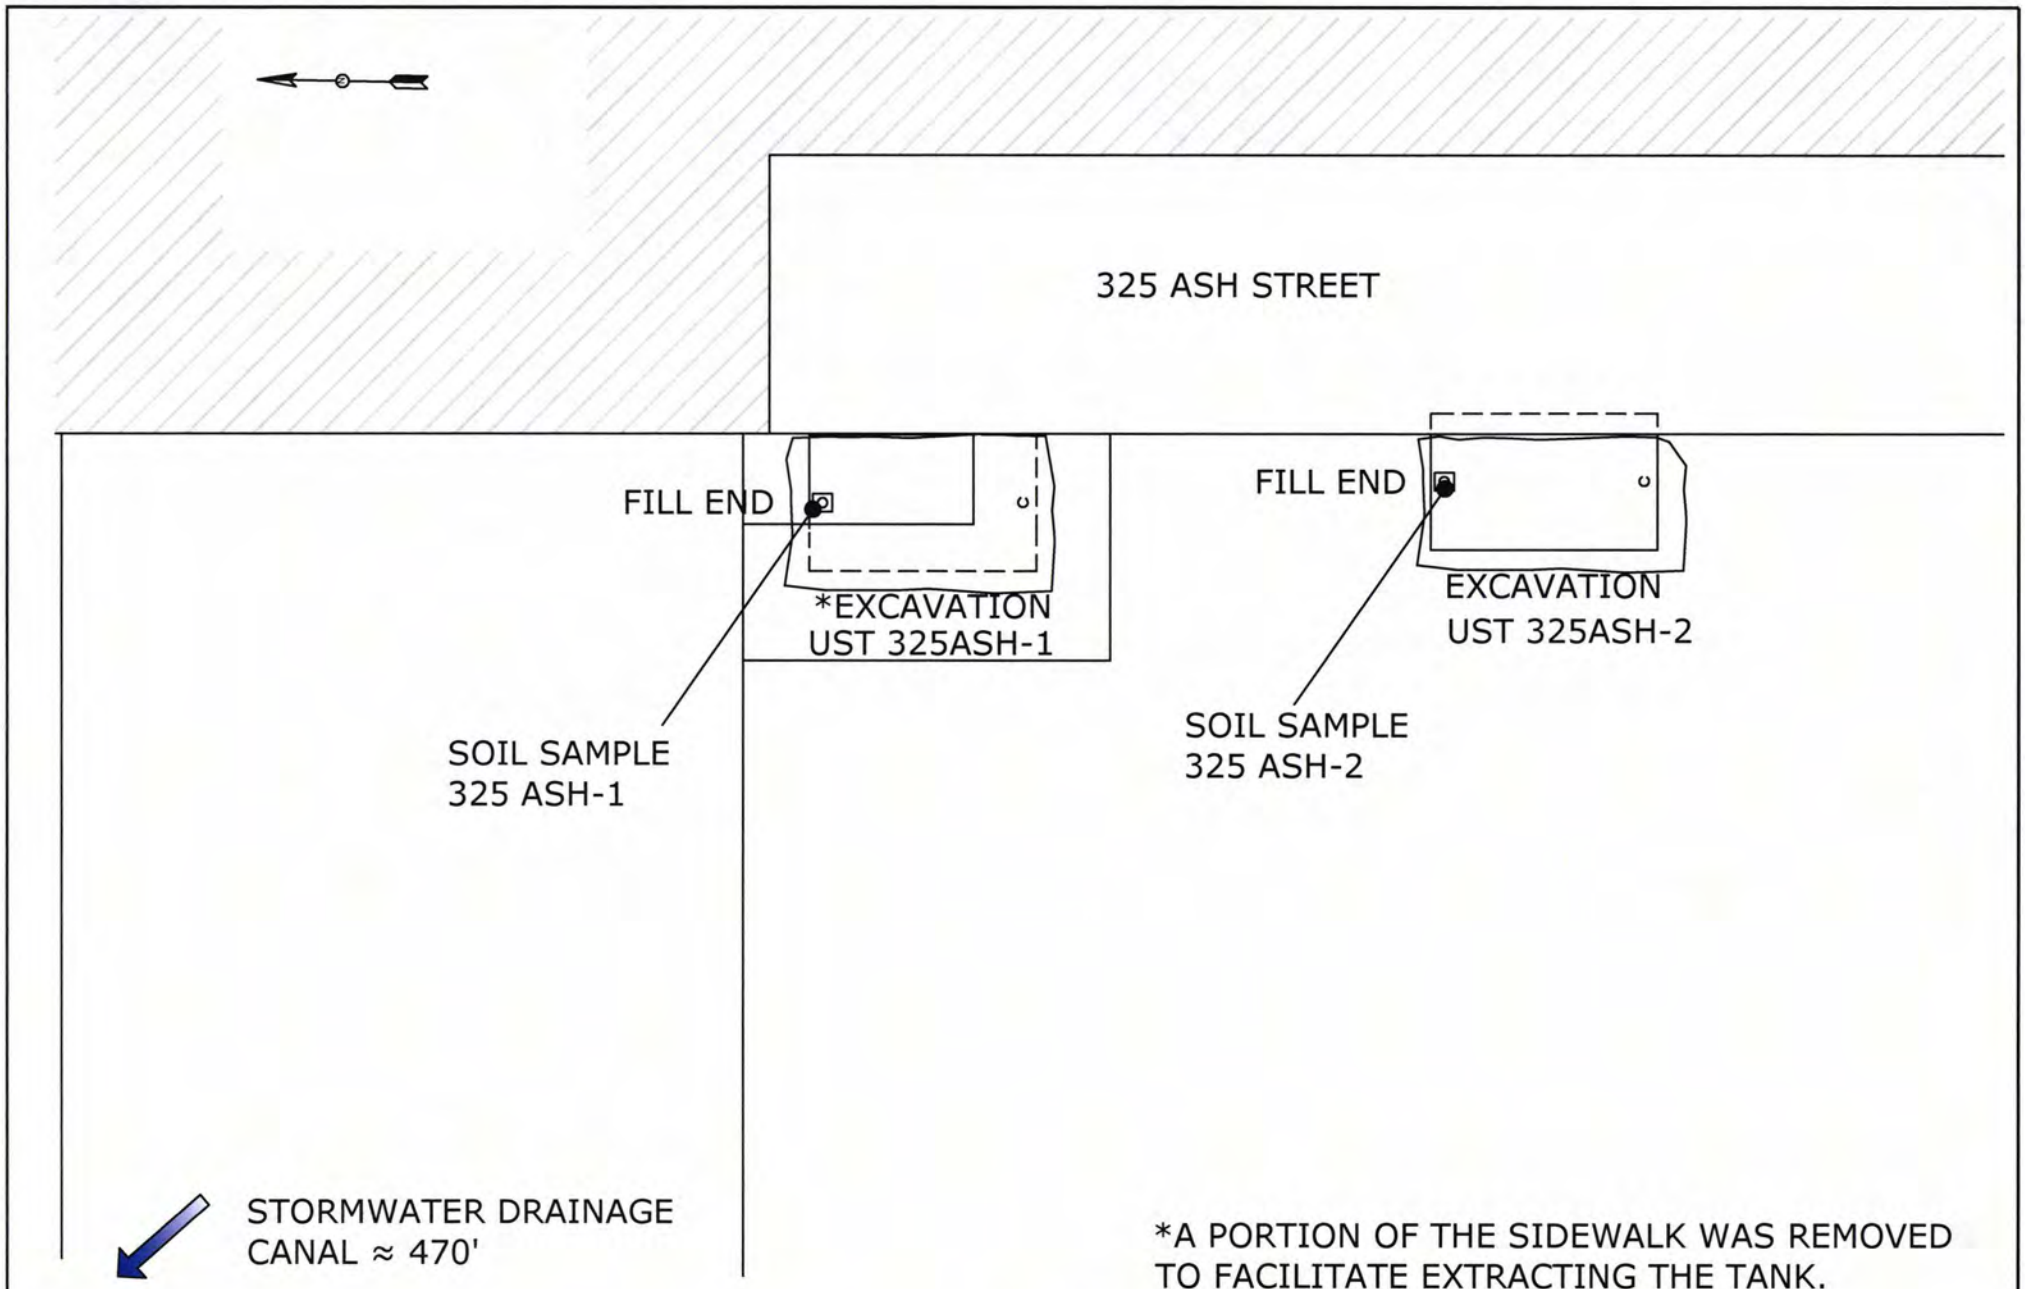
*A PORTION OF THE SIDEWALK WAS REMOVED TO FACILITATE EXTRACTING THE TANK.
