SUMMARY REPORT
174 BANYAN DRIVE (FORMERLY 130 BANYAN DRIVE)
LAUREL BAY MILITARY HOUSING AREA
MARINE CORPS AIR STATION BEAUFORT
BEAUFORT, SC

JUNE 2021

CDM - AECOM
Multimedia Joint Venture

Contract Number: N62470-14-D-9016
CTO WE52
JUNE 2021

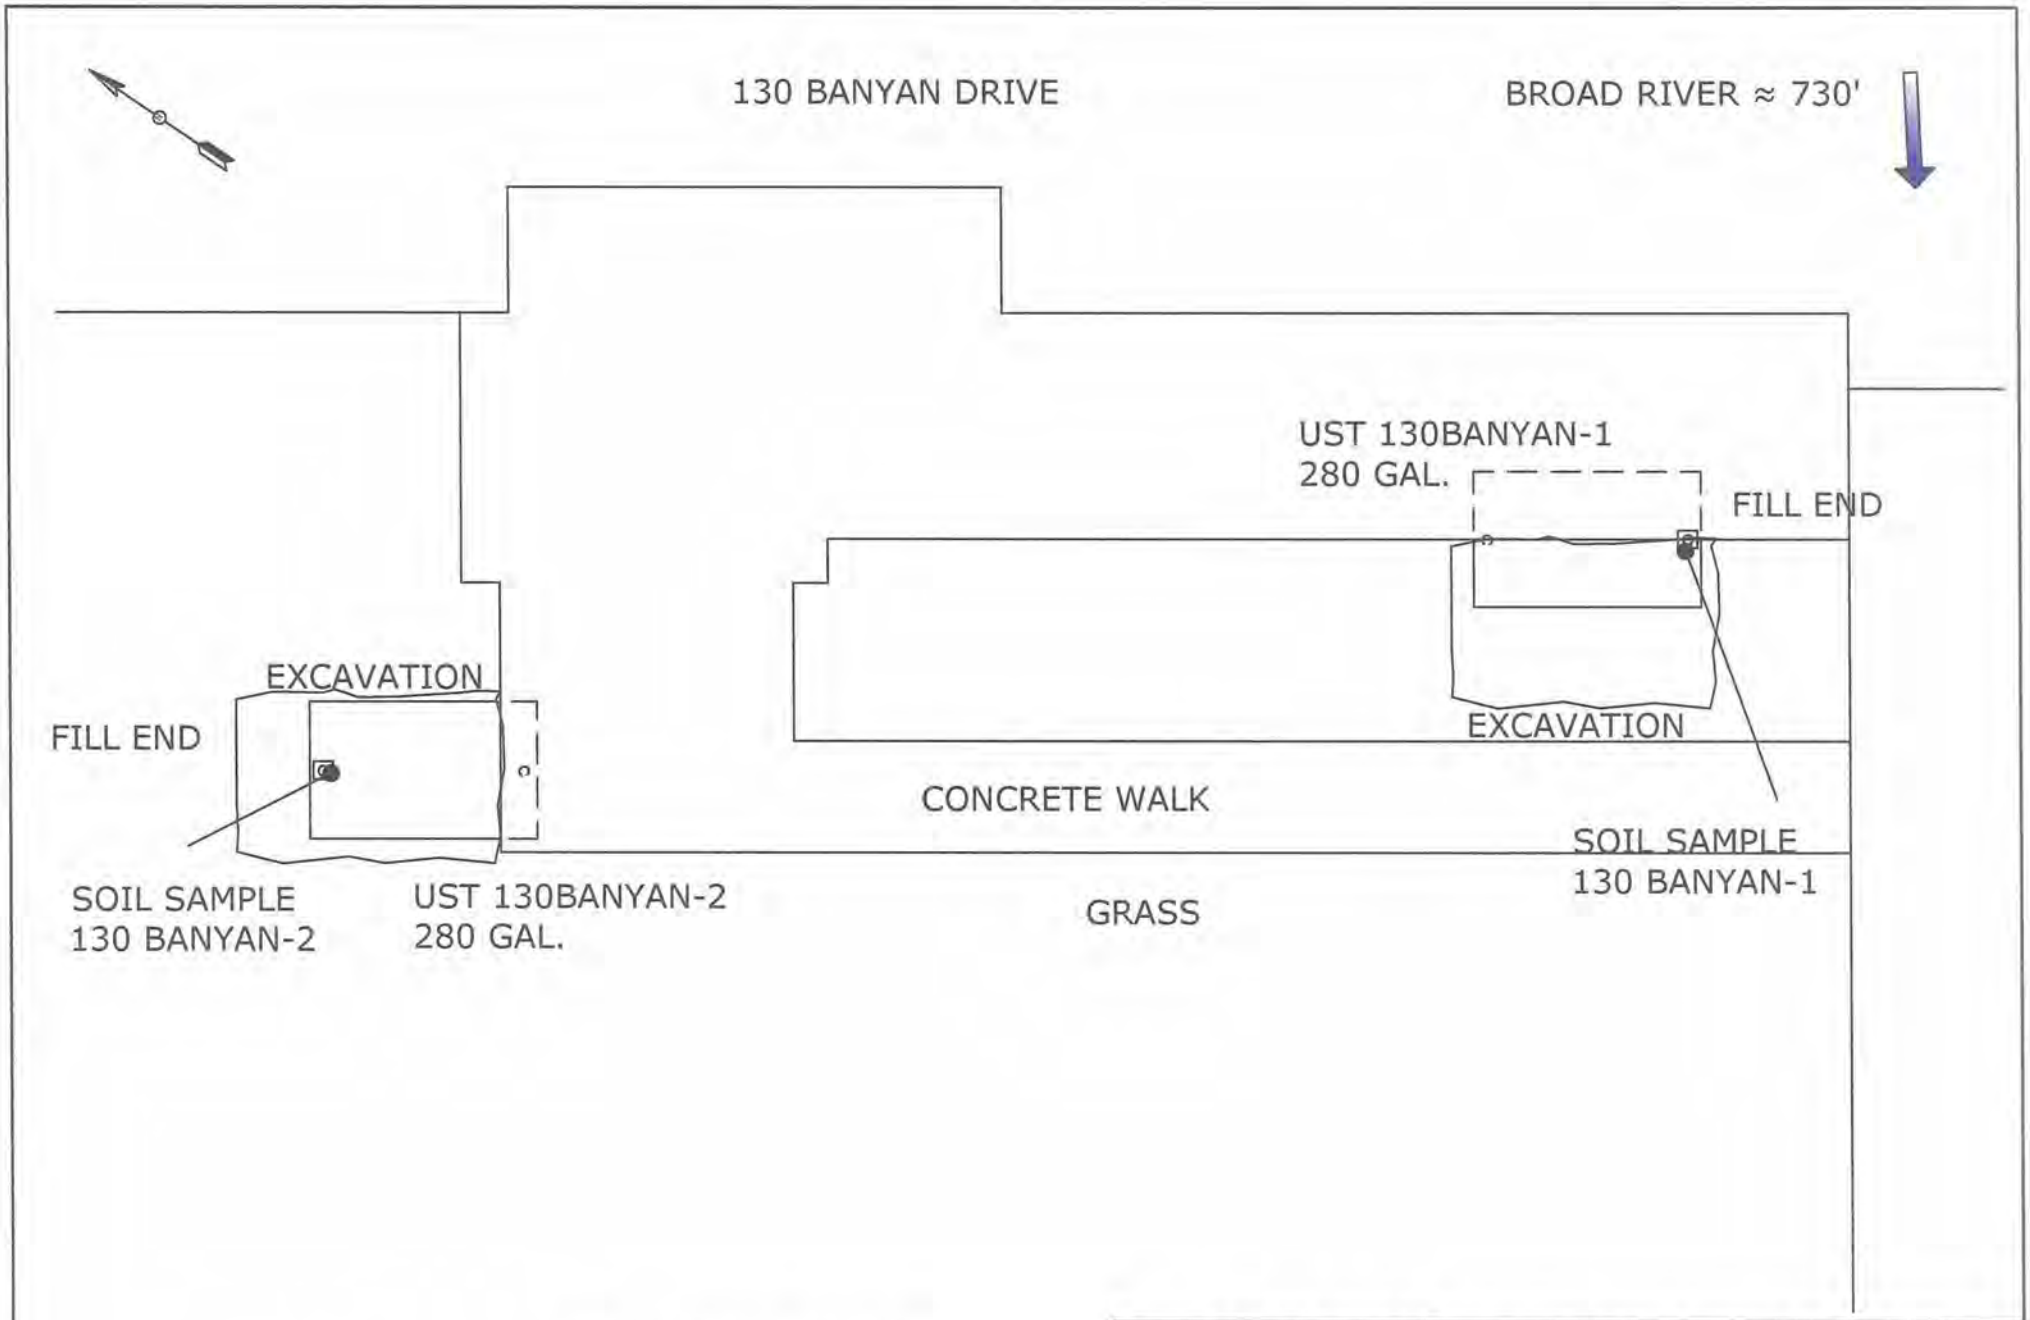
DEPTH BELOW GRADE:
UST 130BANYAN-1 = 39"
UST 130BANYAN-2 = 19"
