SUMMARY REPORT
48 FOXGLOVE STREET (FORMERLY 1007 FOXGLOVE STREET)
LAUREL BAY MILITARY HOUSING AREA
MARINE CORPS AIR STATION BEAUFORT
BEAUFORT, SC

JUNE 2021

Contract Number: N62470-14-D-9016
CTO WE52
JUNE 2021

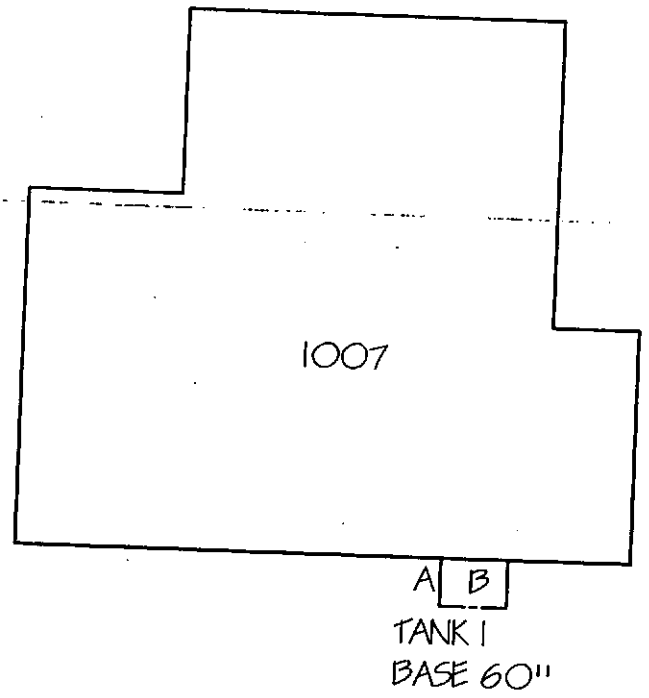
A-SOIL TEST SIDE SAMPLE @ 40"
B-SOIL TEST BOTTOM SAMPLE @ 66"

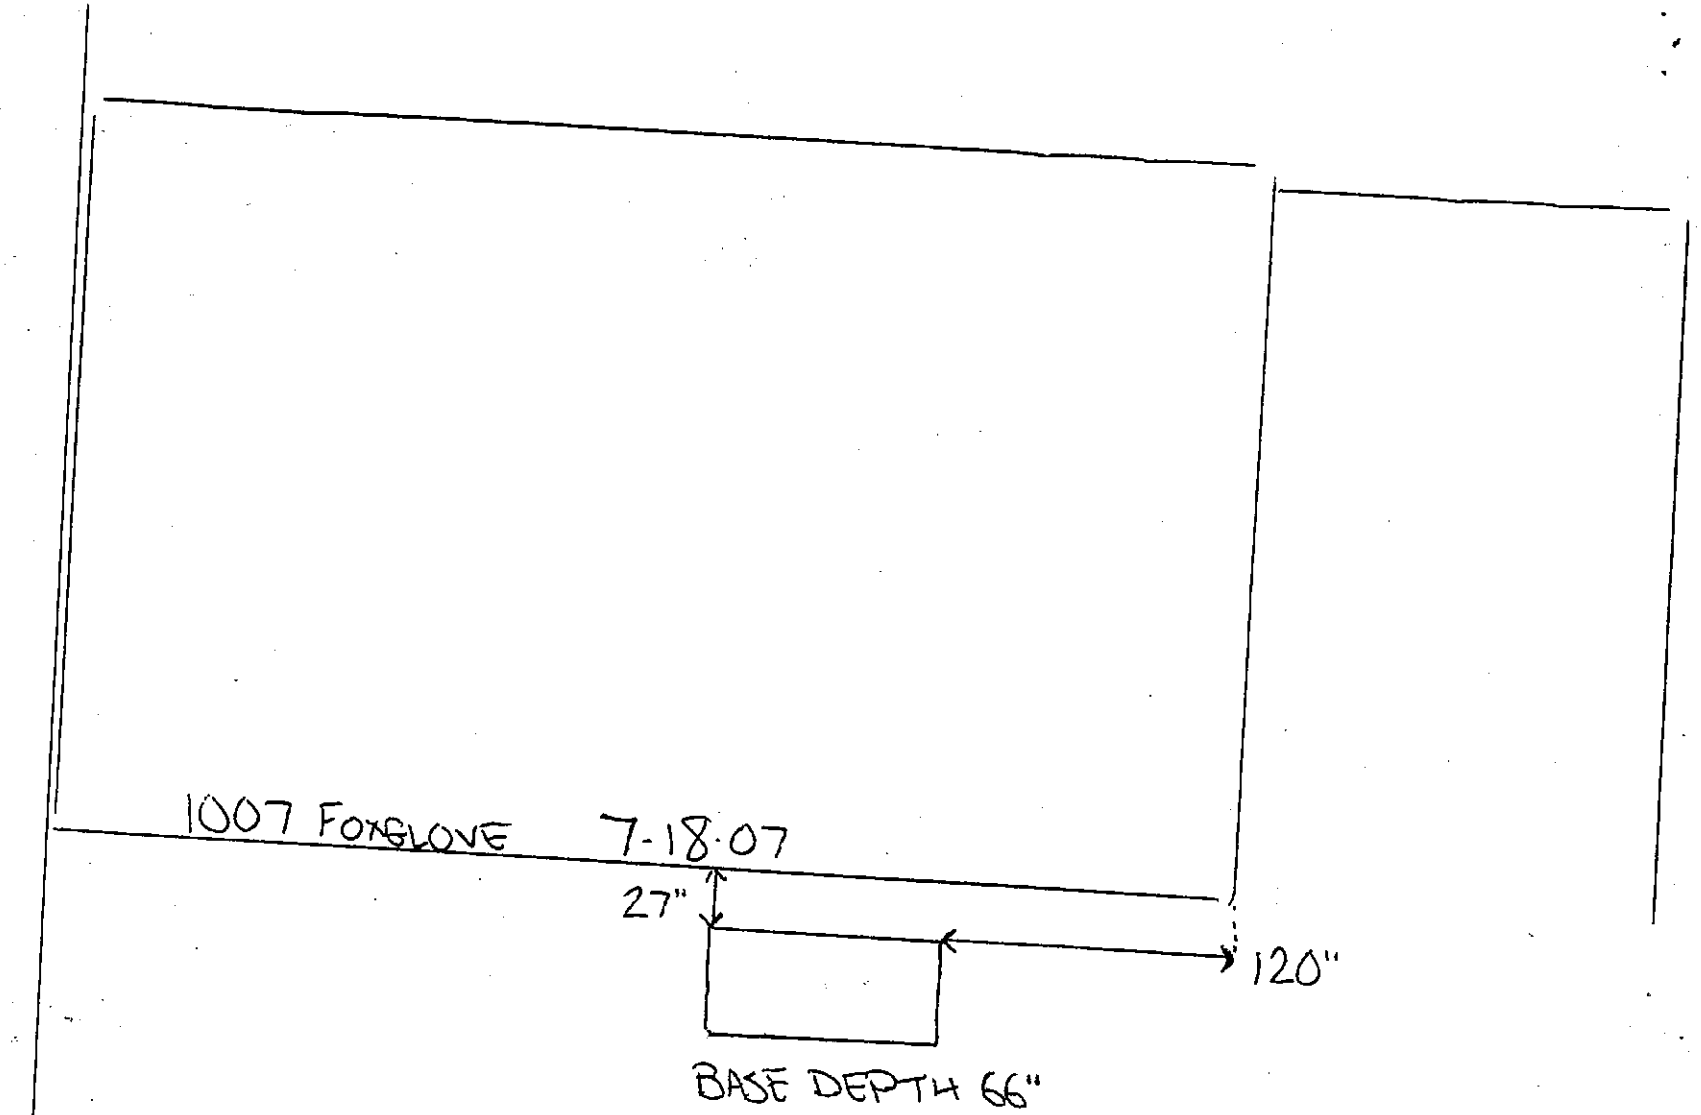
1007 FOXGLOVE 7-18-07
27"
120"
BASE DEPTH 66"
