SUMMARY REPORT
119 FOXGLOVE STREET (FORMERLY 1018 FOXGLOVE STREET)
LAUREL BAY MILITARY HOUSING AREA
MARINE CORPS AIR STATION BEAUFORT
BEAUFORT, SC

Contract Number: N62470-14-D-9016
CTO WE52
JUNE 2021

Attachment 1
South Carolina Department of Health and Environmental Control (SCDHEC)
Underground Storage Tank (UST) Assessment Report

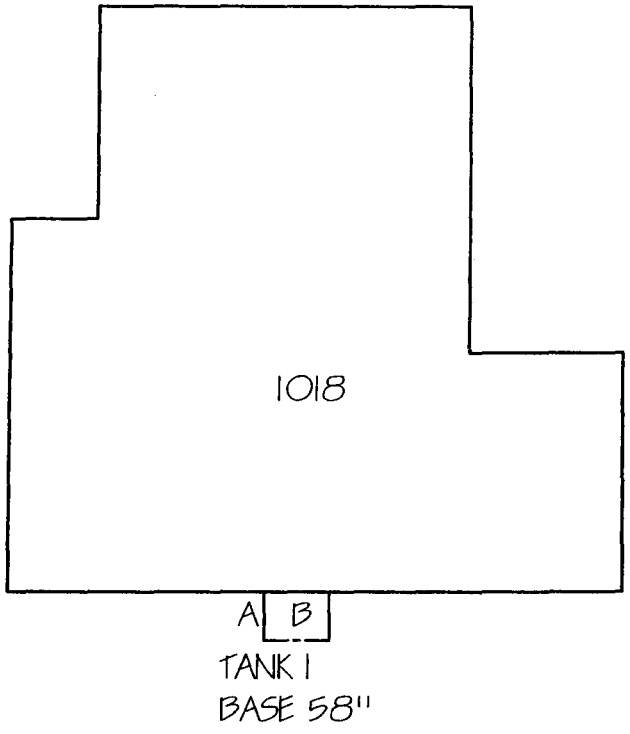
TANK 1 EXCAVATION

A-SOIL TEST SIDE SAMPLE @ 42"
B-SOIL TEST BOTTOM SAMPLE @ 58"
