SUMMARY REPORT
146 FOXGLOVE STREET (FORMERLY 1019 FOXGLOVE STREET)
LAUREL BAY MILITARY HOUSING AREA
MARINE CORPS AIR STATION BEAUFORT
BEAUFORT, SC

JUNE 2021

CDM - AECOM
Multimedia Joint Venture

Contract Number: N62470-14-D-9016
CTO WE52
JUNE 2021

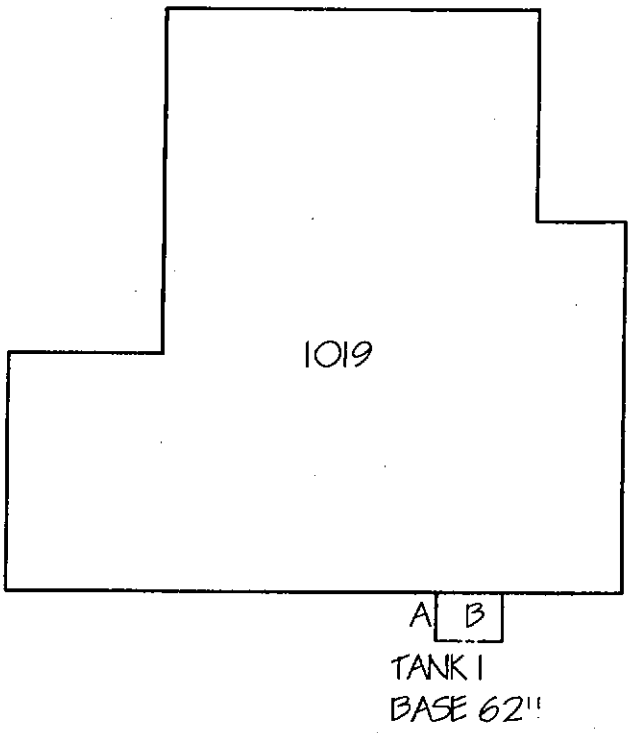
07.17.2007 09:15
1019 FOXGLOVE

TANK HAD PREVIOUSLY BEEN CUT OPEN AND FILLED W/ SAND. EXCAVATION APPEARED TO BE CLEAN.

Fill pipe and vent pipe had mild corrosion

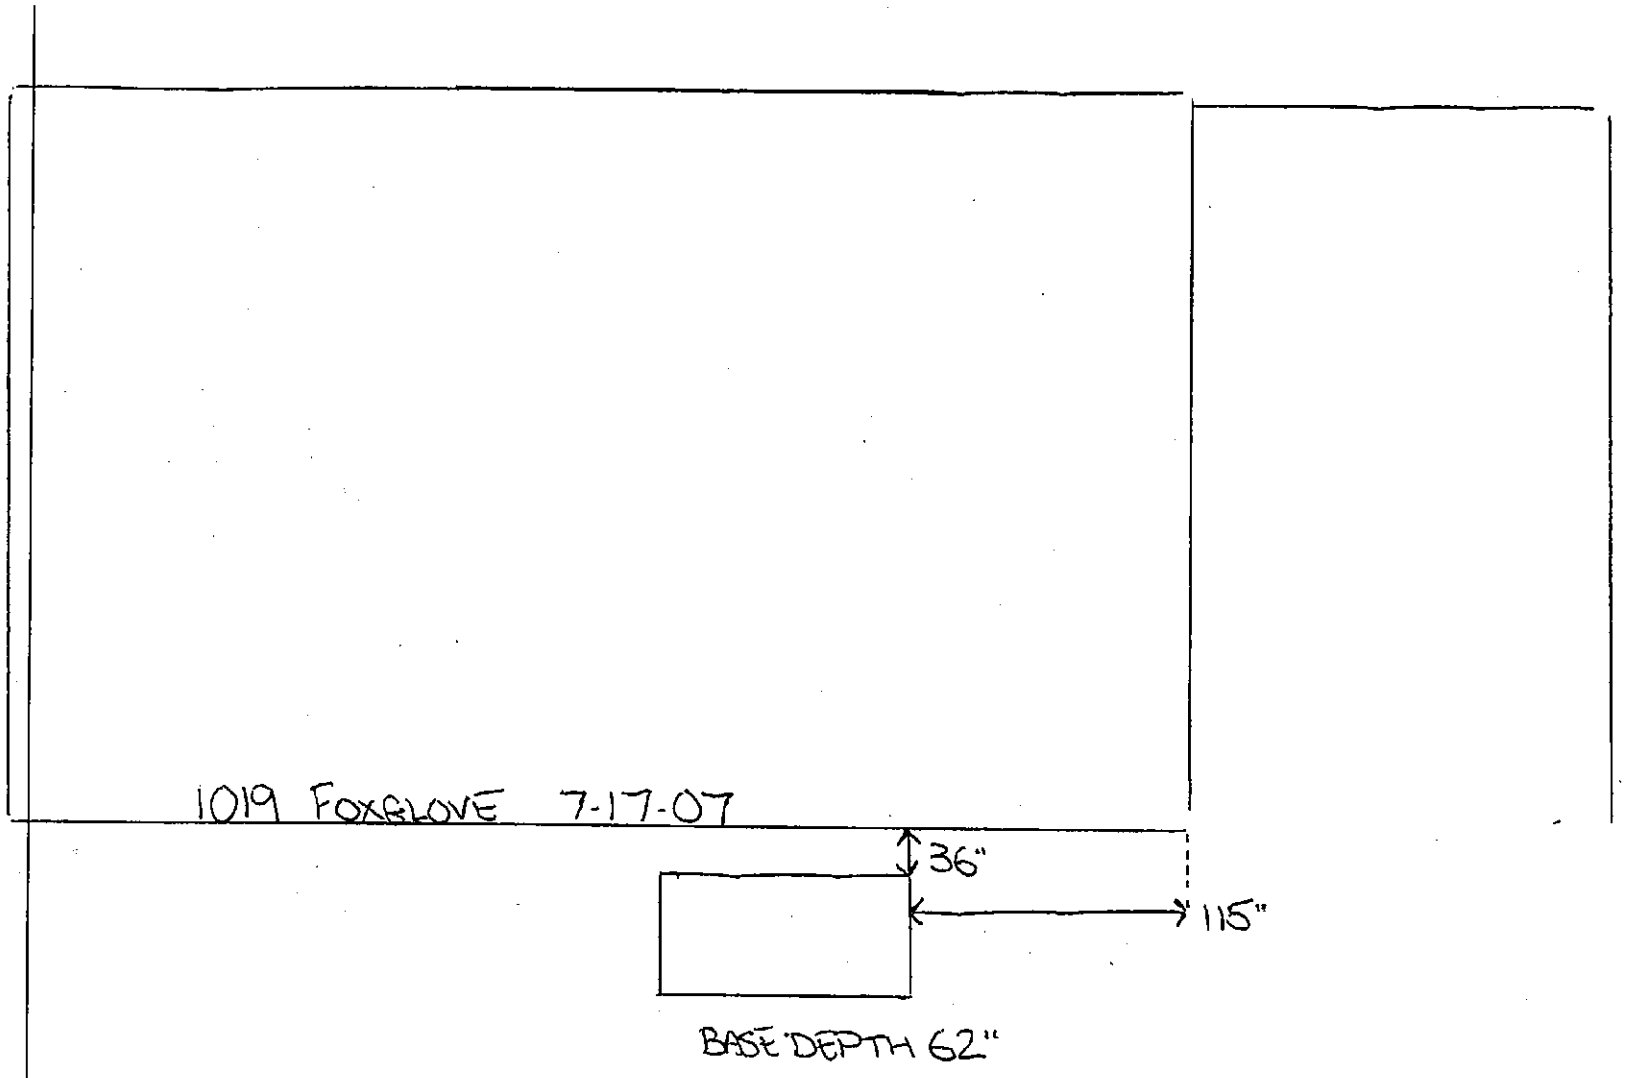
CUSTOMER: BEAUFORT MILITARY COMPLEX FAMILY HOUSING	SCALE: 1/16"=1'-0"	EPG INC.
SITE ADDRESS: 1019 FOX GLOVE STREET	SUPPLIER: EPG INC.	P.O. BOX 1096
	DATE: 9/22/2007	MOUNT PLEASANT, SC 29465-1096

A-SOIL TEST SIDE SAMPLE @ 40"
B-SOIL TEST BOTTOM SAMPLE @ 62"

1019 FOXGLOVE 7-17-07
36"
115"
BASE DEPTH 62"
