SUMMARY REPORT
191 FOXGLOVE STREET (FORMERLY 1026 FOXGLOVE STREET)
LAUREL BAY MILITARY HOUSING AREA
MARINE CORPS AIR STATION BEAUFORT
BEAUFORT, SC

JUNE 2021

Contract Number: N62470-14-D-9016
CTO WE52
JUNE 2021

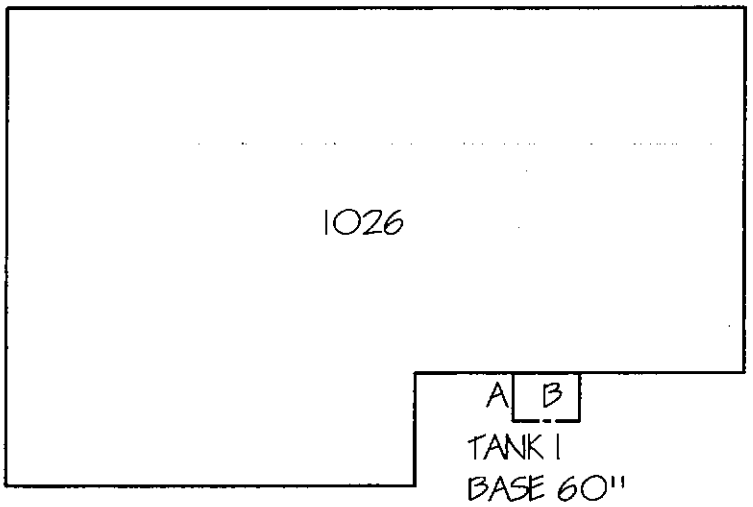
07.31.2007 11:11
1026 FOXGLOVE

Tank 1	Ta	Tank 3	Tank 4	Tank 5	Tank 6
A. Product...(ex. Gas, Kerosene).....	#2 DIESEL					
B. Capacity..(ex. 1k, 2k)..... (APPROX.)	350g					
C. Age.....						
D. Construction Material..(ex. Steel, FRP).....	Steel					
E. Month/Year of Last Use.....						
F. Depth (ft.) To Base of Tank.....	60"					
G. Spill Prevention Equipment Y/N.....	N					
H. Overfill Prevention Equipment Y/N.....	N					
I. Method of Closure (Removed/Filled).....	Removed					
J. Date Tanks Removed/Filled.....	7-31-07					
K. Visible Corrosion or Pitting Y/N.....	N					
L. Visible Holes Y/N.....	Y

Tank had previously been cut open and filled w/ sand.
