SUMMARY REPORT
17 IRIS LANE (FORMERLY 1036 IRIS LANE)
LAUREL BAY MILITARY HOUSING AREA
MARINE CORPS AIR STATION BEAUFORT
BEAUFORT, SC

Contract Number: N62470-14-D-9016
CTO WE52
JUNE 2021

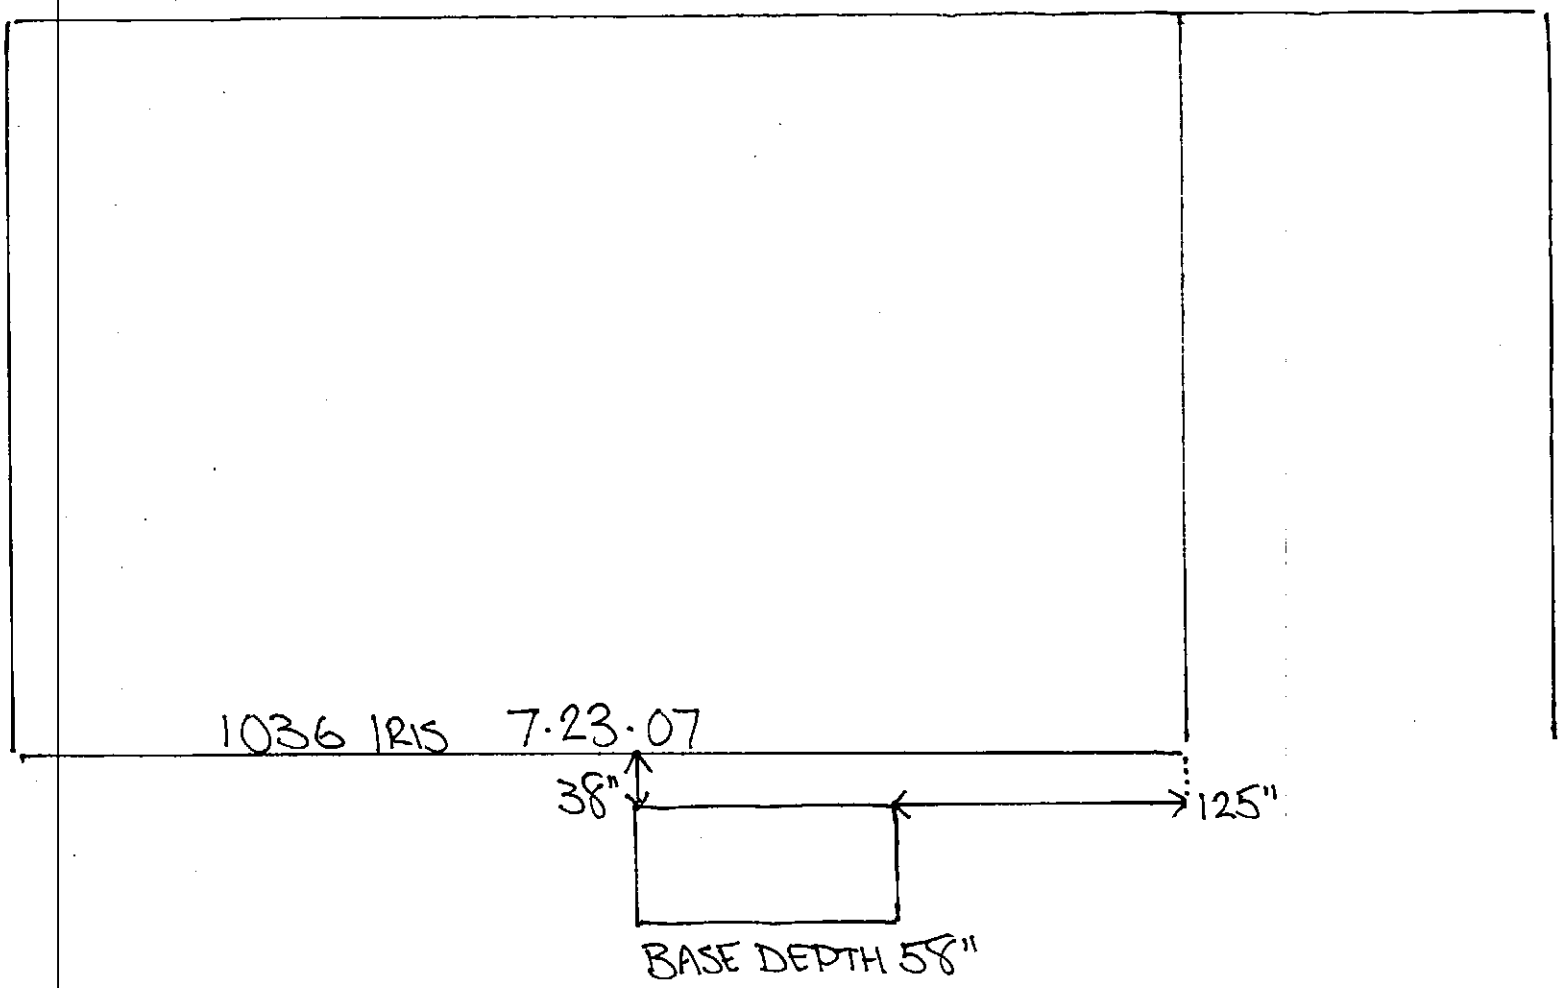
CUSTOMER: BEAUFORT MILITARY COMPLEX FAMILY HOUSING	SCALE: 1/16"=1'-0"	EPG INC.
SITE ADDRESS: 1036 IRIS LANE	SUPPLIER: EPG INC.	P.O. BOX 1096
	DATE: 9/22/2007	MOUNT PLEASANT, SC 29465-1096

TANK 1 EXCAVATION

A-SOIL TEST SIDE SAMPLE @ 37"
B-SOIL TEST BOTTOM SAMPLE @ 58"
