SUMMARY REPORT
283 GARDENIA DRIVE (FORMERLY 1043 GARDENIA DRIVE)
LAUREL BAY MILITARY HOUSING AREA
MARINE CORPS AIR STATION BEAUFORT
BEAUFORT, SC

JUNE 2021

Contract Number: N62470-14-D-9016
CTO WE52
JUNE 2021

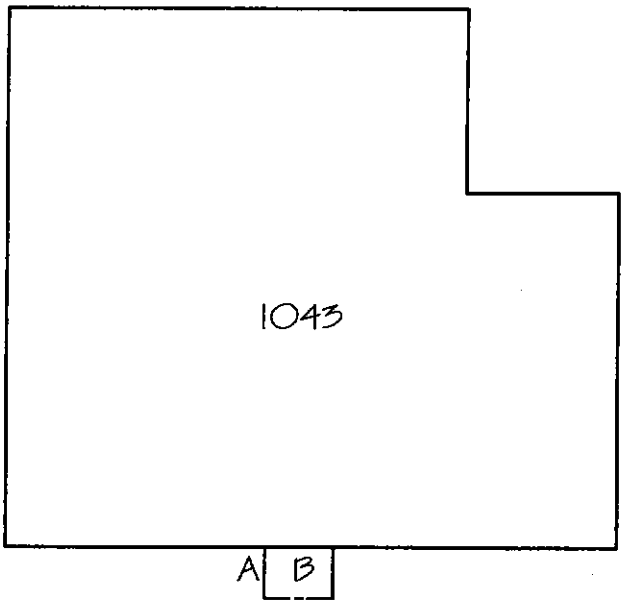
TANK 1
BASE 71"

TANK 1 EXCAVATION

A-SOIL TEST SIDE SAMPLE @ 58"
B-SOIL TEST BOTTOM SAMPLE @ 71"
