SUMMARY REPORT
266 GARDENIA DRIVE (FORMERLY 1044 GARDENIA DRIVE)
LAUREL BAY MILITARY HOUSING AREA
MARINE CORPS AIR STATION BEAUFORT
BEAUFORT, SC

JUNE 2021

Contract Number: N62470-14-D-9016
CTO WE52
JUNE 2021

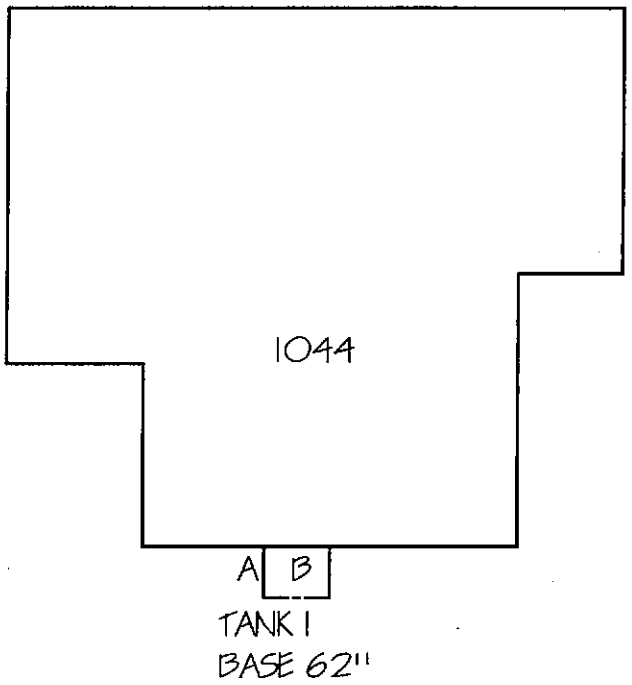
TANK 1 EXCAVATION

A-SOIL TEST SIDE SAMPLE @ 51"
B-SOIL TEST BOTTOM SAMPLE @ 62"
