SUMMARY REPORT
230 GARDENIA DRIVE (FORMERLY 1048 GARDENIA DRIVE)
LAUREL BAY MILITARY HOUSING AREA
MARINE CORPS AIR STATION BEAUFORT
BEAUFORT, SC

JUNE 2021

Contract Number: N62470-14-D-9016
CTO WE52
JUNE 2021

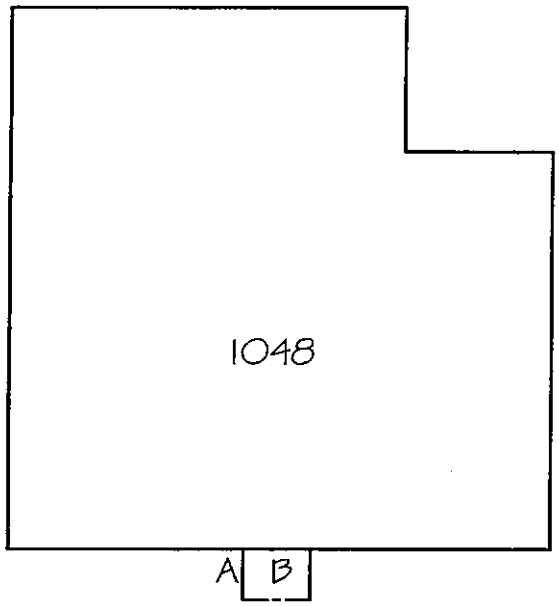
TANK 1 EXCAVATION

TANK 1
BASE 58"

A-SOIL TEST SIDE SAMPLE @ 44"
B-SOIL TEST BOTTOM SAMPLE @ 58"
