SUMMARY REPORT
88 GARDENIA DRIVE (FORMERLY 1060 GARDENIA DRIVE)
LAUREL BAY MILITARY HOUSING AREA
MARINE CORPS AIR STATION BEAUFORT
BEAUFORT, SC

JUNE 2021

Contract Number: N62470-14-D-9016
CTO WE52
JUNE 2021

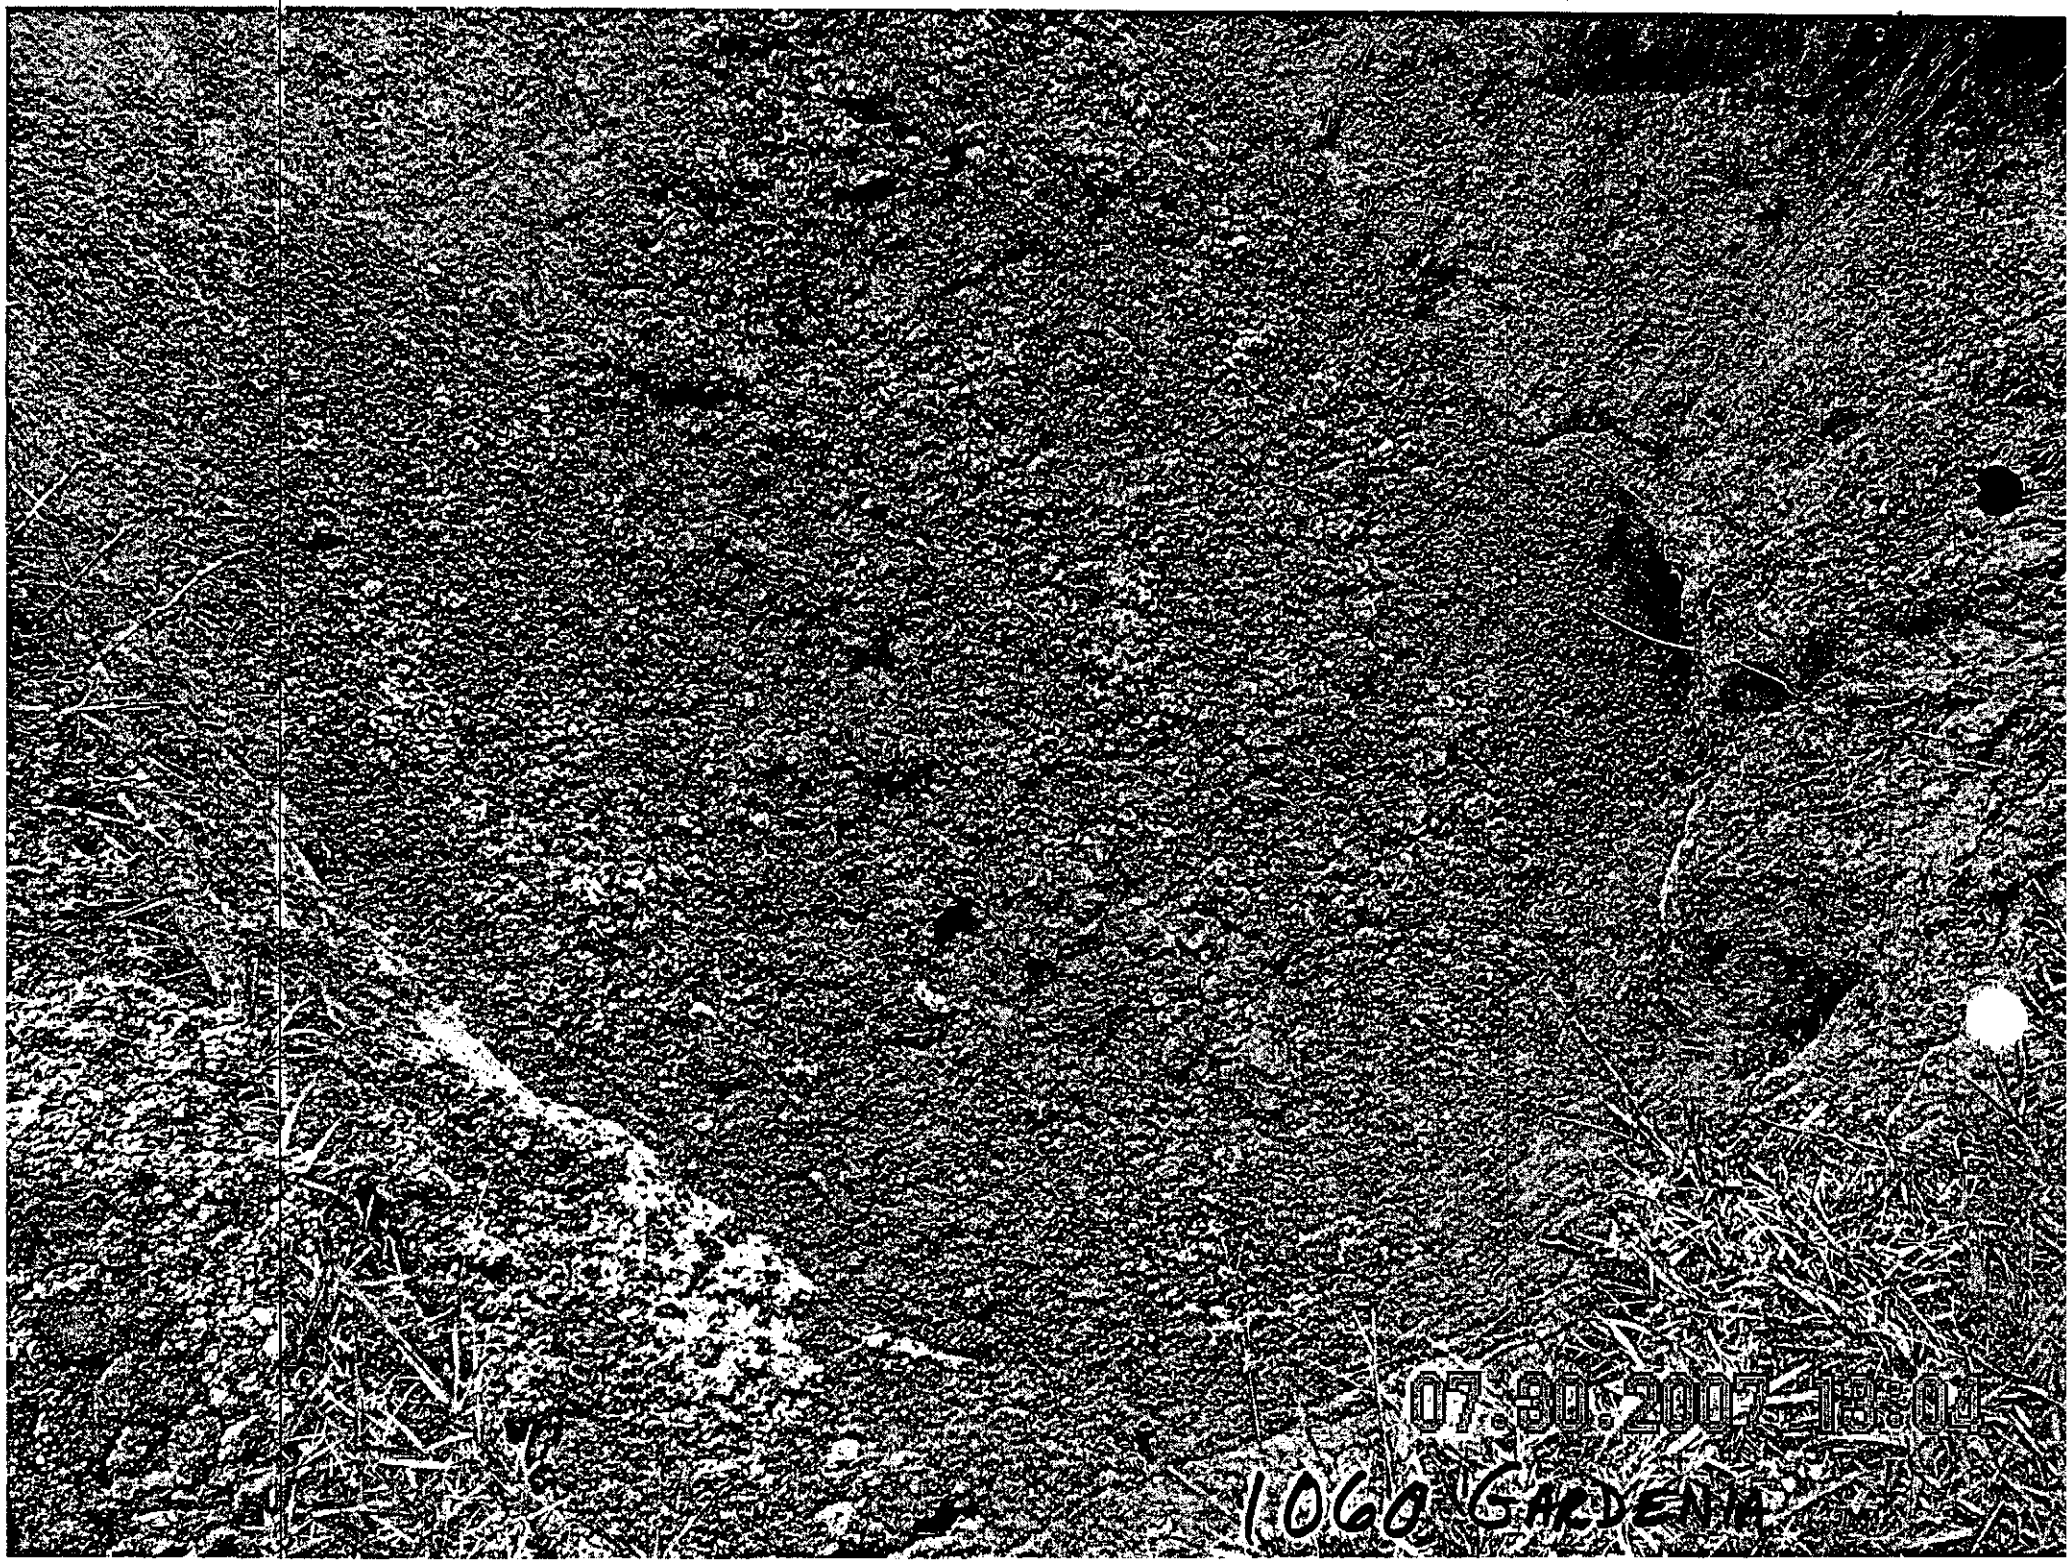
07.30.2007 15:04
1060 GARDENA

MINOR CORROSION WAS NOTED ON THE FILL PIPE AND VENT PIPE.

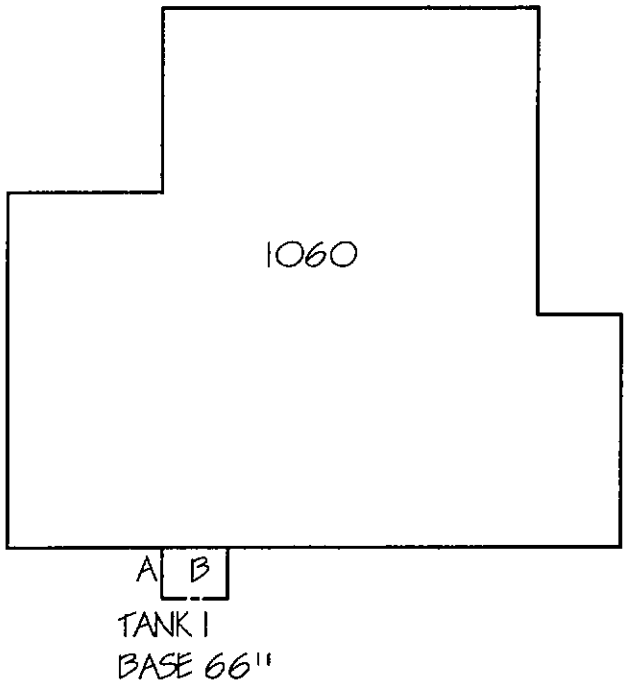
TANK 1 EXCAVATION

A-SOIL TEST SIDE SAMPLE @ 45"
B-SOIL TEST BOTTOM SAMPLE @ 66"
