SUMMARY REPORT
25 GARDENIA DRIVE (FORMERLY 1067 GARDENIA DRIVE)
LAUREL BAY MILITARY HOUSING AREA
MARINE CORPS AIR STATION BEAUFORT
BEAUFORT, SC

Contract Number: N62470-14-D-9016
CTO WE52
JUNE 2021

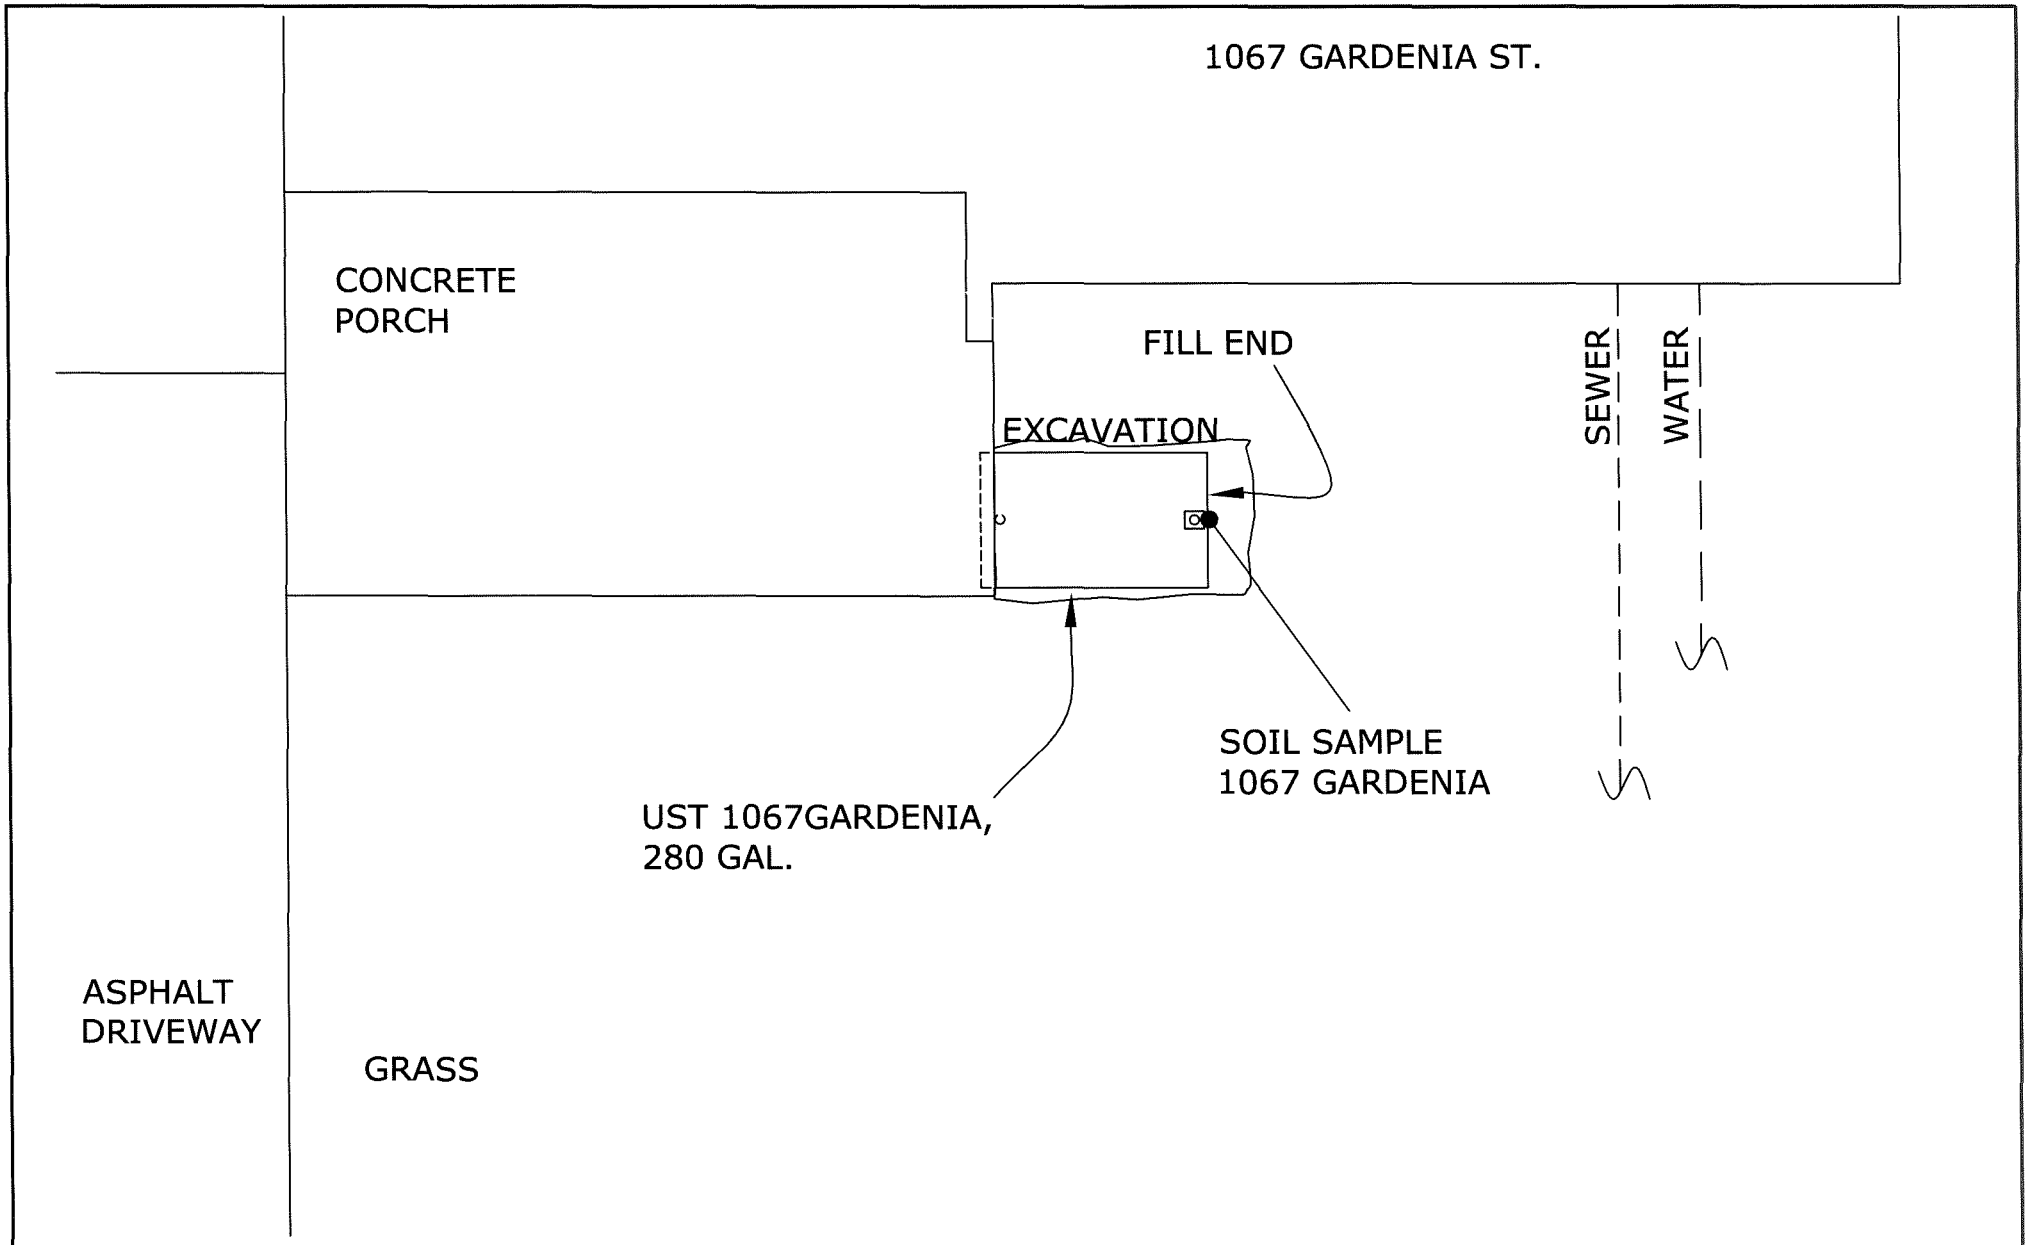
FIGURE 3 UST SAMPLE LOCATIONS
1067 GARDENIA ST., LAUREL BAY
MCAS BEAUFORT SC

UST 1067GARDENIA WAS
36" BELOW GRADE.
