SUMMARY REPORT
56 HEATHER STREET (FORMERLY 1079 HEATHER STREET)
LAUREL BAY MILITARY HOUSING AREA
MARINE CORPS AIR STATION BEAUFORT
BEAUFORT, SC

JUNE 2021

CDM - AECOM
Multimedia Joint Venture

Contract Number: N62470-14-D-9016
CTO WE52
JUNE 2021

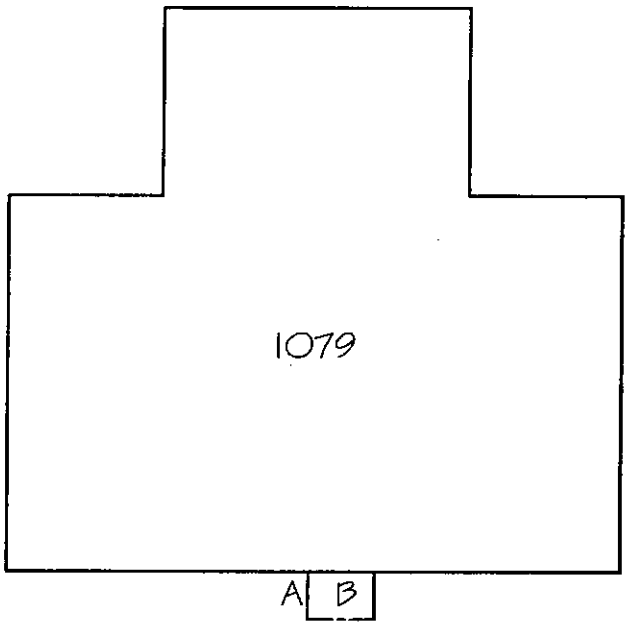
TANK 1
BASE 52"
