SUMMARY REPORT
159 IRIS LANE (FORMERLY 1106 IRIS LANE)
LAUREL BAY MILITARY HOUSING AREA
MARINE CORPS AIR STATION BEAUFORT
BEAUFORT, SC

JUNE 2021

CDM - AECOM
Multimedia Joint Venture

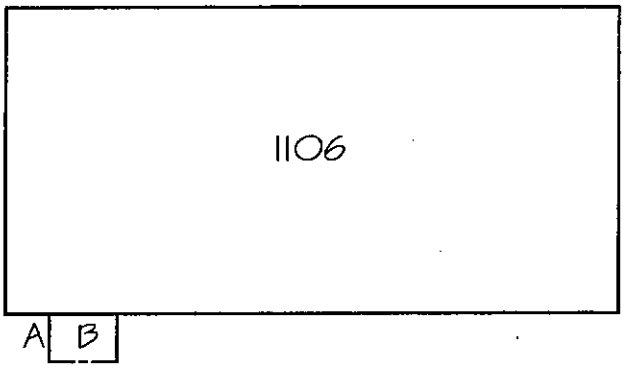
07.23.2007 12:58
1106 IRIS

TANK 1
BASE 66"
