SUMMARY REPORT
177 IRIS LANE (FORMERLY 1108 IRIS LANE)
LAUREL BAY MILITARY HOUSING AREA
MARINE CORPS AIR STATION BEAUFORT
BEAUFORT, SC

Contract Number: N62470-14-D-9016
CTO WE52
JUNE 2021

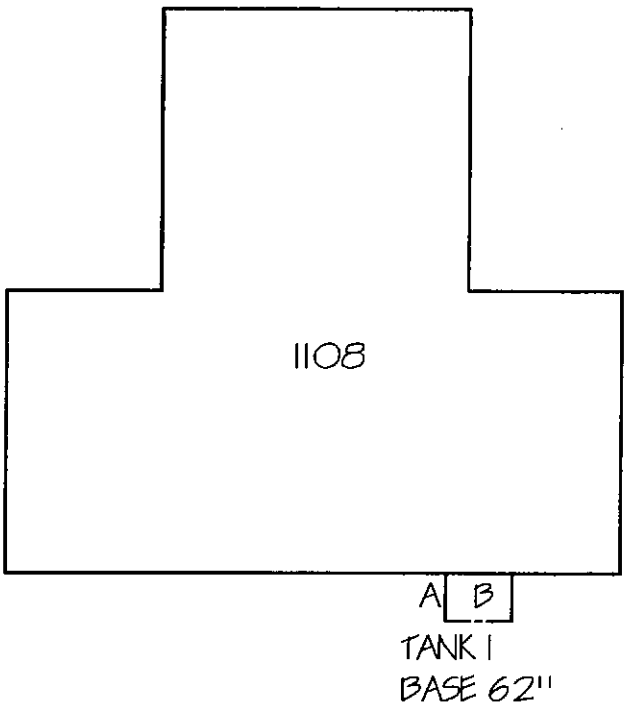
TANK 1 EXCAVATION

A-SOIL TEST SIDE SAMPLE @ 50"
B-SOIL TEST BOTTOM SAMPLE @ 62"
