SUMMARY REPORT
280 IRIS LANE (FORMERLY 1115 IRIS LANE)
LAUREL BAY MILITARY HOUSING AREA
MARINE CORPS AIR STATION BEAUFORT
BEAUFORT, SC

Contract Number: N62470-14-D-9016
CTO WE52
JUNE 2021

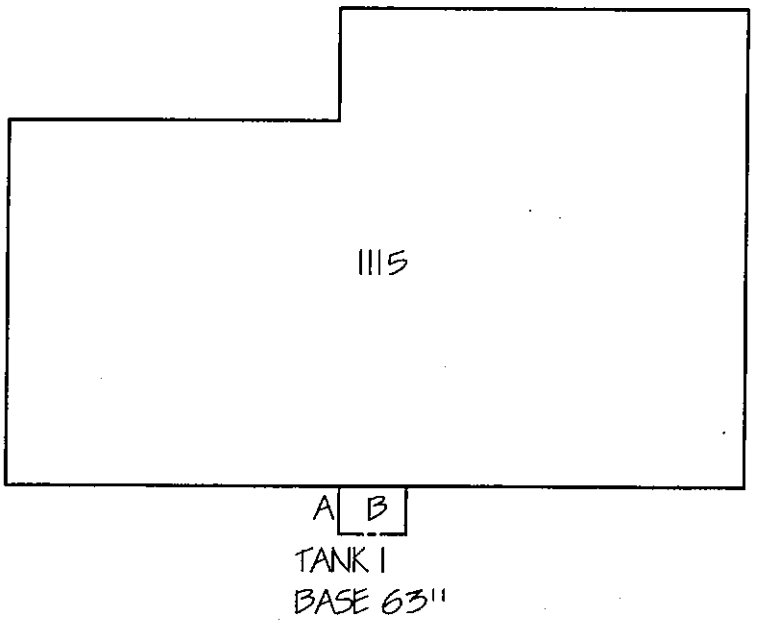
TANK 1 EXCAVATION

A-SOIL TEST SIDE SAMPLE @ 47"
B-SOIL TEST BOTTOM SAMPLE @ 63"
