SUMMARY REPORT
239 IRIS LANE (FORMERLY 1116 IRIS LANE)
LAUREL BAY MILITARY HOUSING AREA
MARINE CORPS AIR STATION BEAUFORT
BEAUFORT, SC

Contract Number: N62470-14-D-9016
CTO WE52
JUNE 2021

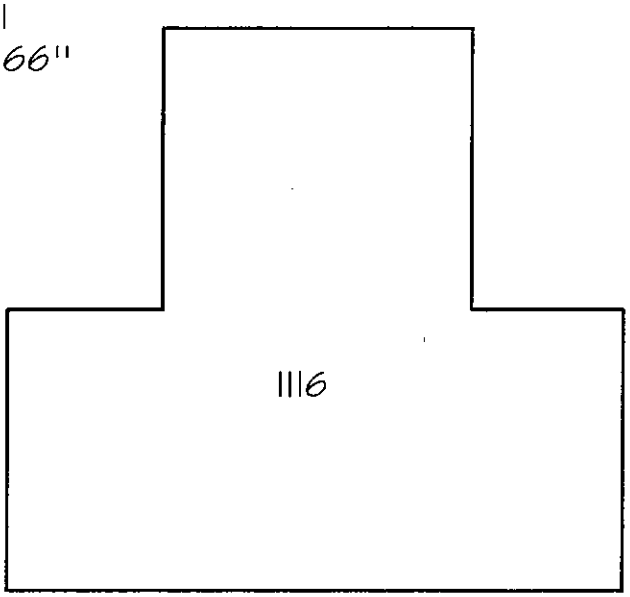
TANK 1 EXCAVATION

TANK 1
BASE 66"

A-SOIL TEST SIDE SAMPLE @ 48"
B-SOIL TEST BOTTOM SAMPLE @ 66"

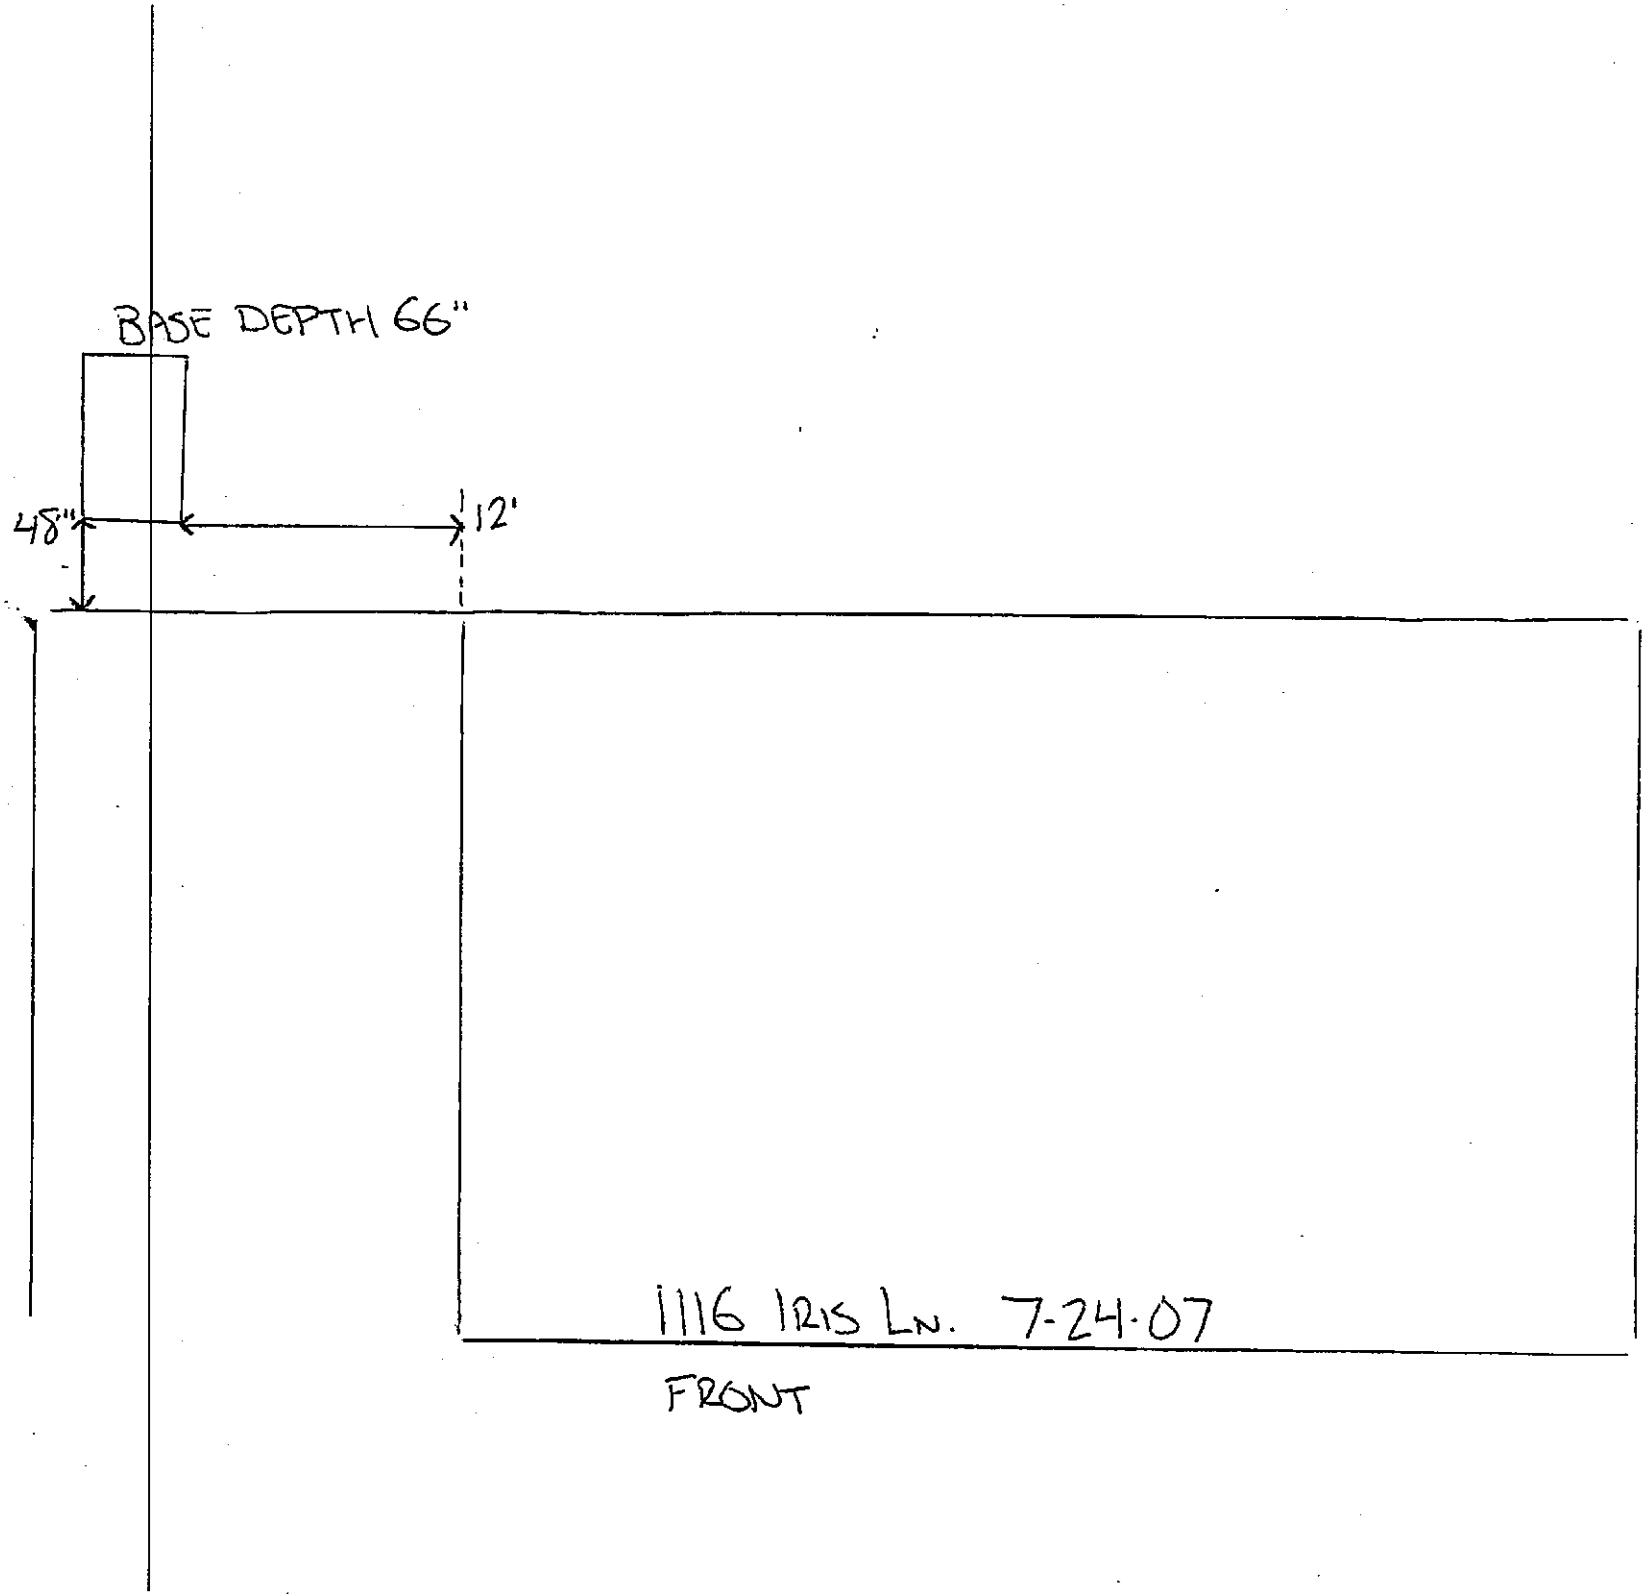
BASE DEPTH 66"
48"
12'
1116 IRIS LN. 7-24-07
FRONT
