SUMMARY REPORT
247 IRIS LANE (FORMERLY 1118 IRIS LANE)
LAUREL BAY MILITARY HOUSING AREA
MARINE CORPS AIR STATION BEAUFORT
BEAUFORT, SC

JUNE 2021

CDM - AECOM Multimedia Joint Venture
10560 Arrowhead Drive, Suite 500
Fairfax, Virginia 22030

Contract Number: N62470-14-D-9016
CTO WE52
JUNE 2021

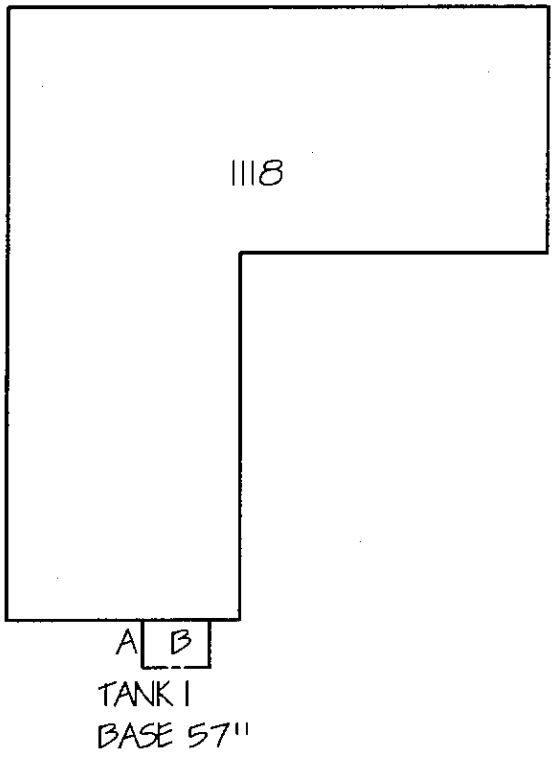
CUSTOMER: BEAUFORT MILITARY COMPLEX FAMILY HOUSING	SCALE: 1/16"=1'-0"	EPG INC.
SITE ADDRESS: 1118 IRIS LANE	SUPPLIER: EPG INC.	P.O. BOX 1096
	DATE: 9/22/2007	MOUNT PLEASANT, SC 29465-1096

TANK I EXCAVATION

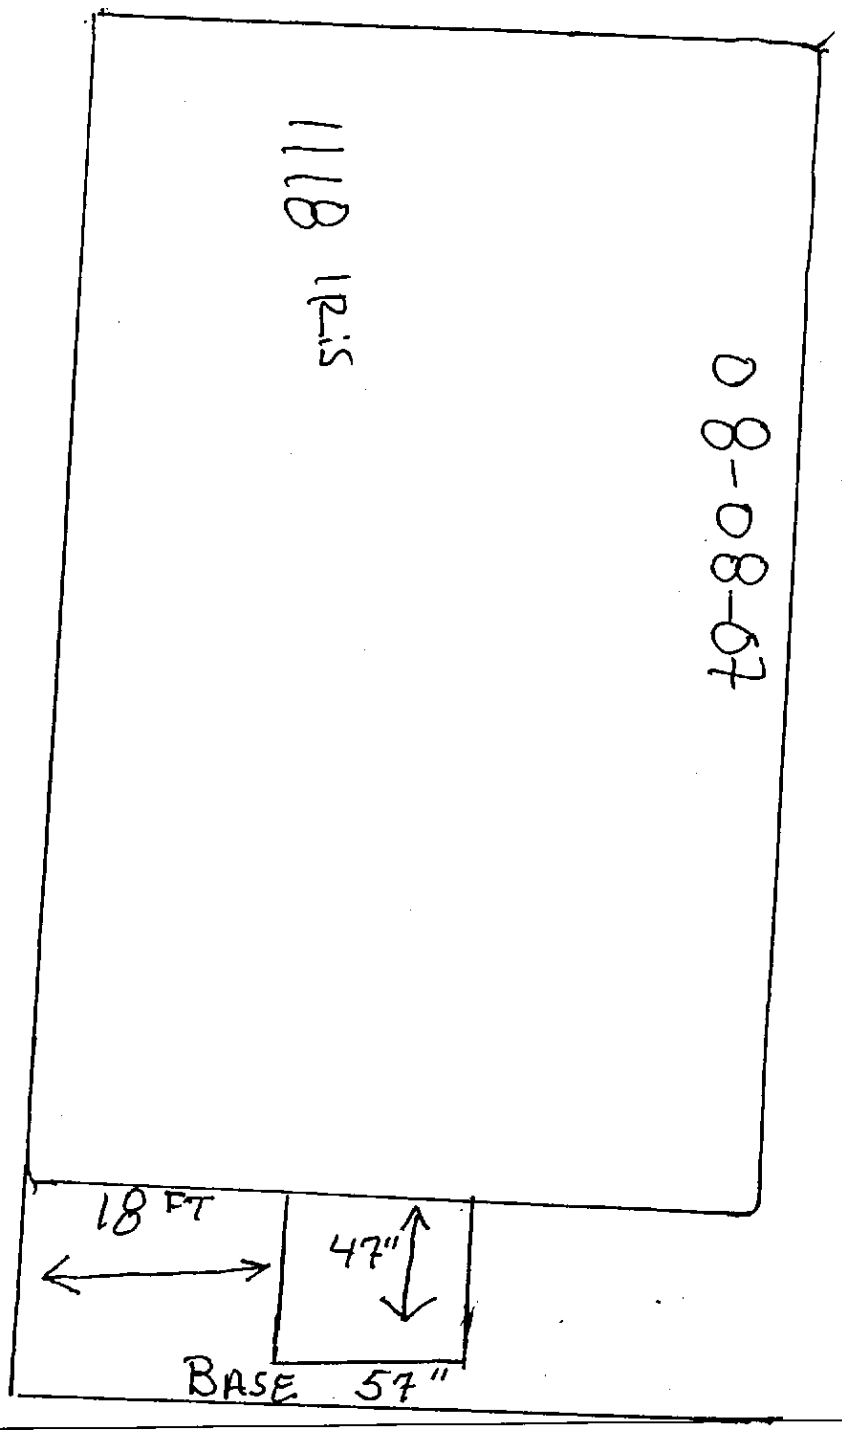
1118 IRIS
08.18.2007 16:28

SIGN 8111
10-80-07
18 FT
47"
BASE 57"
