SUMMARY REPORT
287 IRIS LANE (FORMERLY 1124 IRIS LANE)
LAUREL BAY MILITARY HOUSING AREA
MARINE CORPS AIR STATION BEAUFORT
BEAUFORT, SC

JUNE 2021

CDM - AECOM Multimedia Joint Venture
10560 Arrowhead Drive, Suite 500
Fairfax, Virginia 22030

Contract Number: N62470-14-D-9016
CTO WE52
JUNE 2021

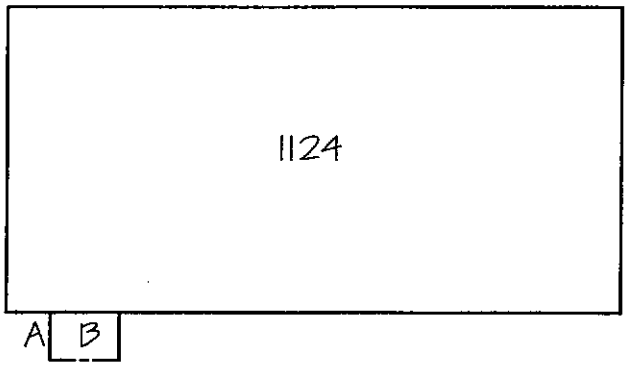
TANK 1
BASE 60"

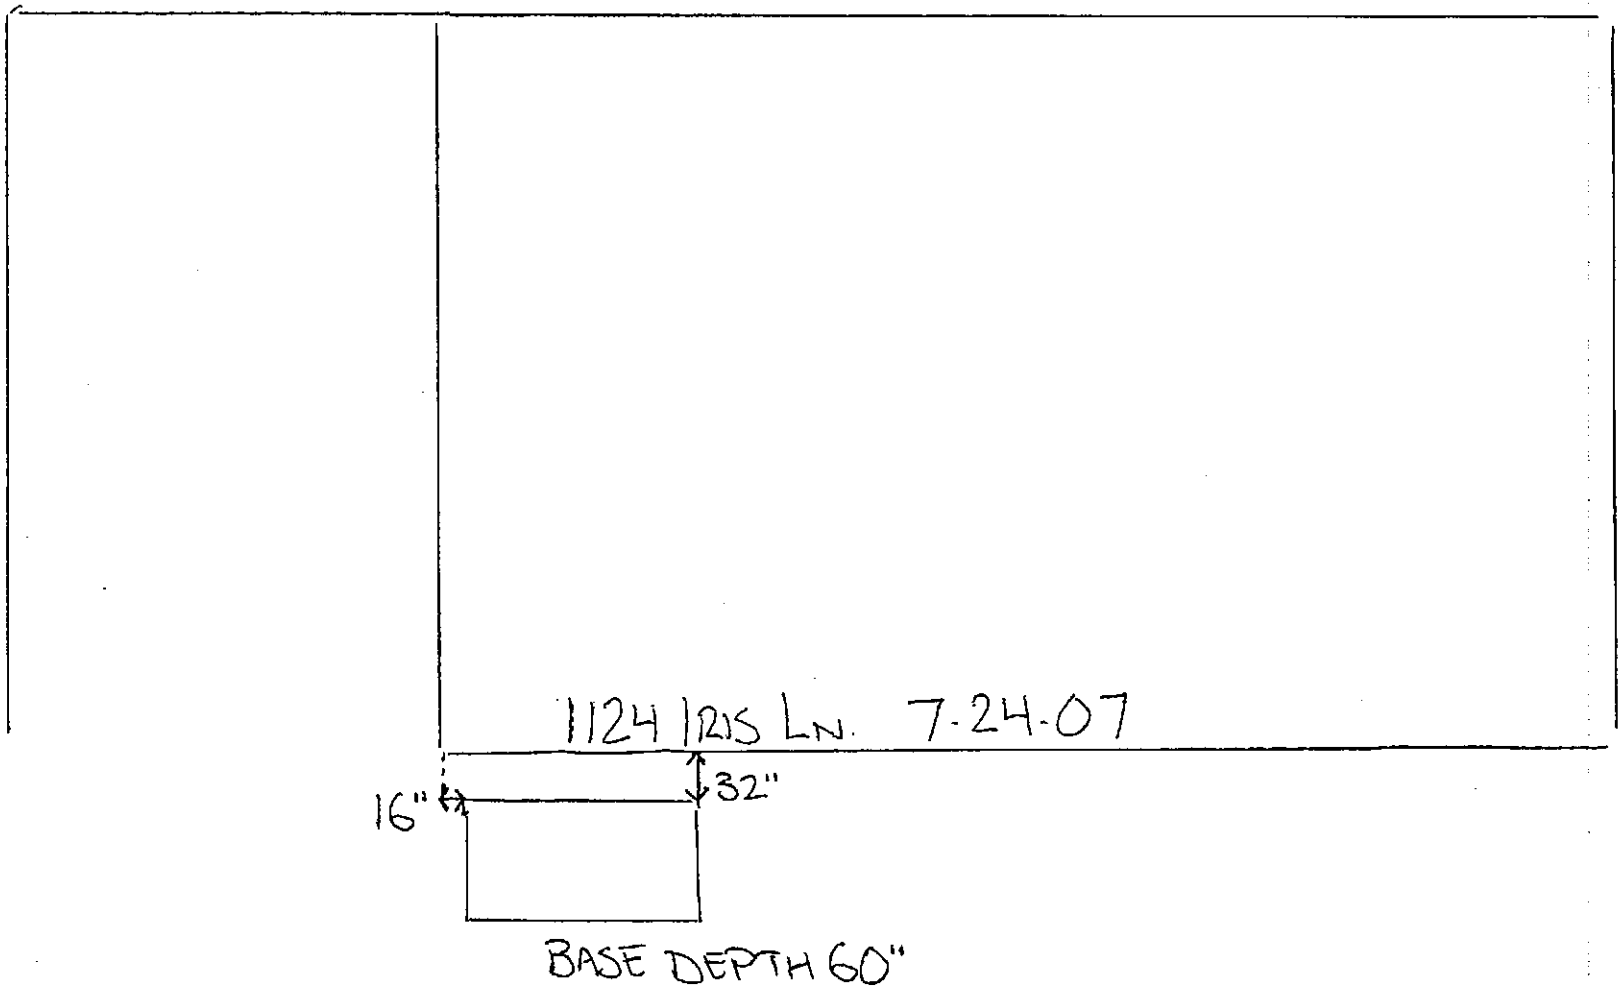
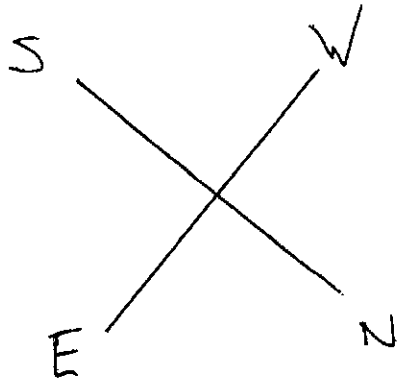
BROAD RIVER IS SOUTHWEST OF THE HOME.
WITHIN 1000 FT.

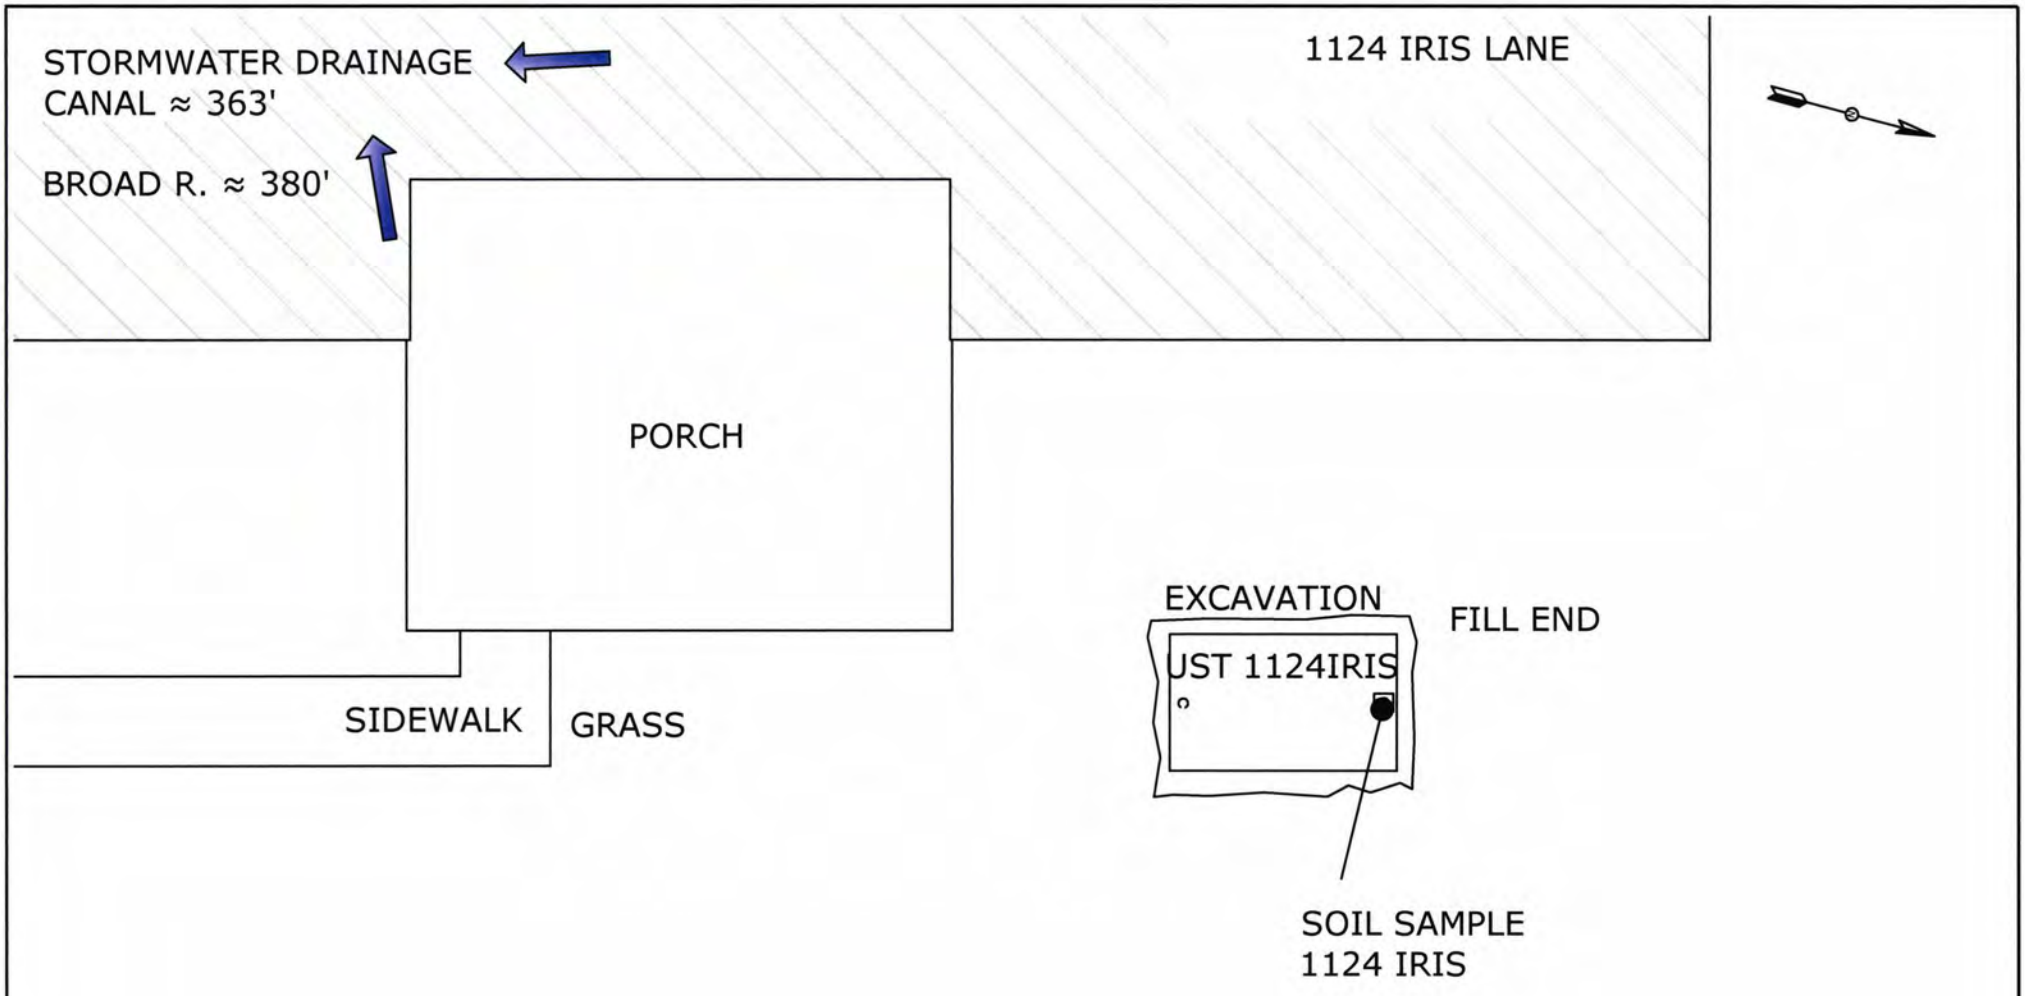
UST 1124IRIS WAS
28" BELOW GRADE.
