SUMMARY REPORT
392 IRIS LANE (FORMERLY 1131 IRIS LANE)
LAUREL BAY MILITARY HOUSING AREA
MARINE CORPS AIR STATION BEAUFORT
BEAUFORT, SC

Contract Number: N62470-14-D-9016
CTO WE52
JUNE 2021

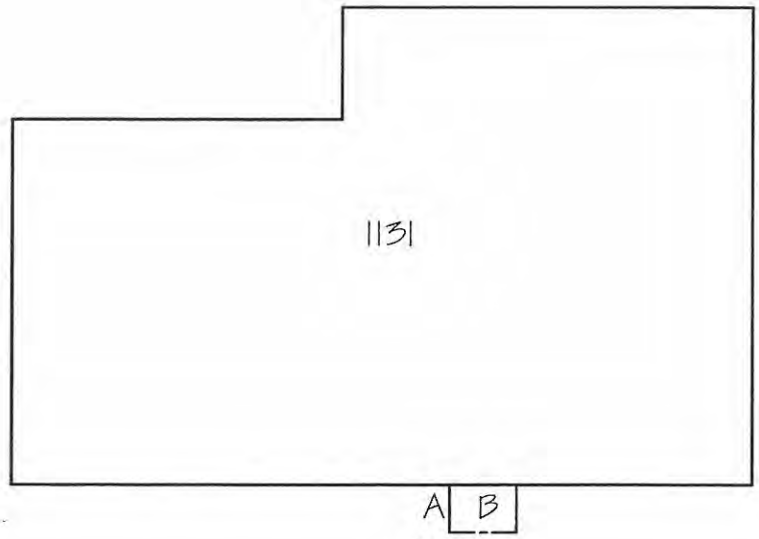
SITE MAP

TANK 1 EXCAVATION

A-SOIL TEST SIDE SAMPLE @ 56"

B-SOIL TEST BOTTOM SAMPLE @ 68"
