SUMMARY REPORT
78 JASMINE STREET (FORMERLY 1164 JASMINE STREET)
LAUREL BAY MILITARY HOUSING AREA
MARINE CORPS AIR STATION BEAUFORT
BEAUFORT, SC

Contract Number: N62470-14-D-9016
CTO WE52
JUNE 2021

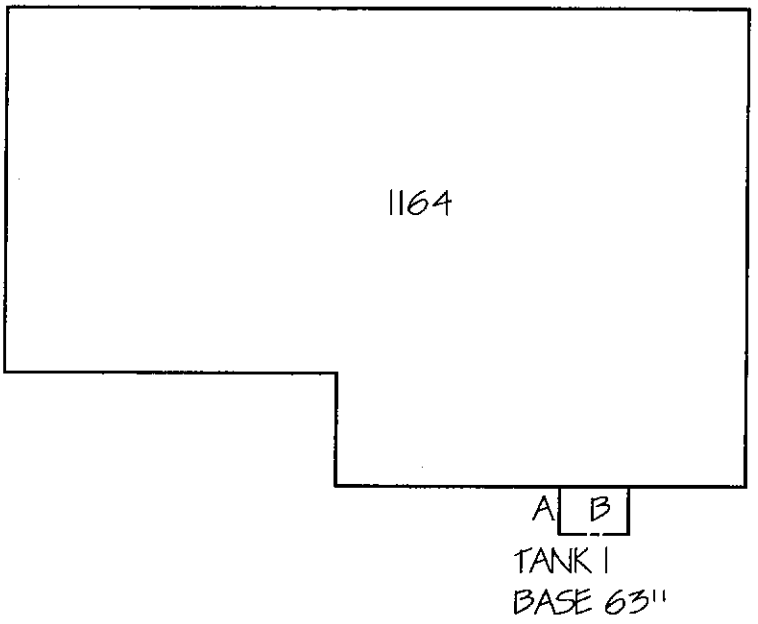
TANK 1 EXCAVATION

A-SOIL TEST SIDE SAMPLE @ 48"
B-SOIL TEST BOTTOM SAMPLE @ 63"

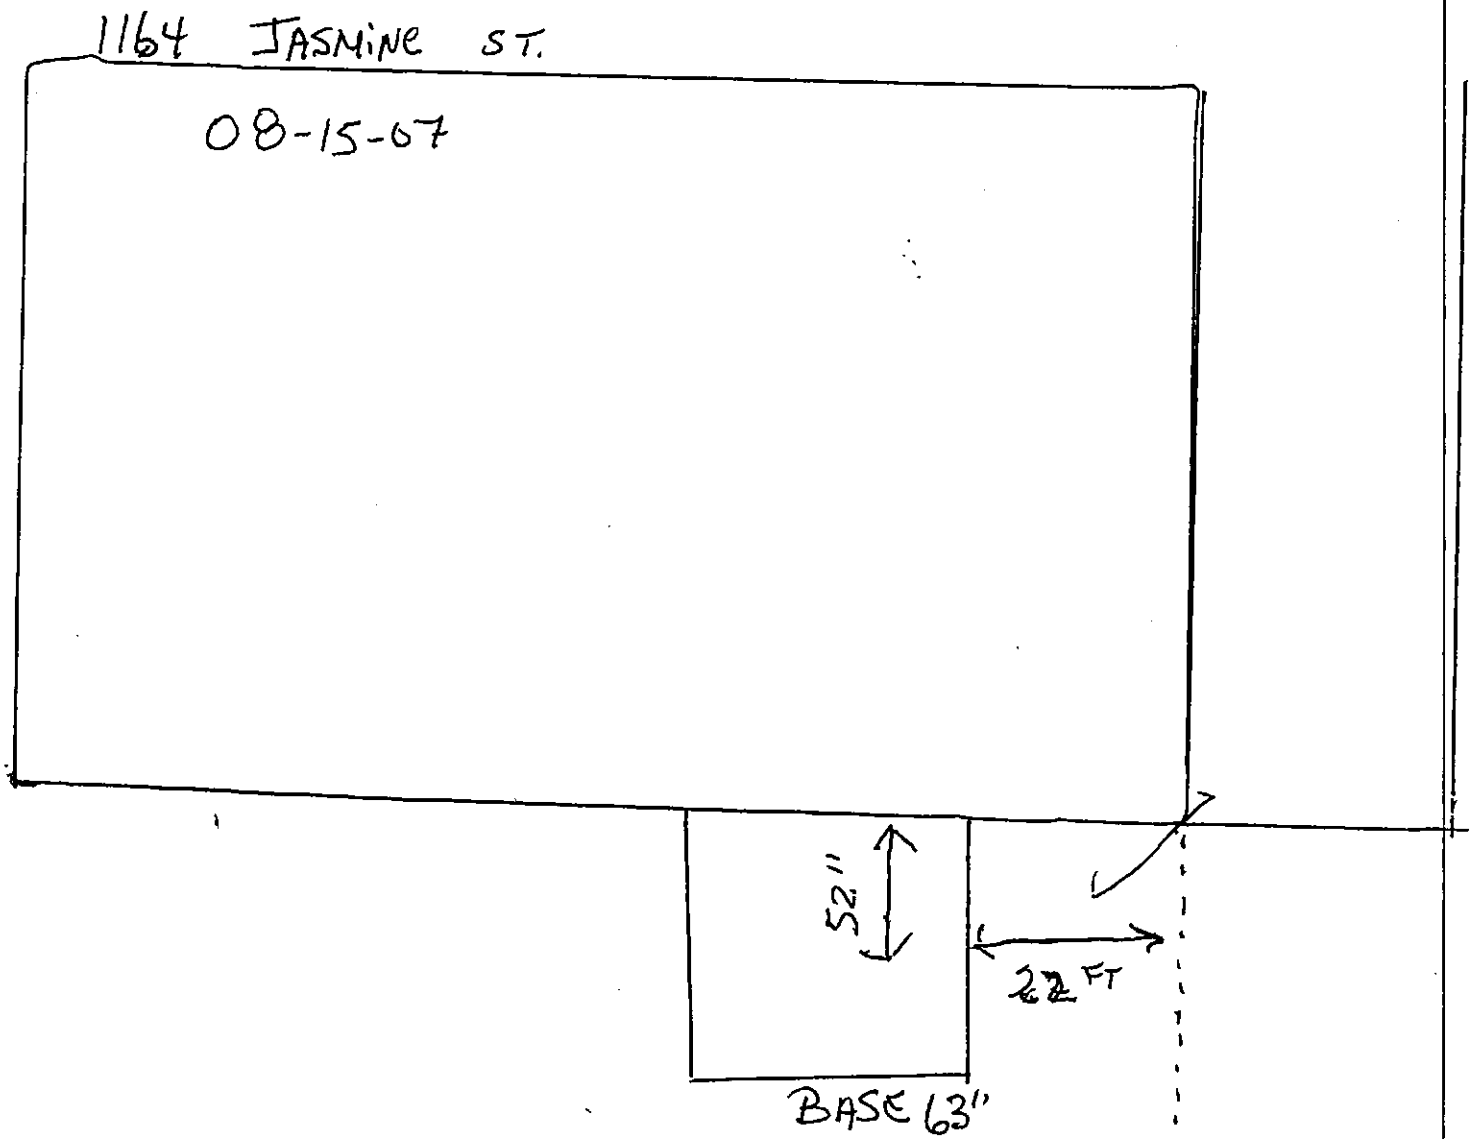
1164 JASMINE ST.
08-15-07
52"
22 FT
BASE 63"
