SUMMARY REPORT
121 EAST DOVE LANE (FORMERLY 1265 EAST DOVE LANE)
LAUREL BAY MILITARY HOUSING AREA
MARINE CORPS AIR STATION BEAUFORT
BEAUFORT, SC

Contract Number: N62470-14-D-9016
CTO WE52

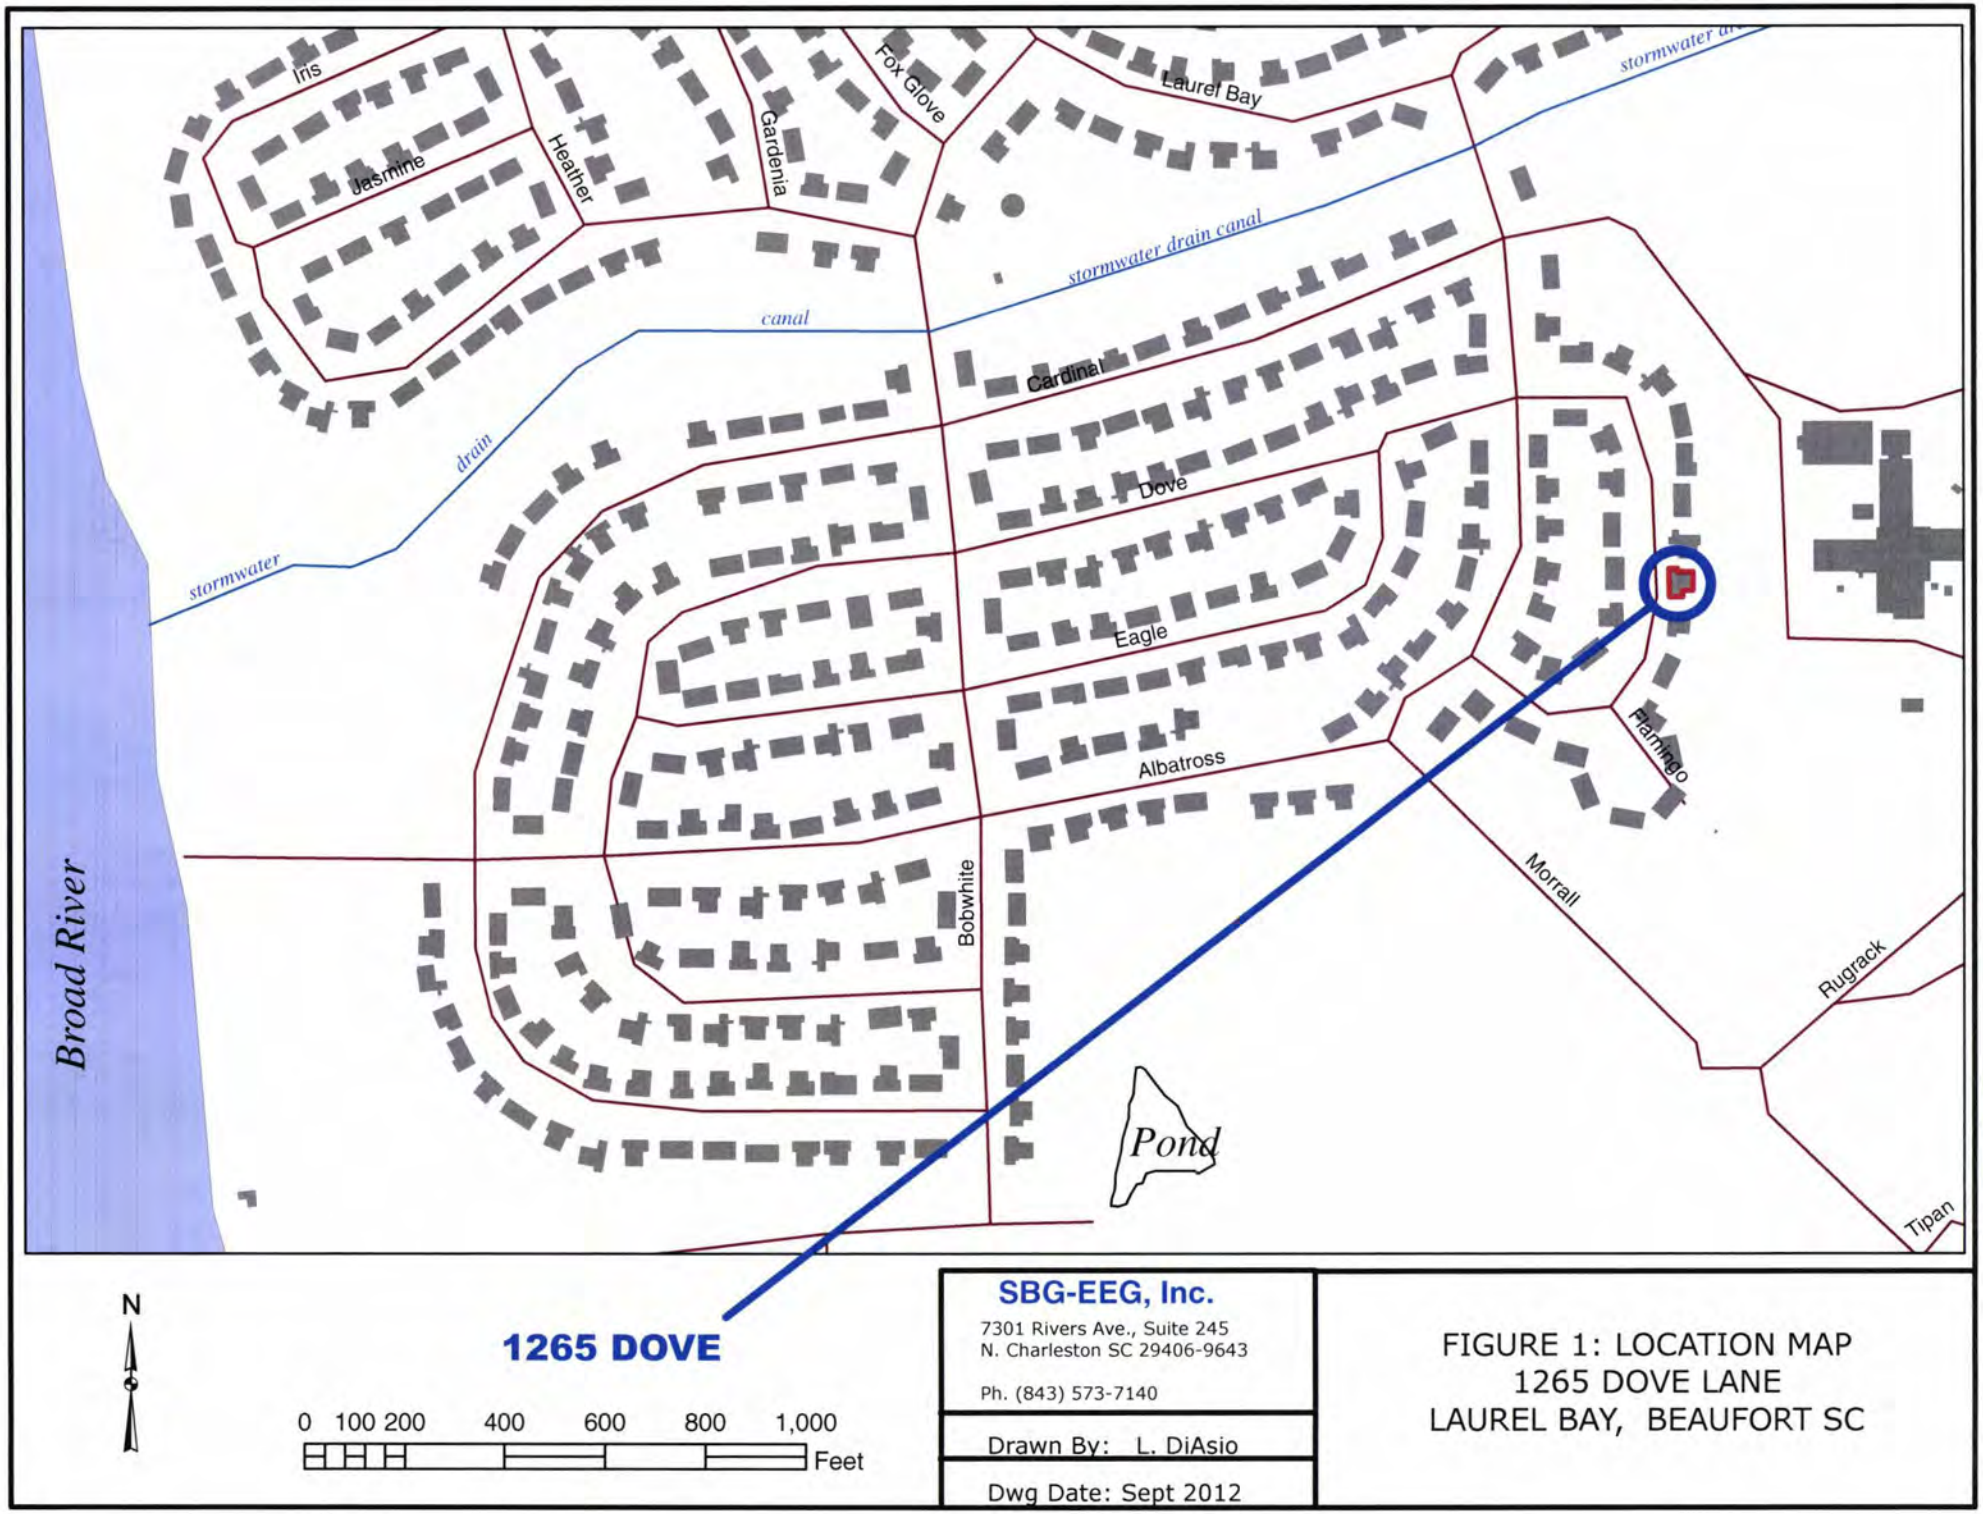
On September 12, 2012, a single 280 gallon heating oil UST was removed from the front yard under the porch area at 121 East Dove Lane (Formerly 1265 East Dove Lane). The former UST location is indicated on Figures 2 and 3 of the UST Assessment Report (Appendix B). The UST was removed and properly disposed of (i.e., shipped offsite for recycling or transported to a landfill). There was no visual evidence (i.e., staining or sheen) of petroleum impact at the time of the UST removal. According to the UST Assessment Report (Appendix B), the depth to the

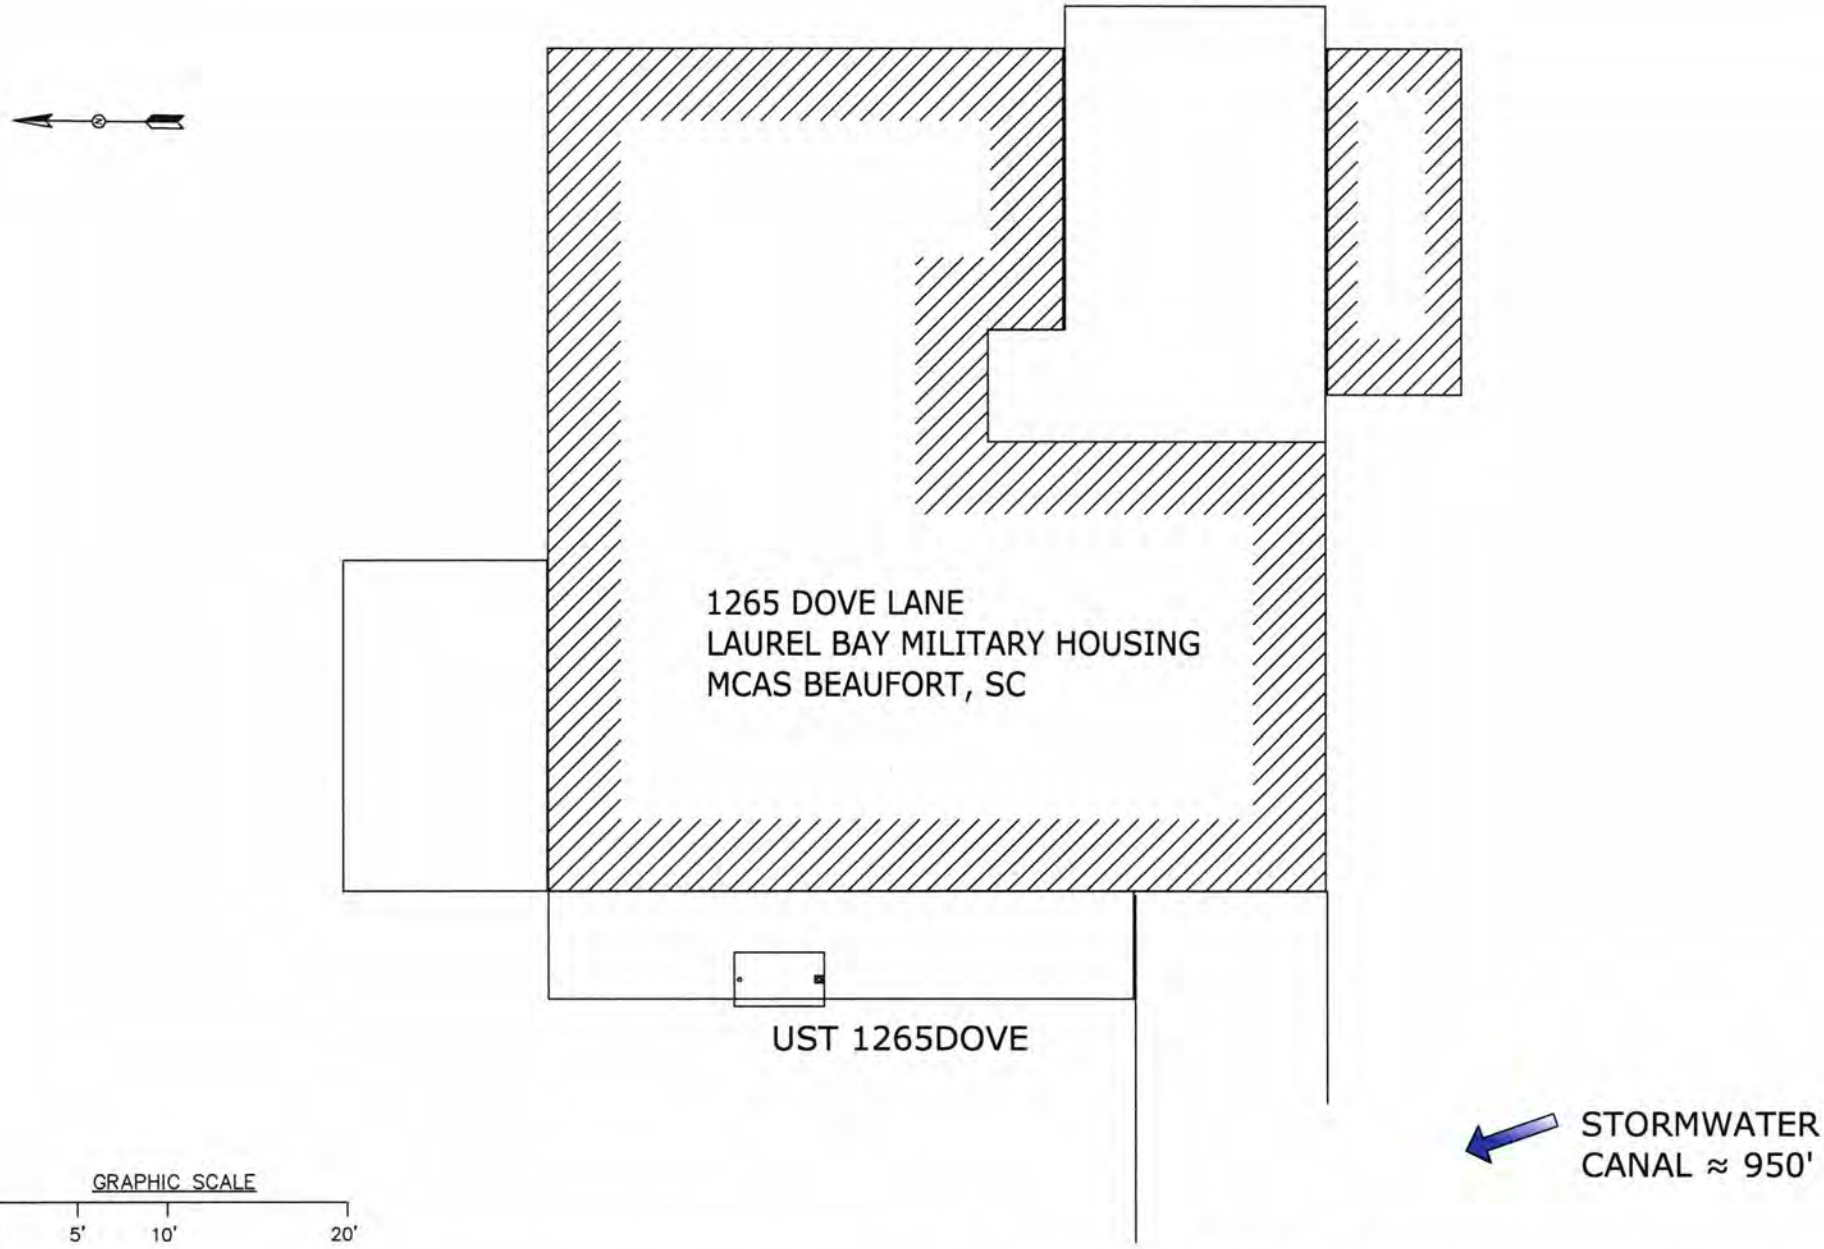
FIGURE 2 SITE MAP
1265 DOVE LANE, LAUREL BAY
MCAS BEAUFORT SC

TANK DEPTH BELOW GRADE
1265DOVE = 32"

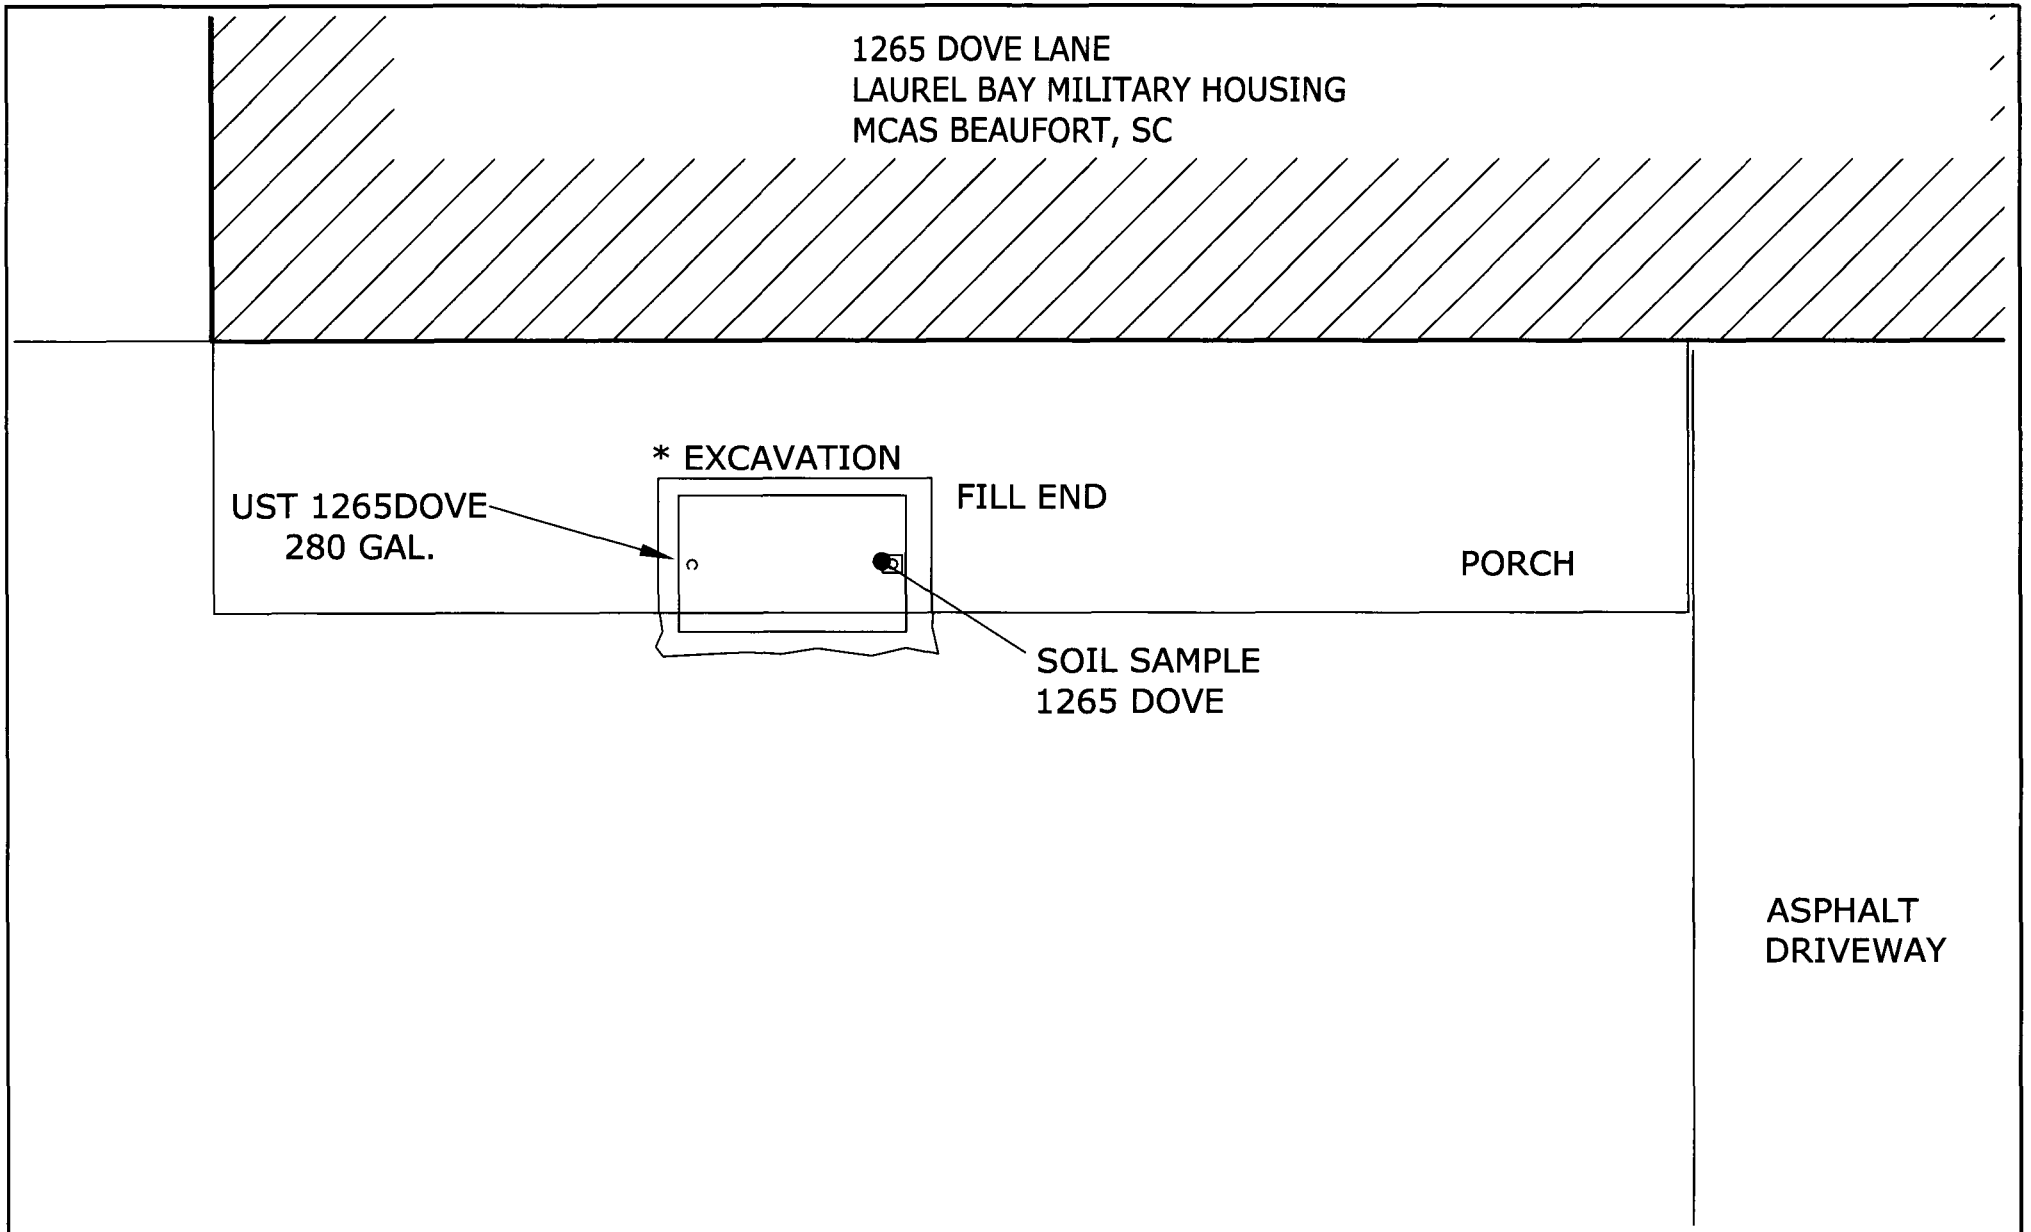
FIGURE 3 UST SAMPLE LOCATIONS
1265 DOVE LANE, LAUREL BAY
MCAS BEAUFORT SC

* A PORTION OF THE PORCH WAS REMOVED TO FACILITATE TANK EXTRACTION.
