SUMMARY REPORT
115 EAGLE LANE (FORMERLY 1302 EAGLE LANE)
LAUREL BAY MILITARY HOUSING AREA
MARINE CORPS AIR STATION BEAUFORT
BEAUFORT, SC

JUNE 2021

Contract Number: N62470-14-D-9016
CTO WE52
JUNE 2021

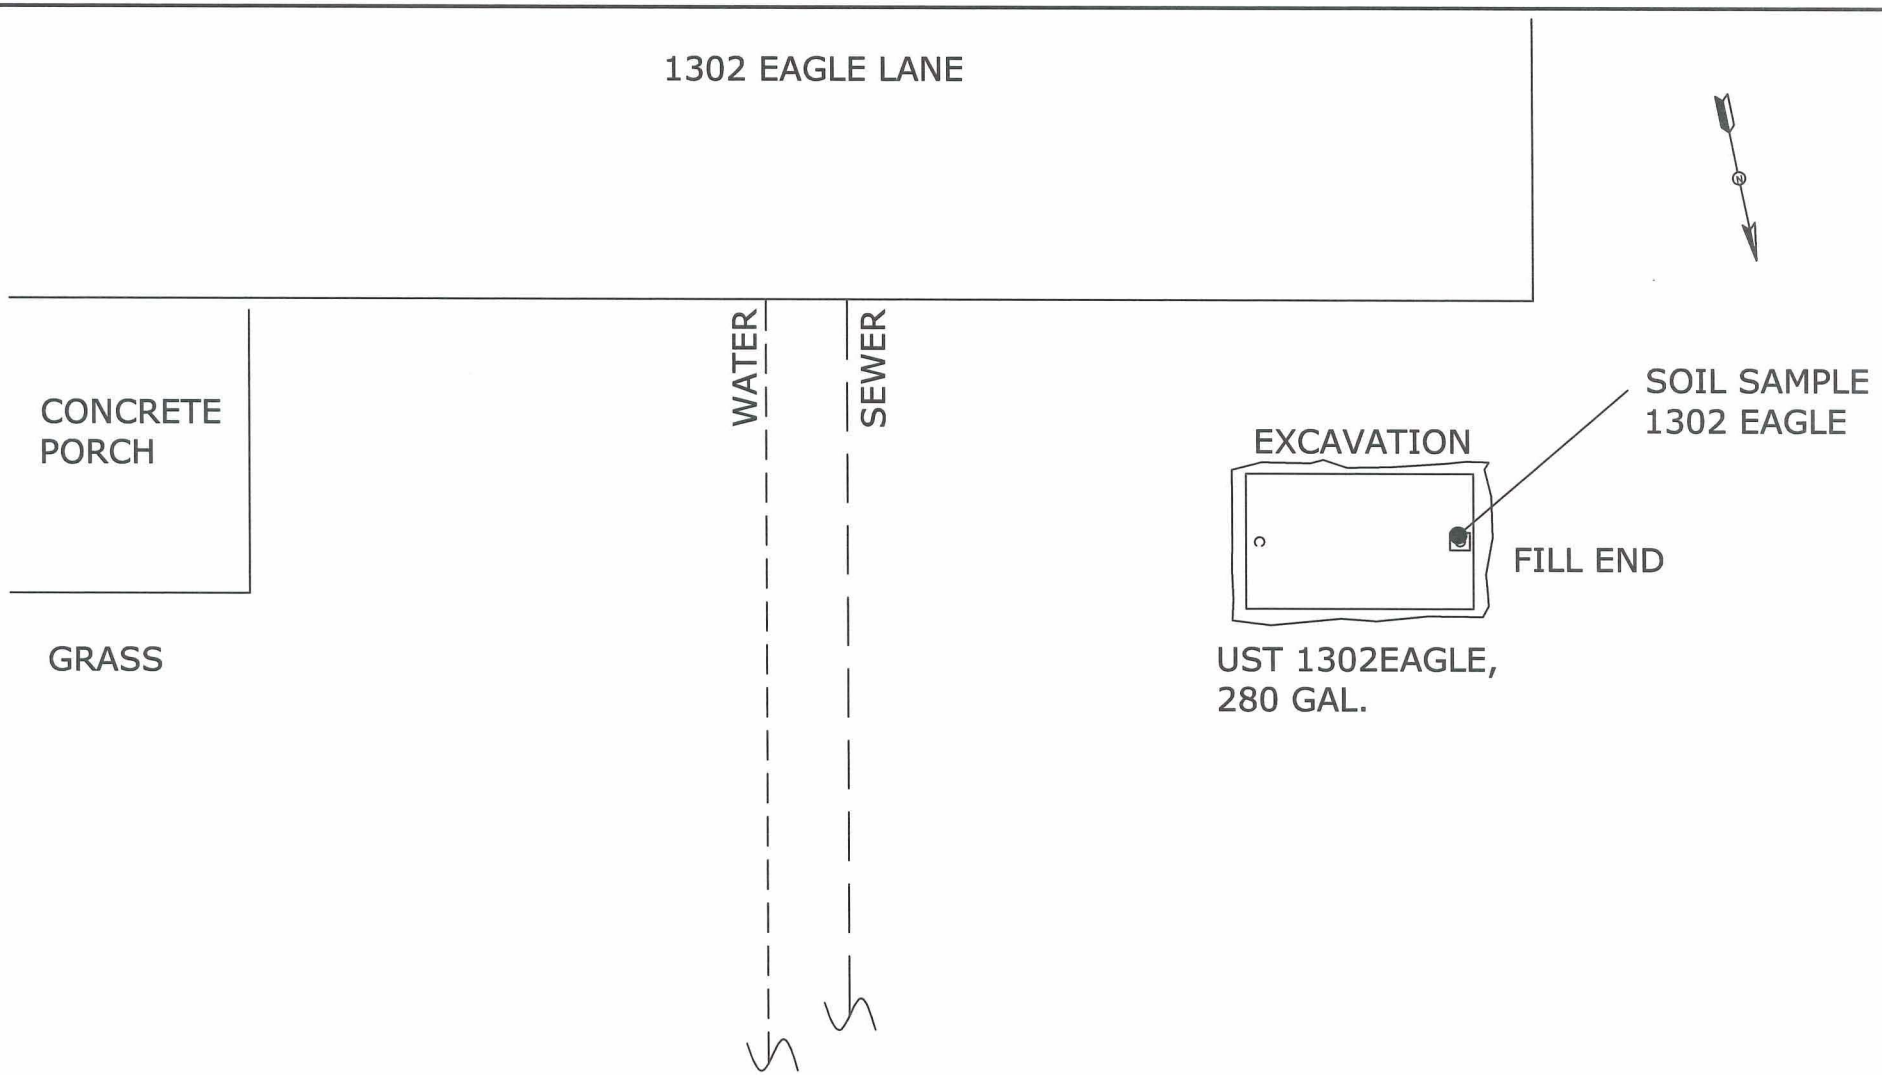
FIGURE 3 UST SAMPLE LOCATIONS
1302 EAGLE LANE, LAUREL BAY
MCAS BEAUFORT SC

Picture 1: Location of UST 1302Eagle.

Picture 2: UST 1302Eagle excavation in progress.
