SUMMARY REPORT
391 ALBATROSS DRIVE (FORMERLY 1336 ALBATROSS DRIVE)
LAUREL BAY MILITARY HOUSING AREA
MARINE CORPS AIR STATION BEAUFORT
BEAUFORT, SC

Contract Number: N62470-14-D-9016
CTO WE52
JUNE 2021

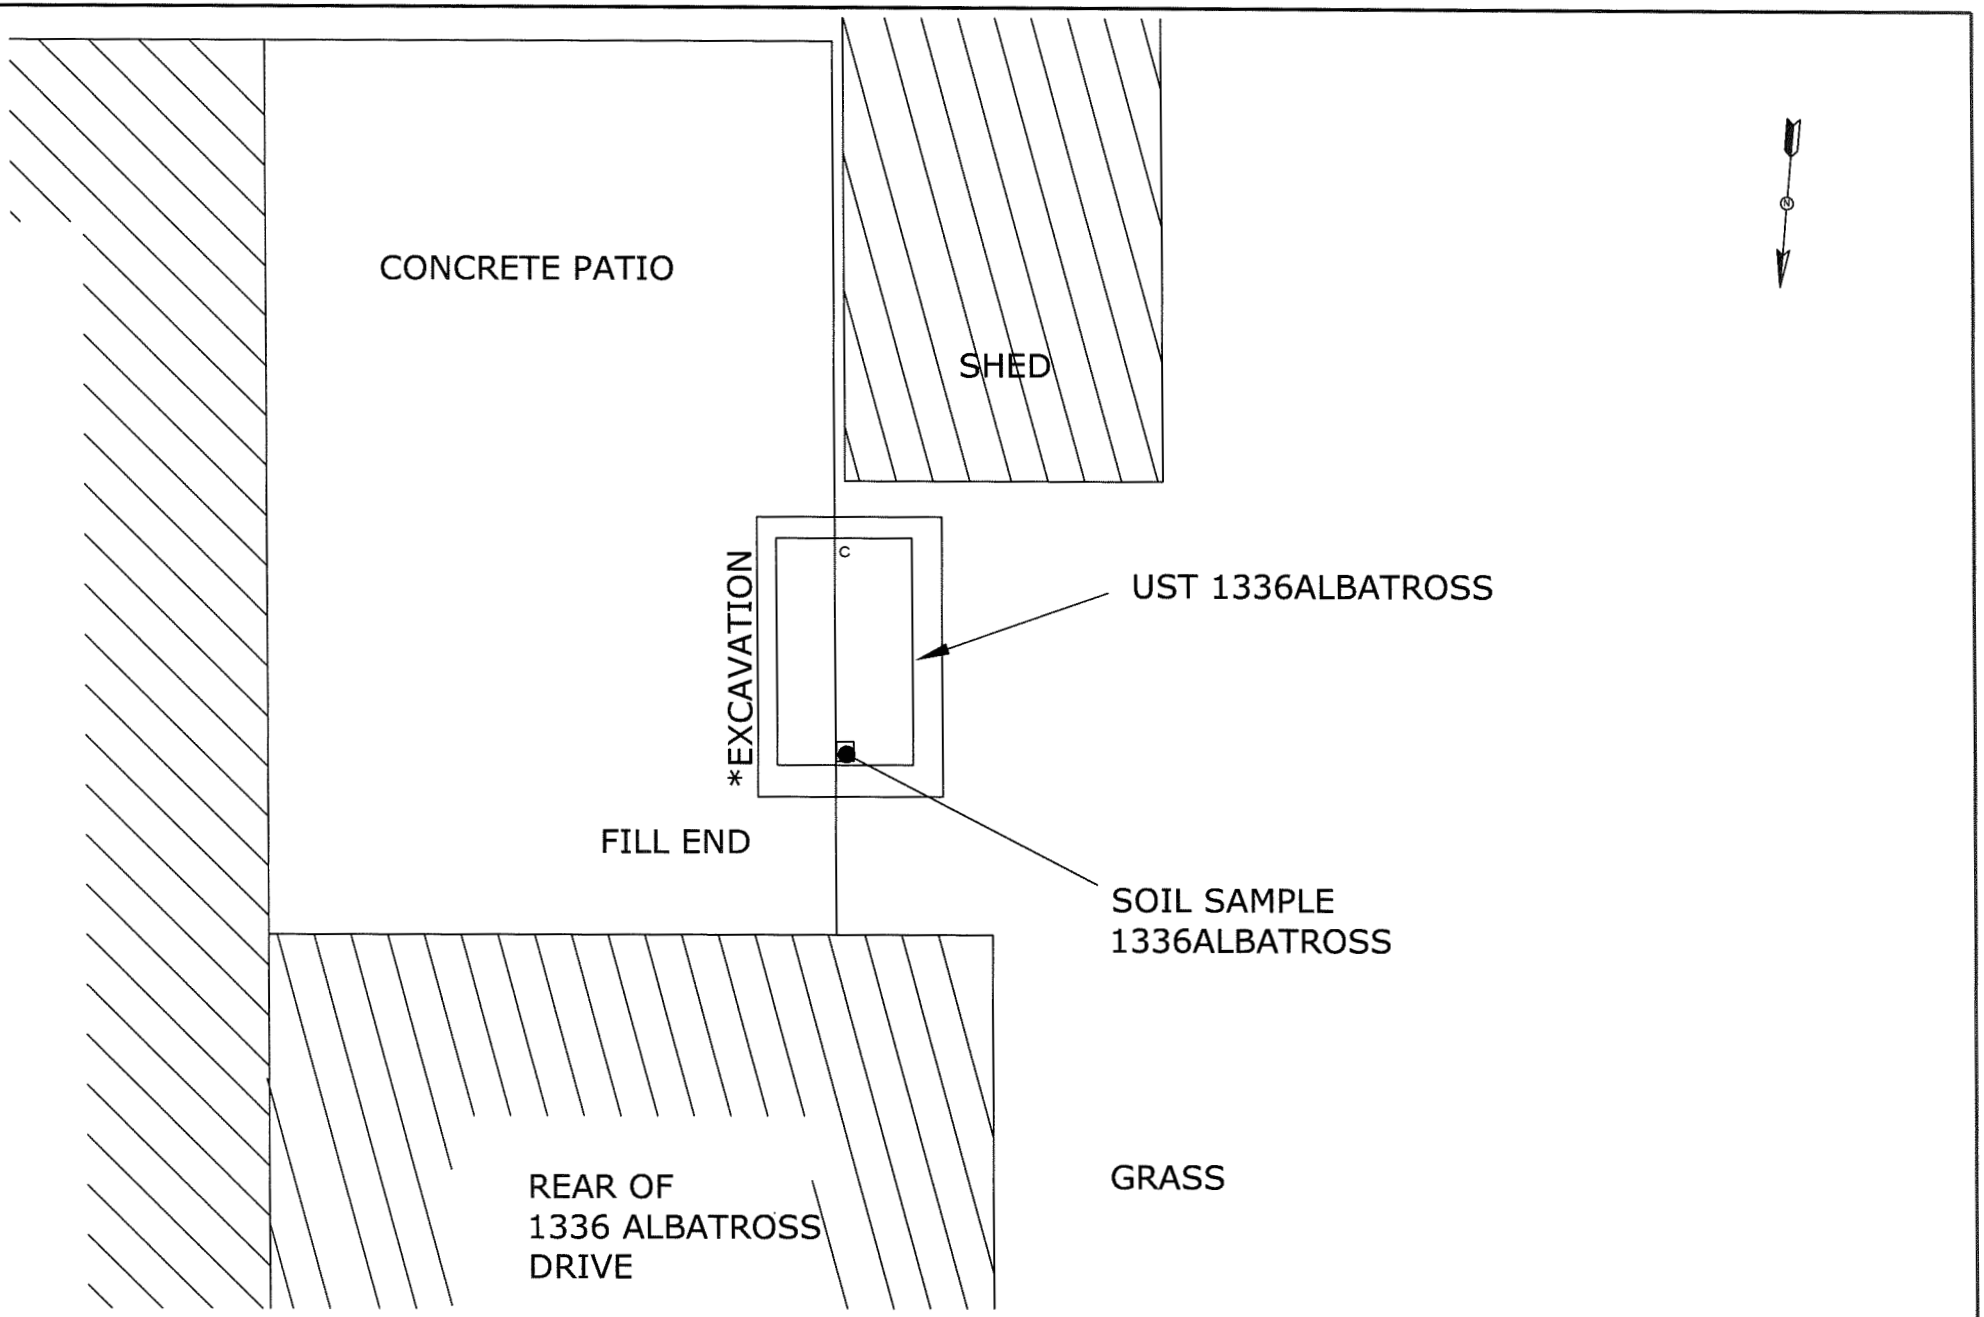
*A PORTION OF THE CONCRETE PATIO WAS REMOVED TO FACILITATE TANK EXTRACTION.
