SUMMARY REPORT
402 WEST DOVE LANE (FORMERLY 1389 WEST DOVE LANE)
LAUREL BAY MILITARY HOUSING AREA
MARINE CORPS AIR STATION BEAUFORT
BEAUFORT, SC

JUNE 2021

CDM - AECOM
Multimedia Joint Venture

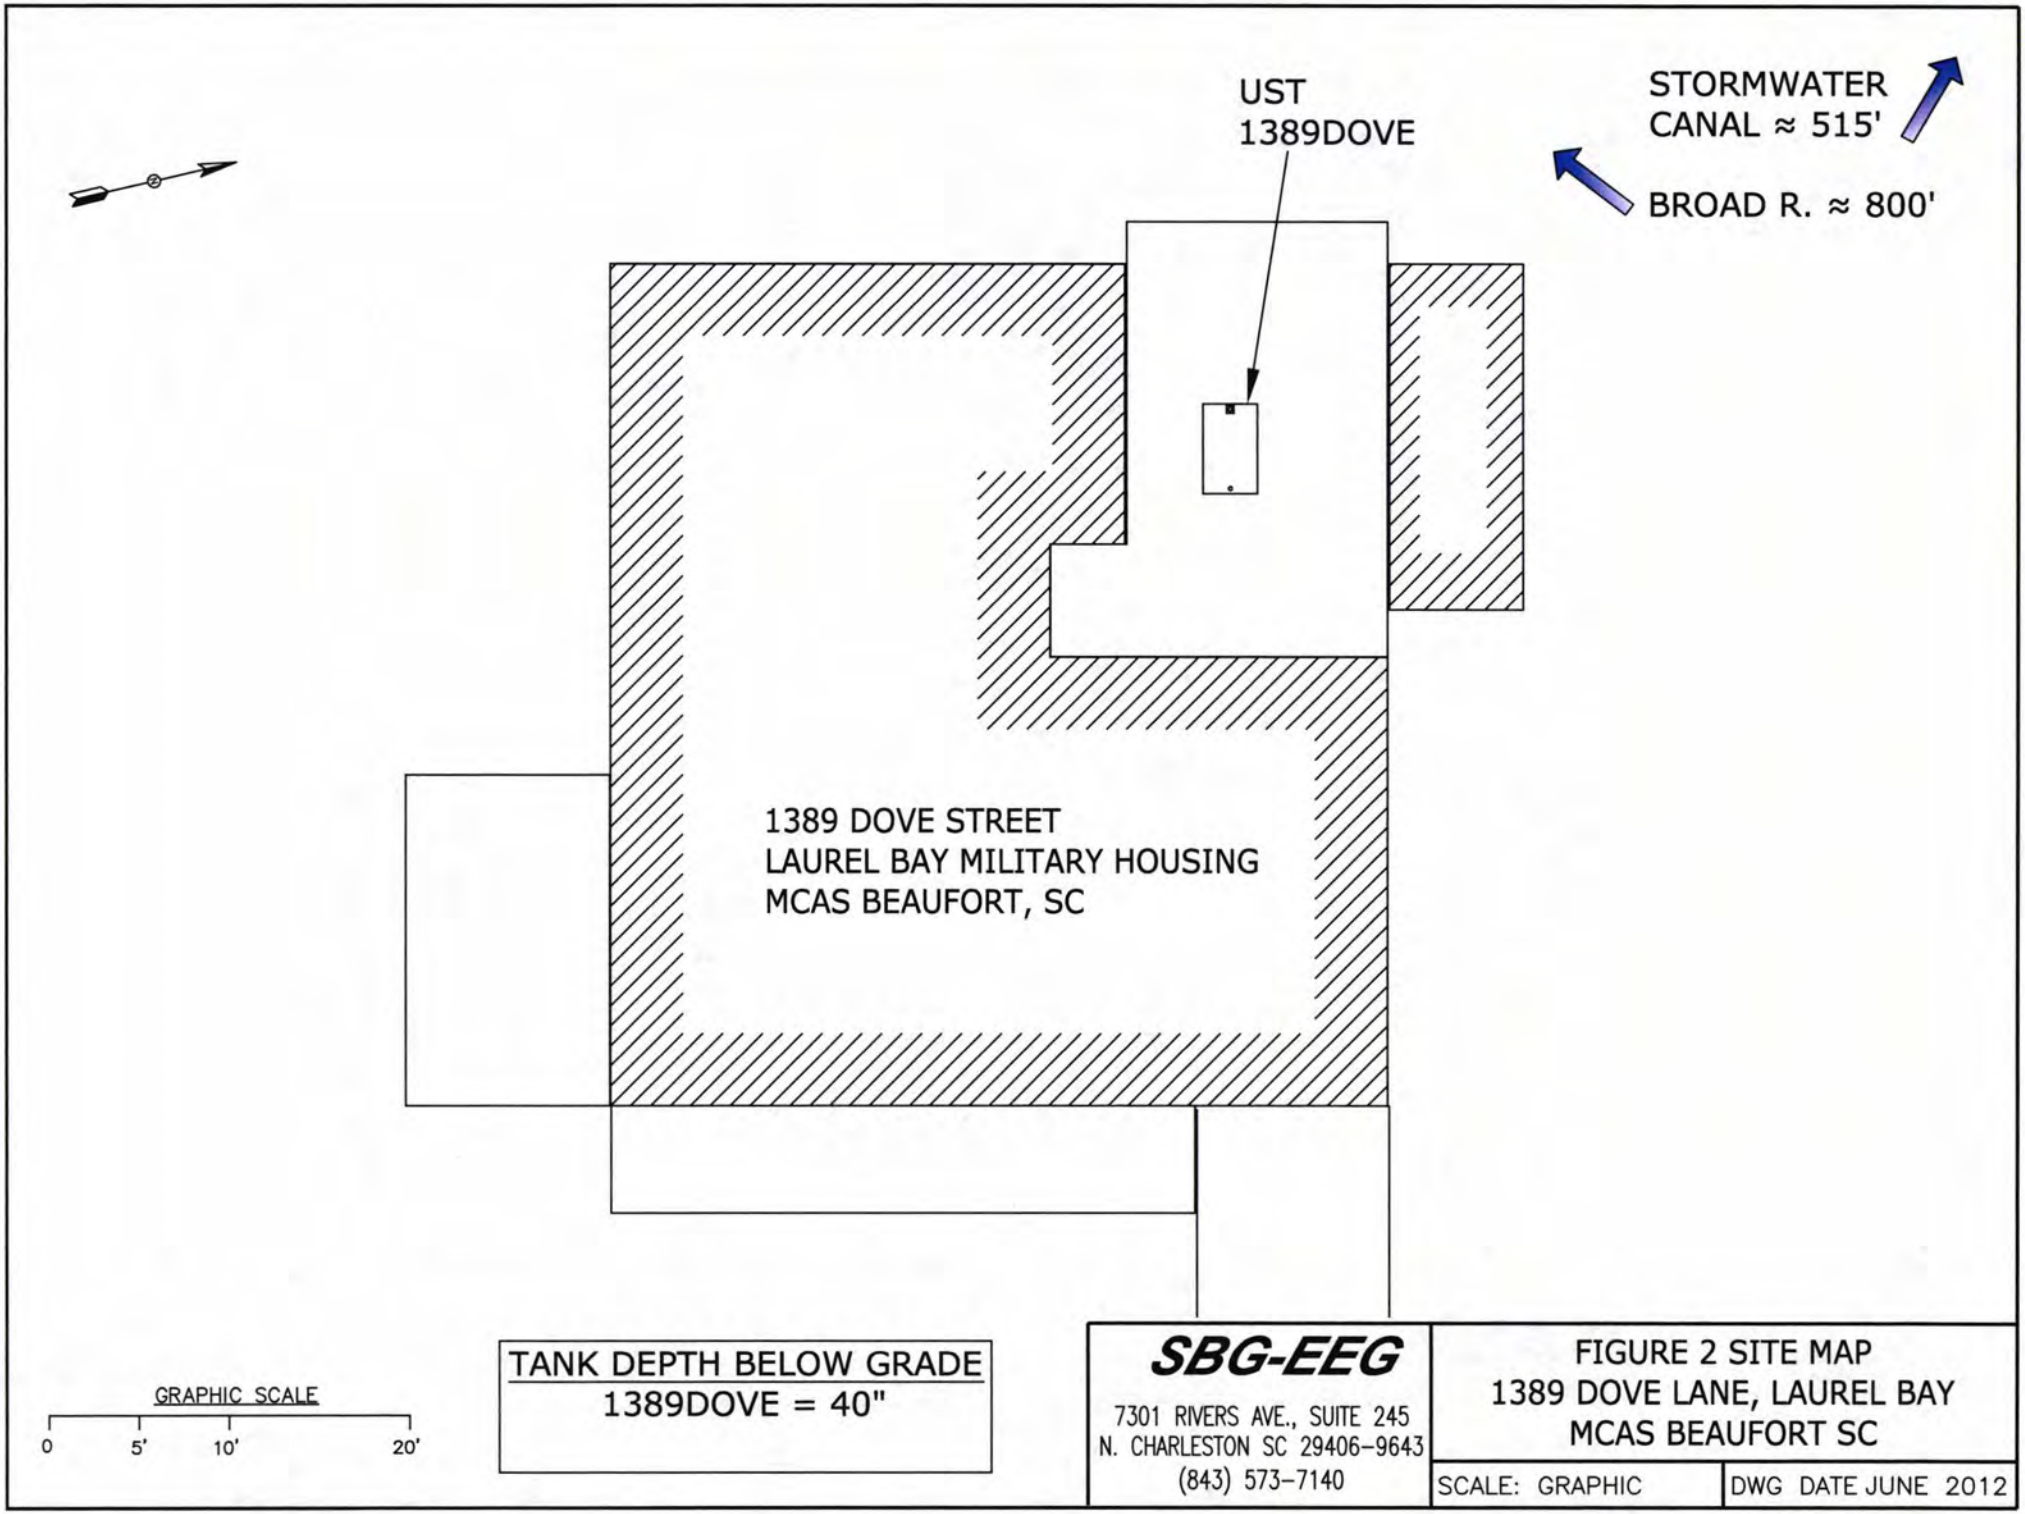
FIGURE 2 SITE MAP
1389 DOVE LANE, LAUREL BAY
MCAS BEAUFORT SC

On April 12, 2012, a single 280 gallon heating oil UST was removed from underneath the rear patio at 402 West Dove Lane (Formerly 1389 West Dove Lane). The former UST location is indicated on Figures 2 and 3 of the UST Assessment Report (Appendix B). The UST was removed and properly disposed of (i.e., shipped offsite for recycling or transported to a landfill). There was no visual evidence (i.e., staining or sheen) of petroleum impact at the time of the

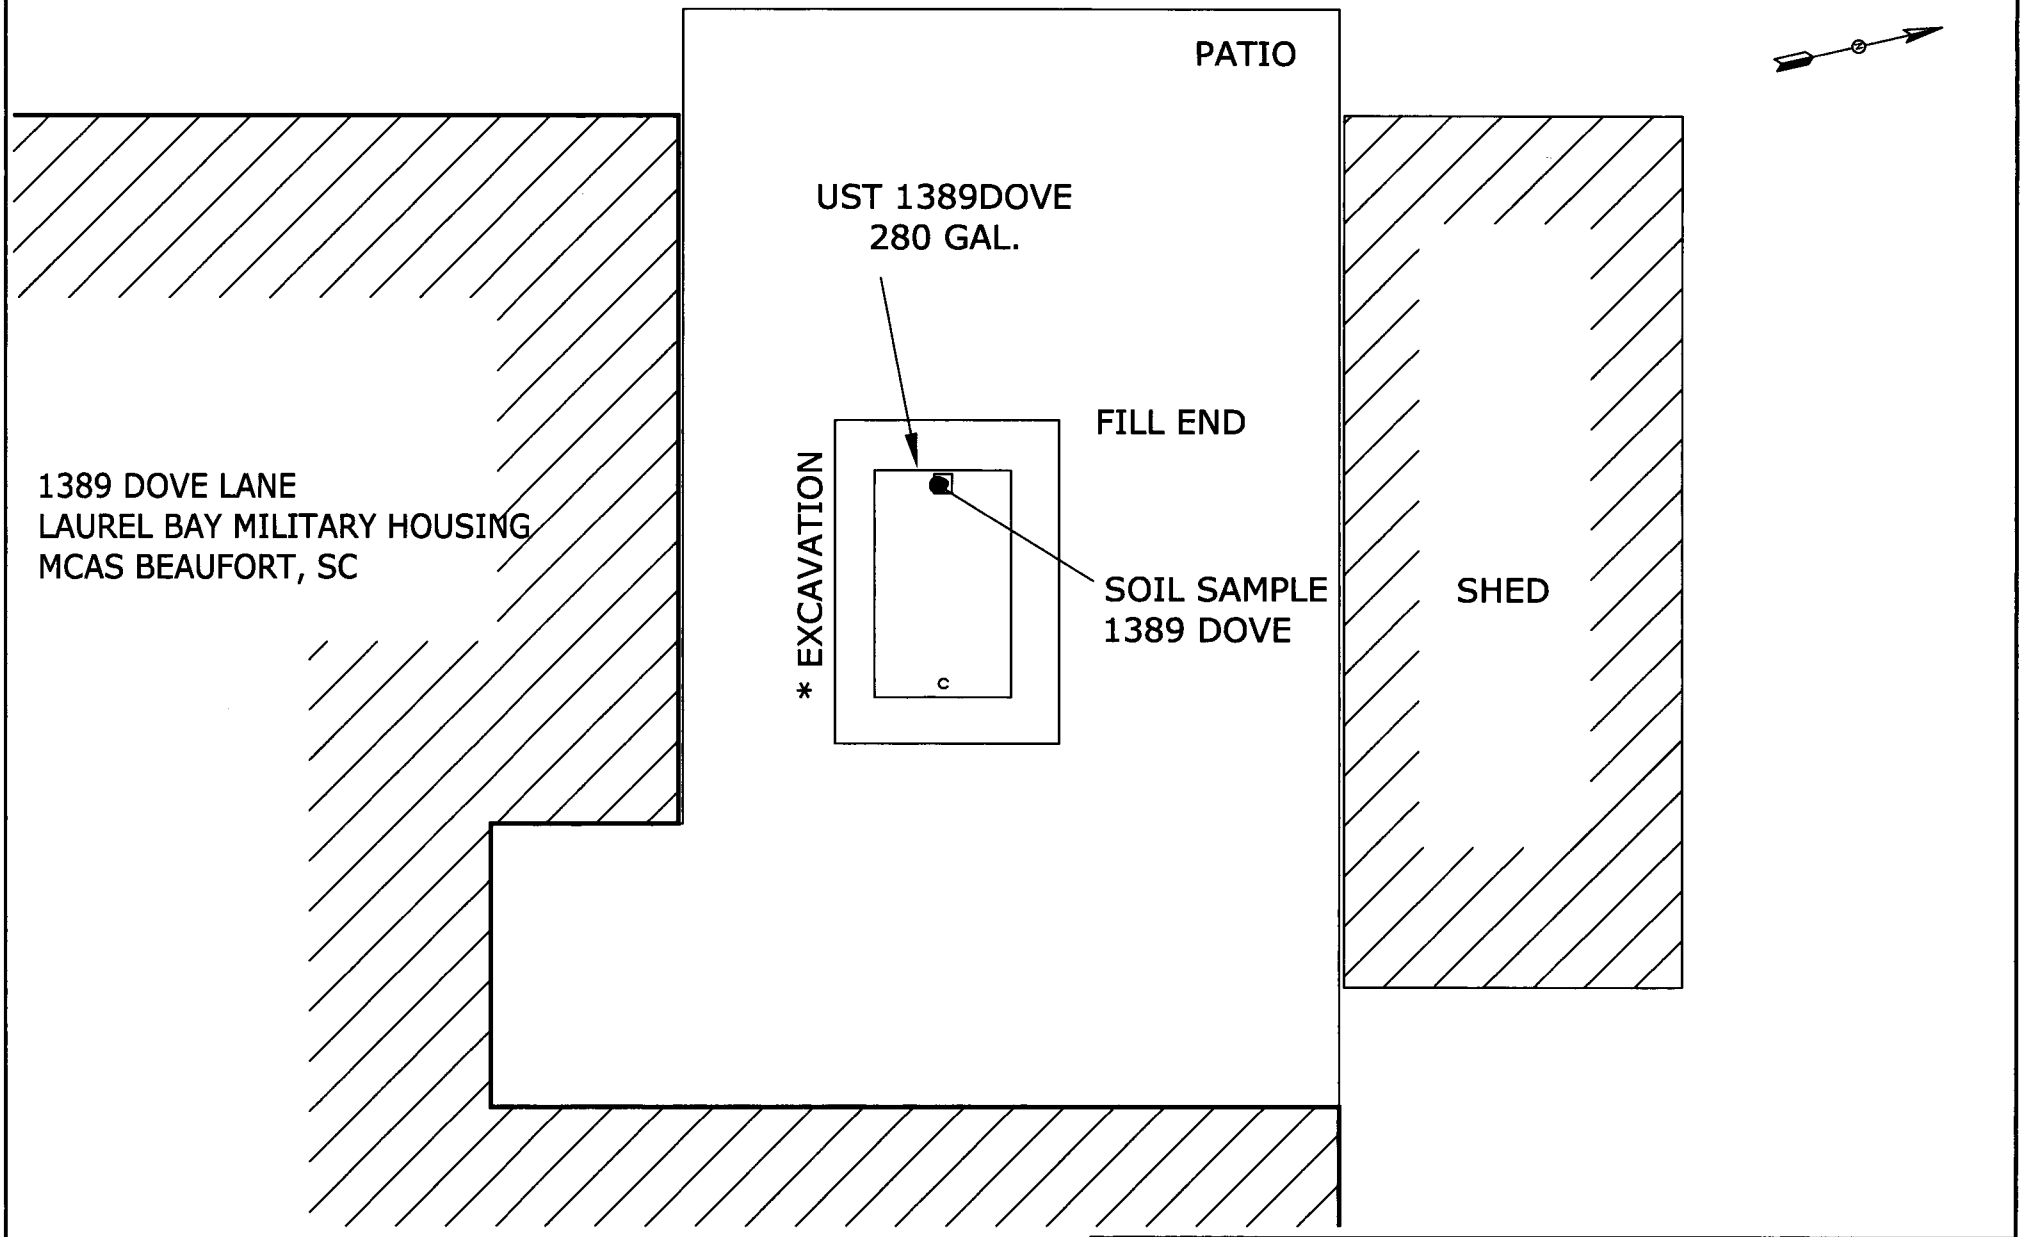
* A PORTION OF THE PATIO WAS REMOVED TO FACILITATE TANK EXTRACTION.
