SUMMARY REPORT
430 WEST DOVE LANE (FORMERLY 1393 WEST DOVE LANE)
LAUREL BAY MILITARY HOUSING AREA
MARINE CORPS AIR STATION BEAUFORT
BEAUFORT, SC

JUNE 2021

CDM - AECOM
Multimedia Joint Venture

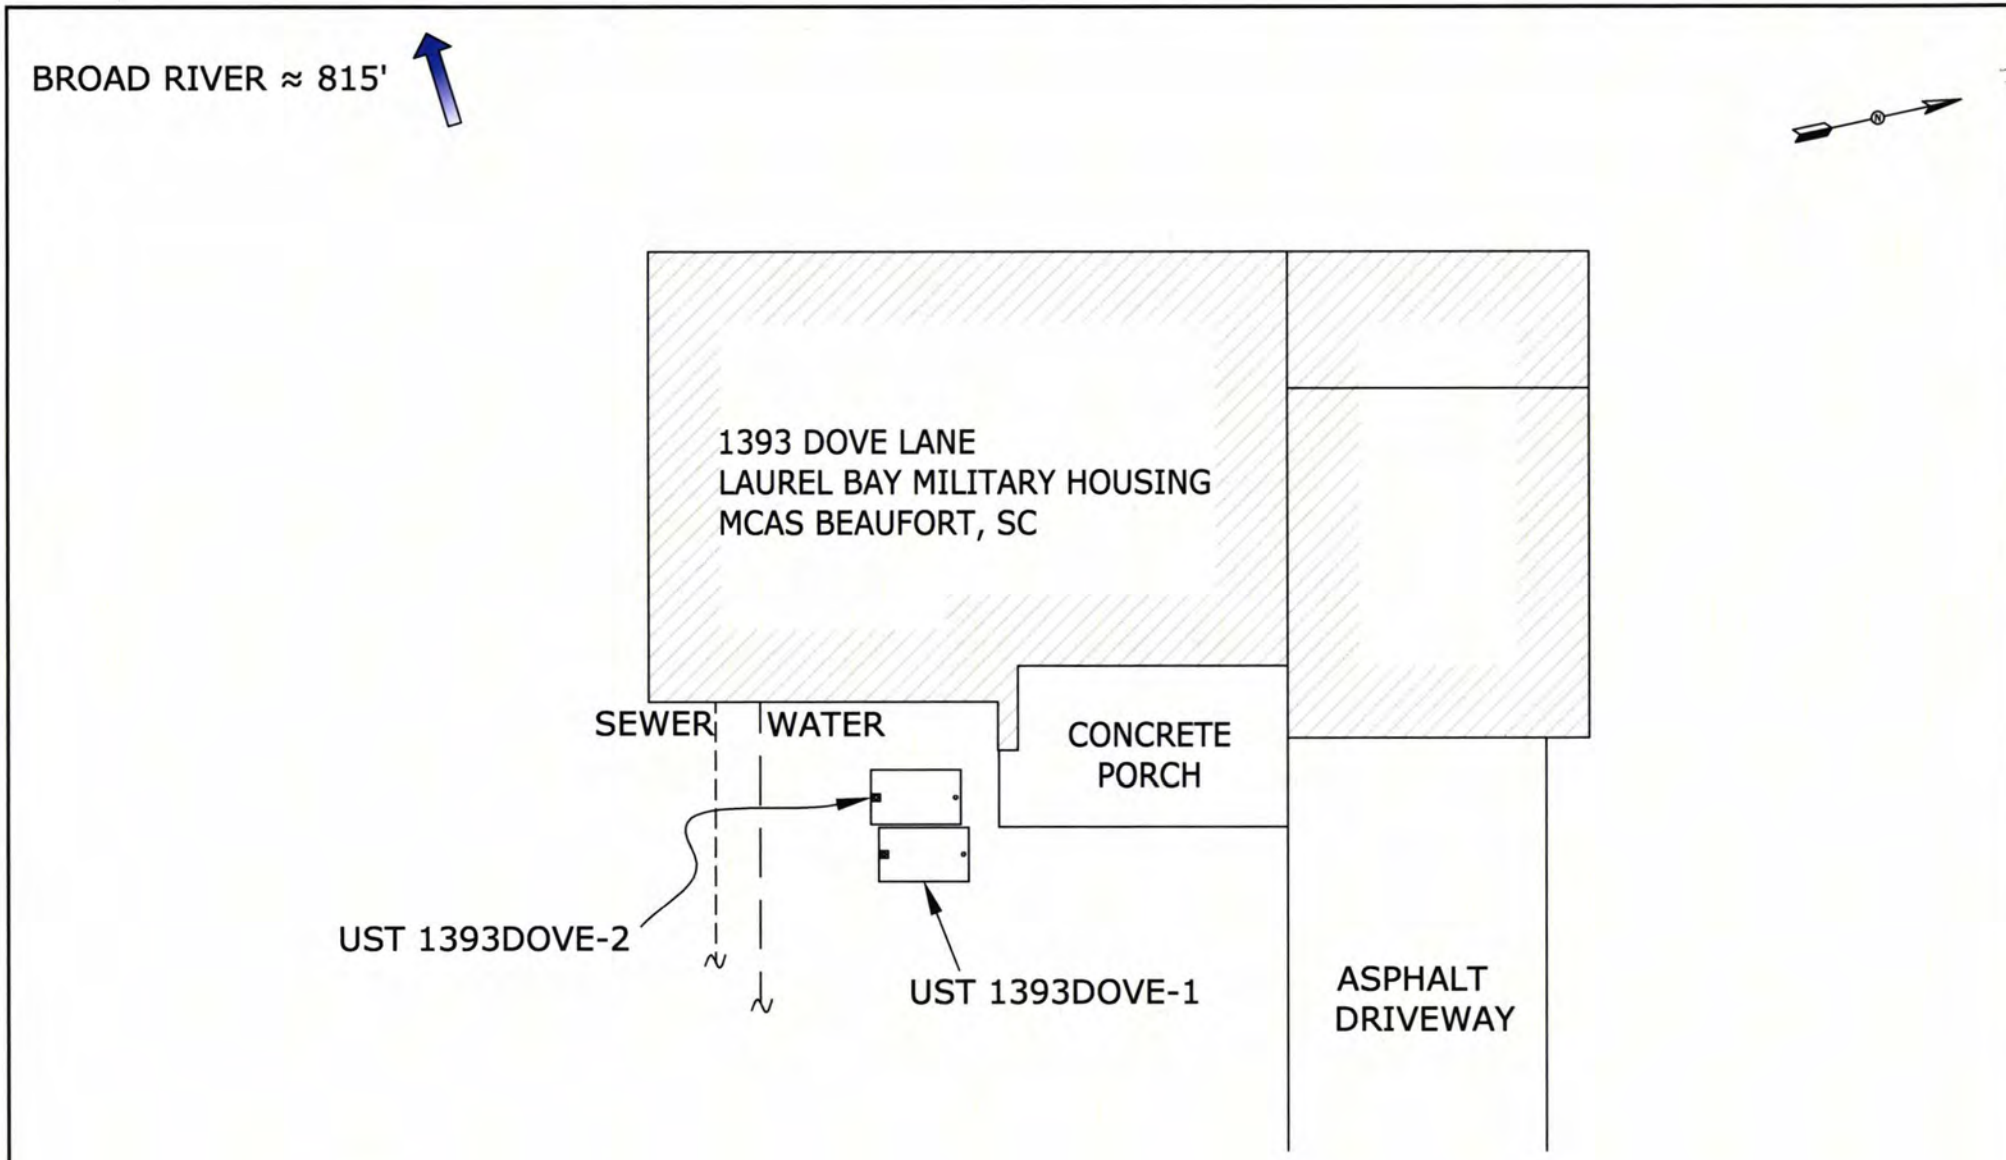
FIGURE 2 SITE MAP
1393 DOVE LANE, LAUREL BAY
MCAS BEAUFORT SC

In July, 2009, two 280 gallon heating oil USTs were removed from the front grassed area, adjacent to the concrete porch at 430 West Dove Lane (Formerly 1393 West Dove Lane). Tank 1 was removed on July 16, 2009. Tank 2 was removed on July 27, 2009. The former UST locations are indicated on Figures 2 and 3 of the UST Assessment Report (Appendix B). The

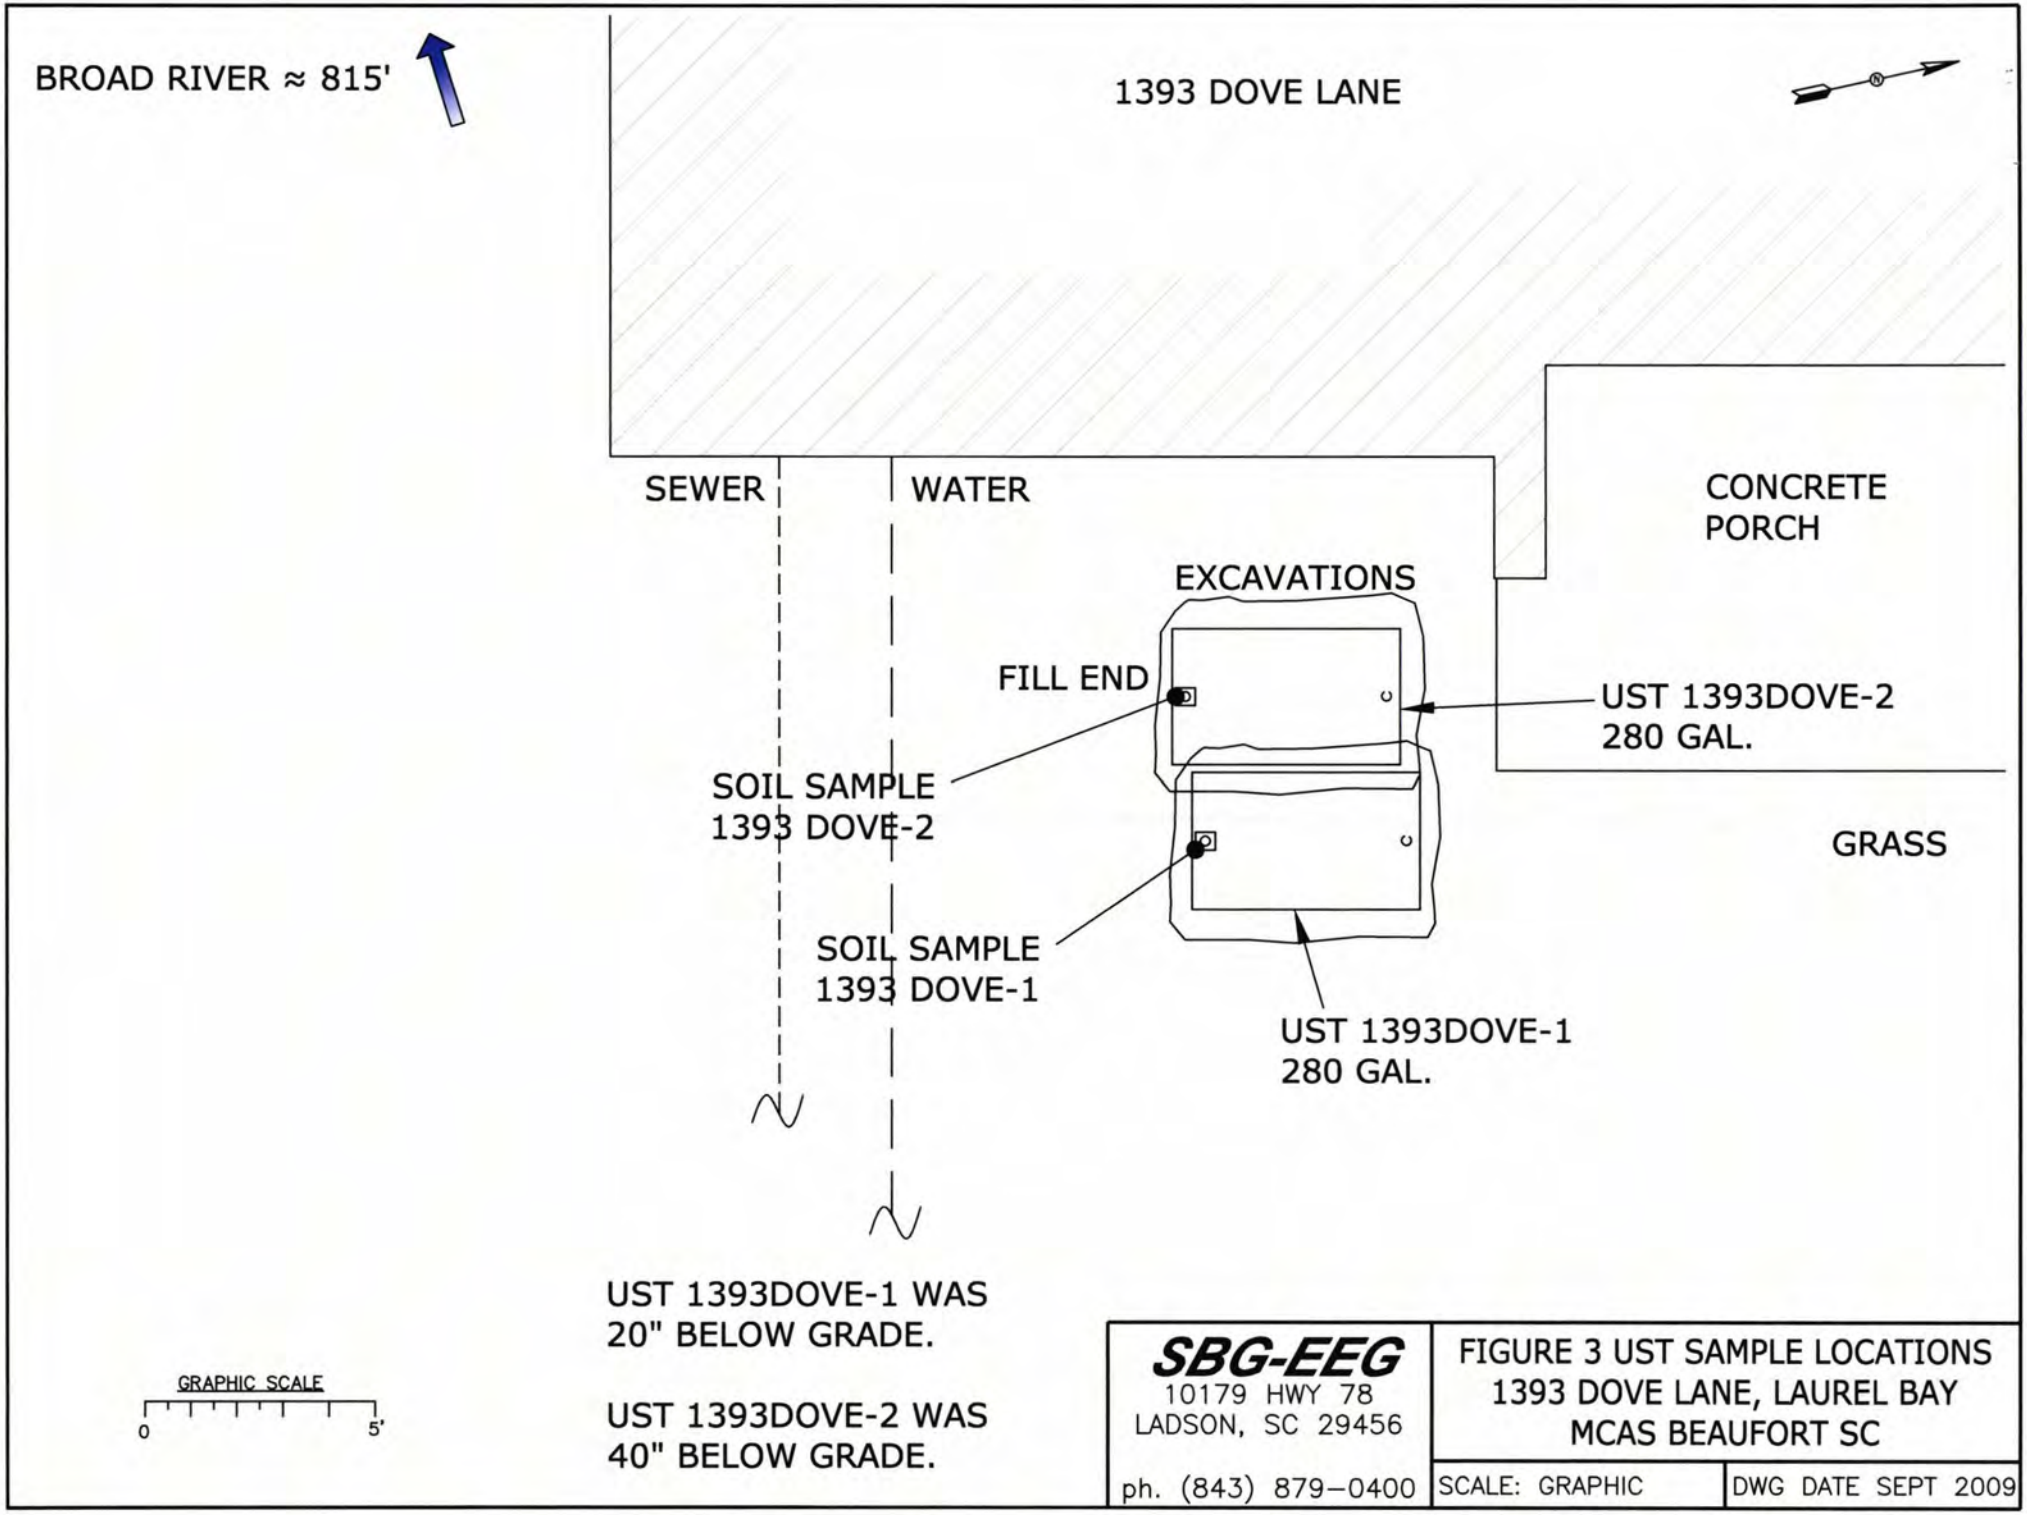
FIGURE 3 UST SAMPLE LOCATIONS
1393 DOVE LANE, LAUREL BAY
MCAS BEAUFORT SC

On June 23, 2015, a single temporary monitoring well was installed at 430 West Dove Lane (Formerly 1393 West Dove Lane), in accordance with the South Carolina Well Standards and Regulations (R.61-71.H-I, updated June 24, 2016). In order to provide data that can be used to determine whether COPCs are migrating to underlying groundwater, the monitoring well was placed in the same general location as the former heating oil USTs (Tanks 1 and 2). The former UST locations are indicated on Figures 2 and 3 of the UST Assessment Report (Appendix
