SUMMARY REPORT
533 ALBATROSS DRIVE (FORMERLY 1420 ALBATROSS DRIVE)
LAUREL BAY MILITARY HOUSING AREA
MARINE CORPS AIR STATION BEAUFORT
BEAUFORT, SC

Contract Number: N62470-14-D-9016
CTO WE52
JUNE 2021

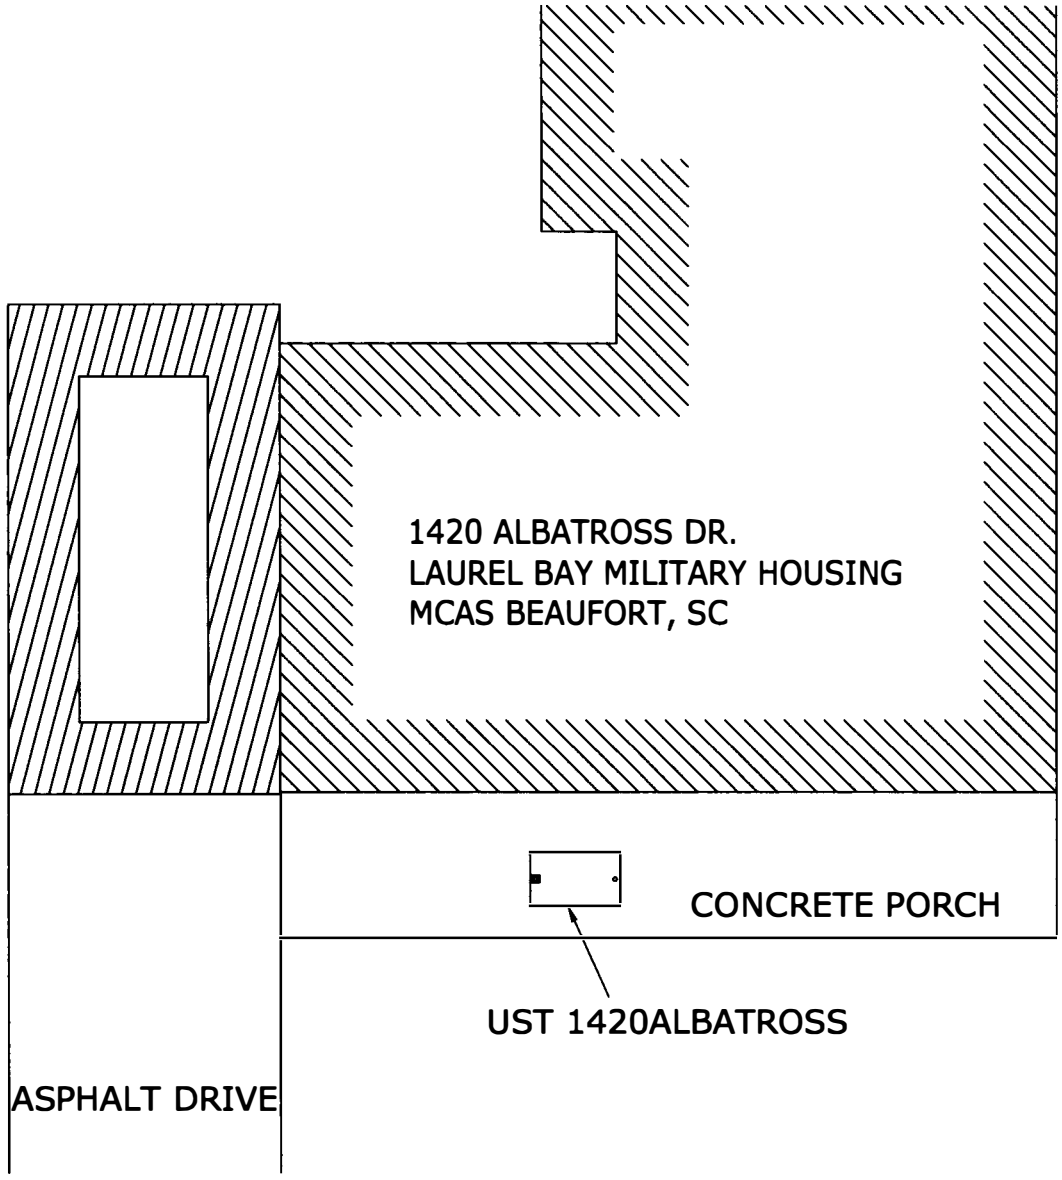
FIGURE 1 SITE MAP
1420 ALBATROSS DR., LAUREL BAY
MCAS BEAUFORT SC

TANK DEPTH BELOW GRADE
1420ALBATROSS = 37"

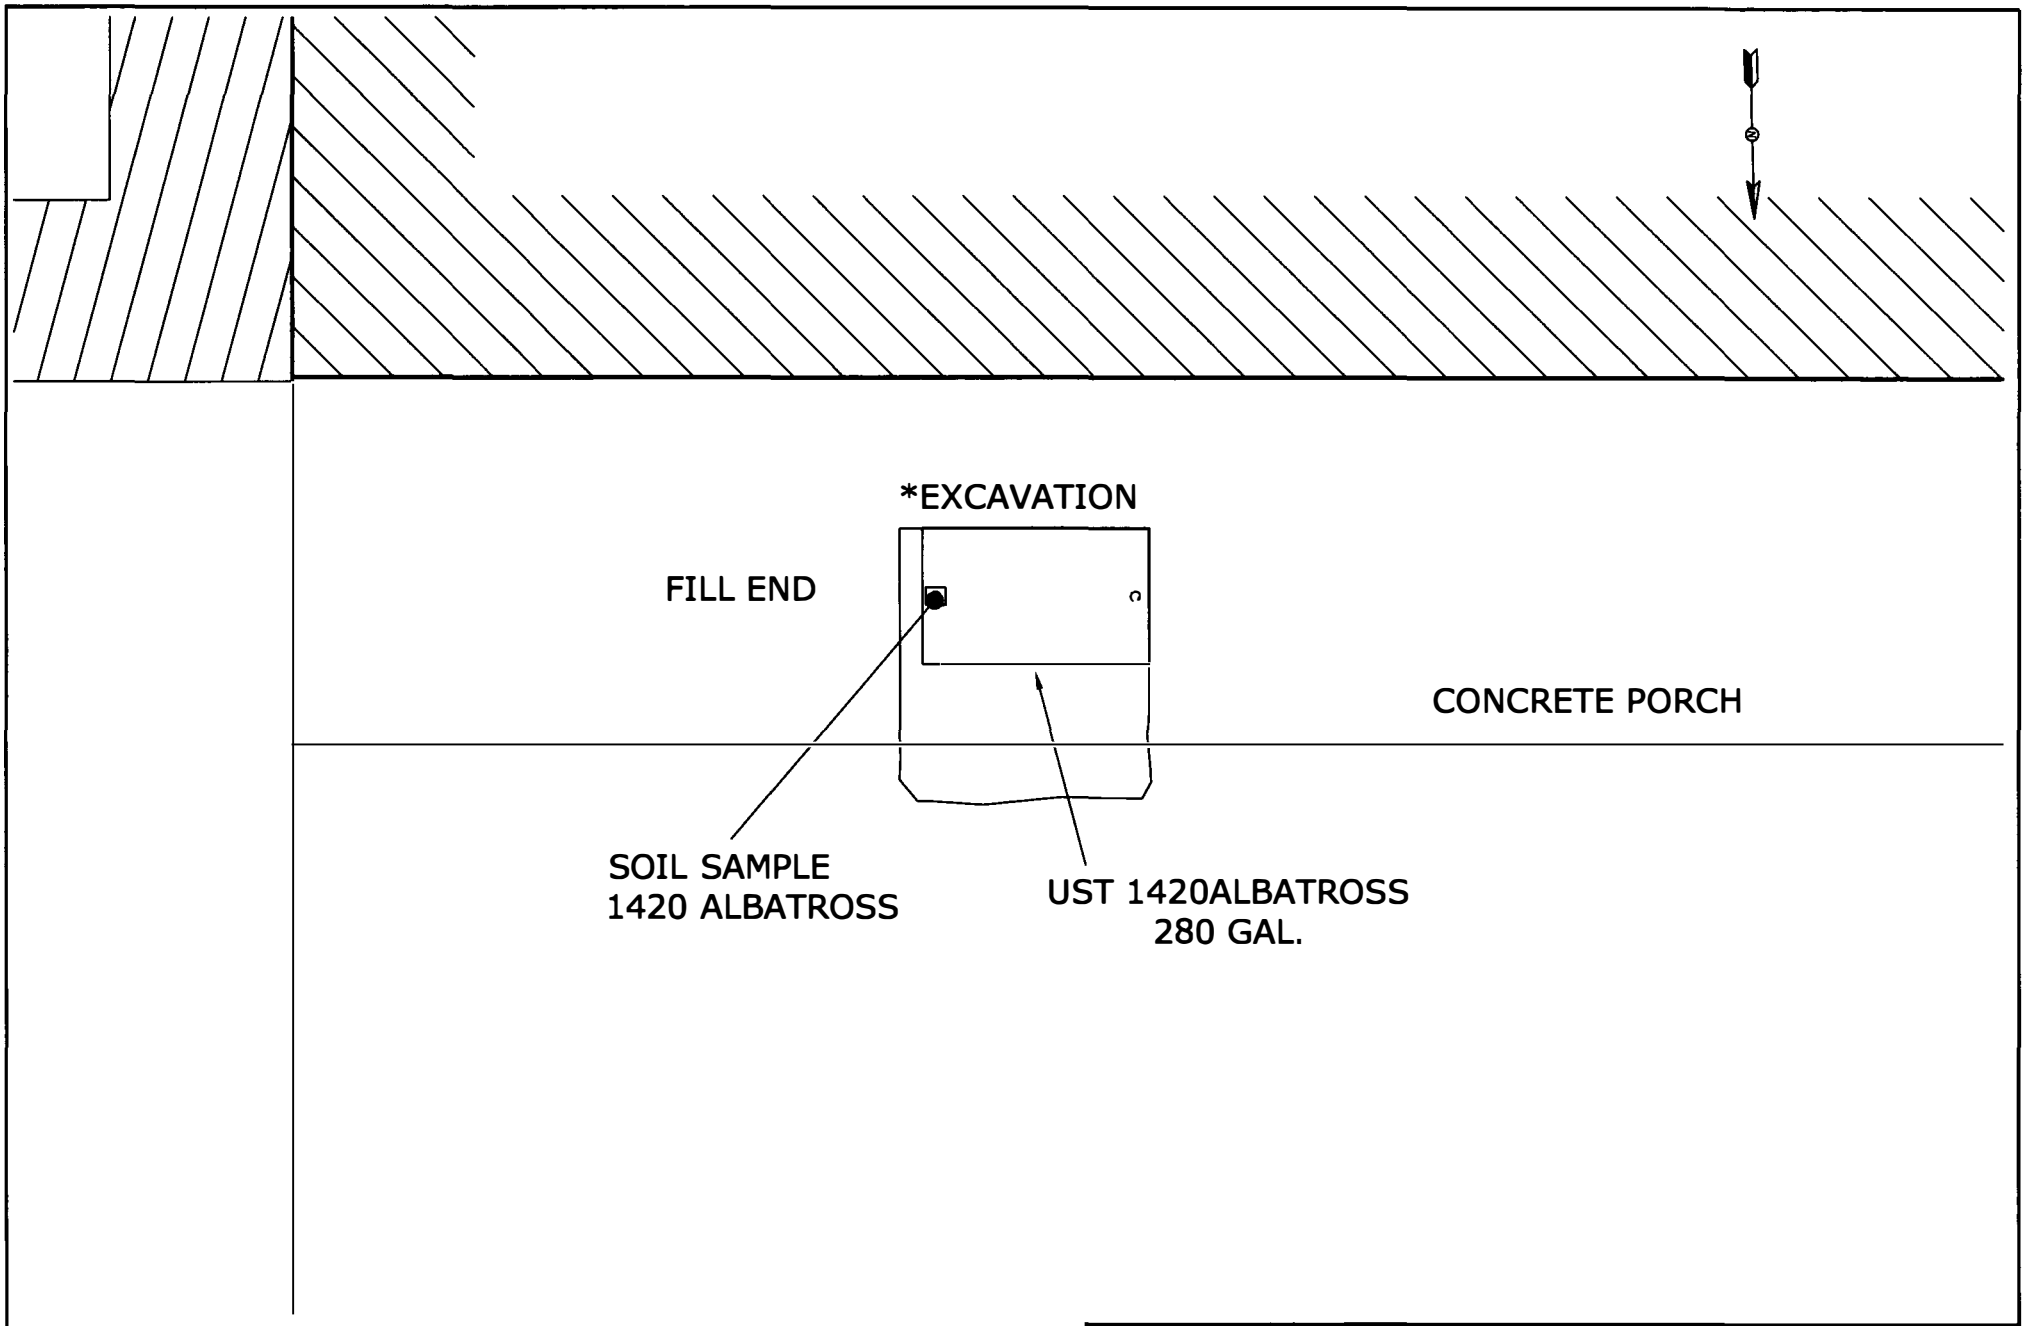
*A PORTION OF THE CONCRETE PORCH WAS REMOVED TO FACILITATE TANK EXTRACTION.
