SUMMARY REPORT
410 ASH STREET (FORMERLY 343 ASH STREET)
LAUREL BAY MILITARY HOUSING AREA
MARINE CORPS AIR STATION BEAUFORT
BEAUFORT, SC

Contract Number: N62470-14-D-9016
CTO WE52
JUNE 2021

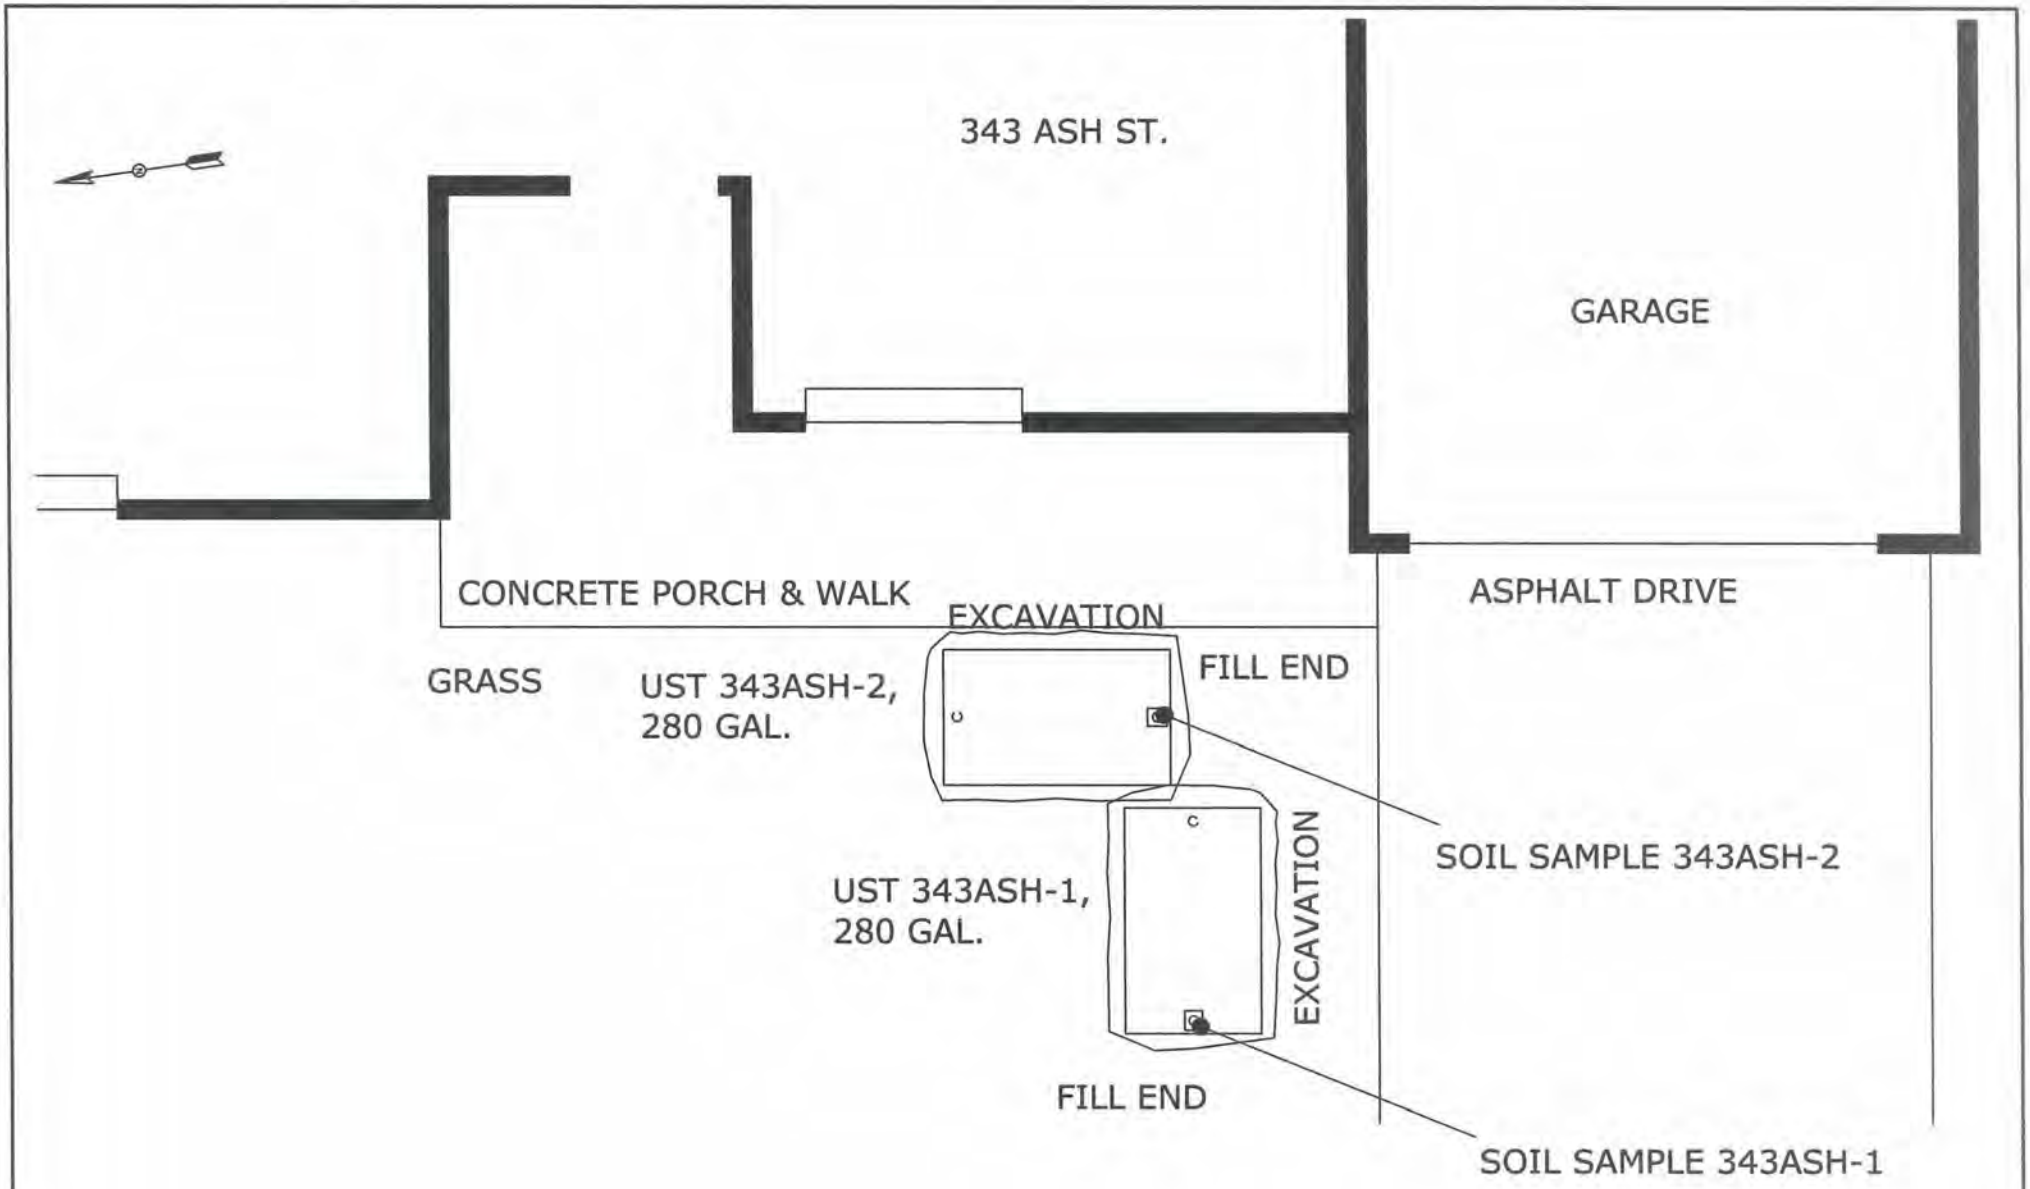
FIGURE 2 SITE MAP
343 ASH STREET, LAUREL BAY
MCAS BEAUFORT SC

UST 343ASH-1 WAS 18" BELOW GRADE.
UST 343ASH-2 WAS 36" BELOW GRADE.
